RAILROAD ACCIDENT INVESTIGATION

Report No. 4123

CHICAGO, SOUTH SHORE AND SOUTH BEND RAILROAD

APRIL 14, 1967

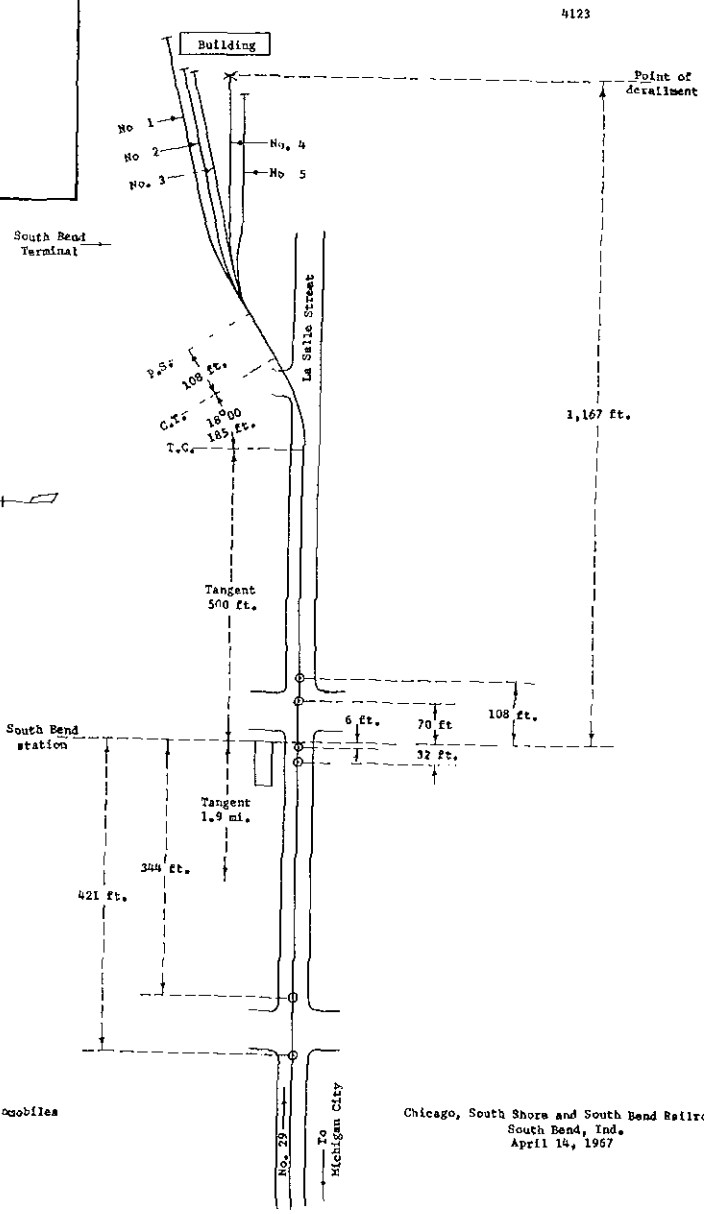
The collisions occurred on LaSalle Street, 421, 344, 32 and 6 feet west, and 70 and 108 feet east, of the east end of the South Bend station. The derailment occurred at South Bend Terminal, at the east end of stub yard track No. 4 and 1,167 feet east of the South Bend station.

While proceeding out of control in the middle of LaSalle Street, No. 29 struck six automobiles at various points between 421 feet west and 108 feet east of the South Bend station. Shortly after striking the sixth automobile, it reached the end of the main track at South Bend Terminal and entered the west end of stub yard track No. 4, at which time the engineer either jumped or fell to the ground from the doorway on the left side of the front vestibule. The train continued eastward on track No. 4, and struck and destroyed a pair of wheel stops attached to the rails near the stub end of that track. Immediately afterward, about 7:15 p. m., while moving out of control at an estimated speed of 30 to 40 miles per hour, it derailed at the stub end of track No. 4, 1,167 feet east of the South Bend station. After derailing, the train continued eastward across a driveway, penetrated the west wall of a building, and stopped with the front end
