# NATIONAL TRANSPORTATION SAFETY BOARD

## RAILROAD ACCIDENT REPORT <sup>2110.</sup>

HEAD-ON COLLISION OF CHICAGO,  
SHORE AND SOUTH BEND RAILROAD  
TRAINS NOS. 123 AND 218  
GARY, INDIANA  
JANUARY 21, 1985

NTSB/RAR-85/13.

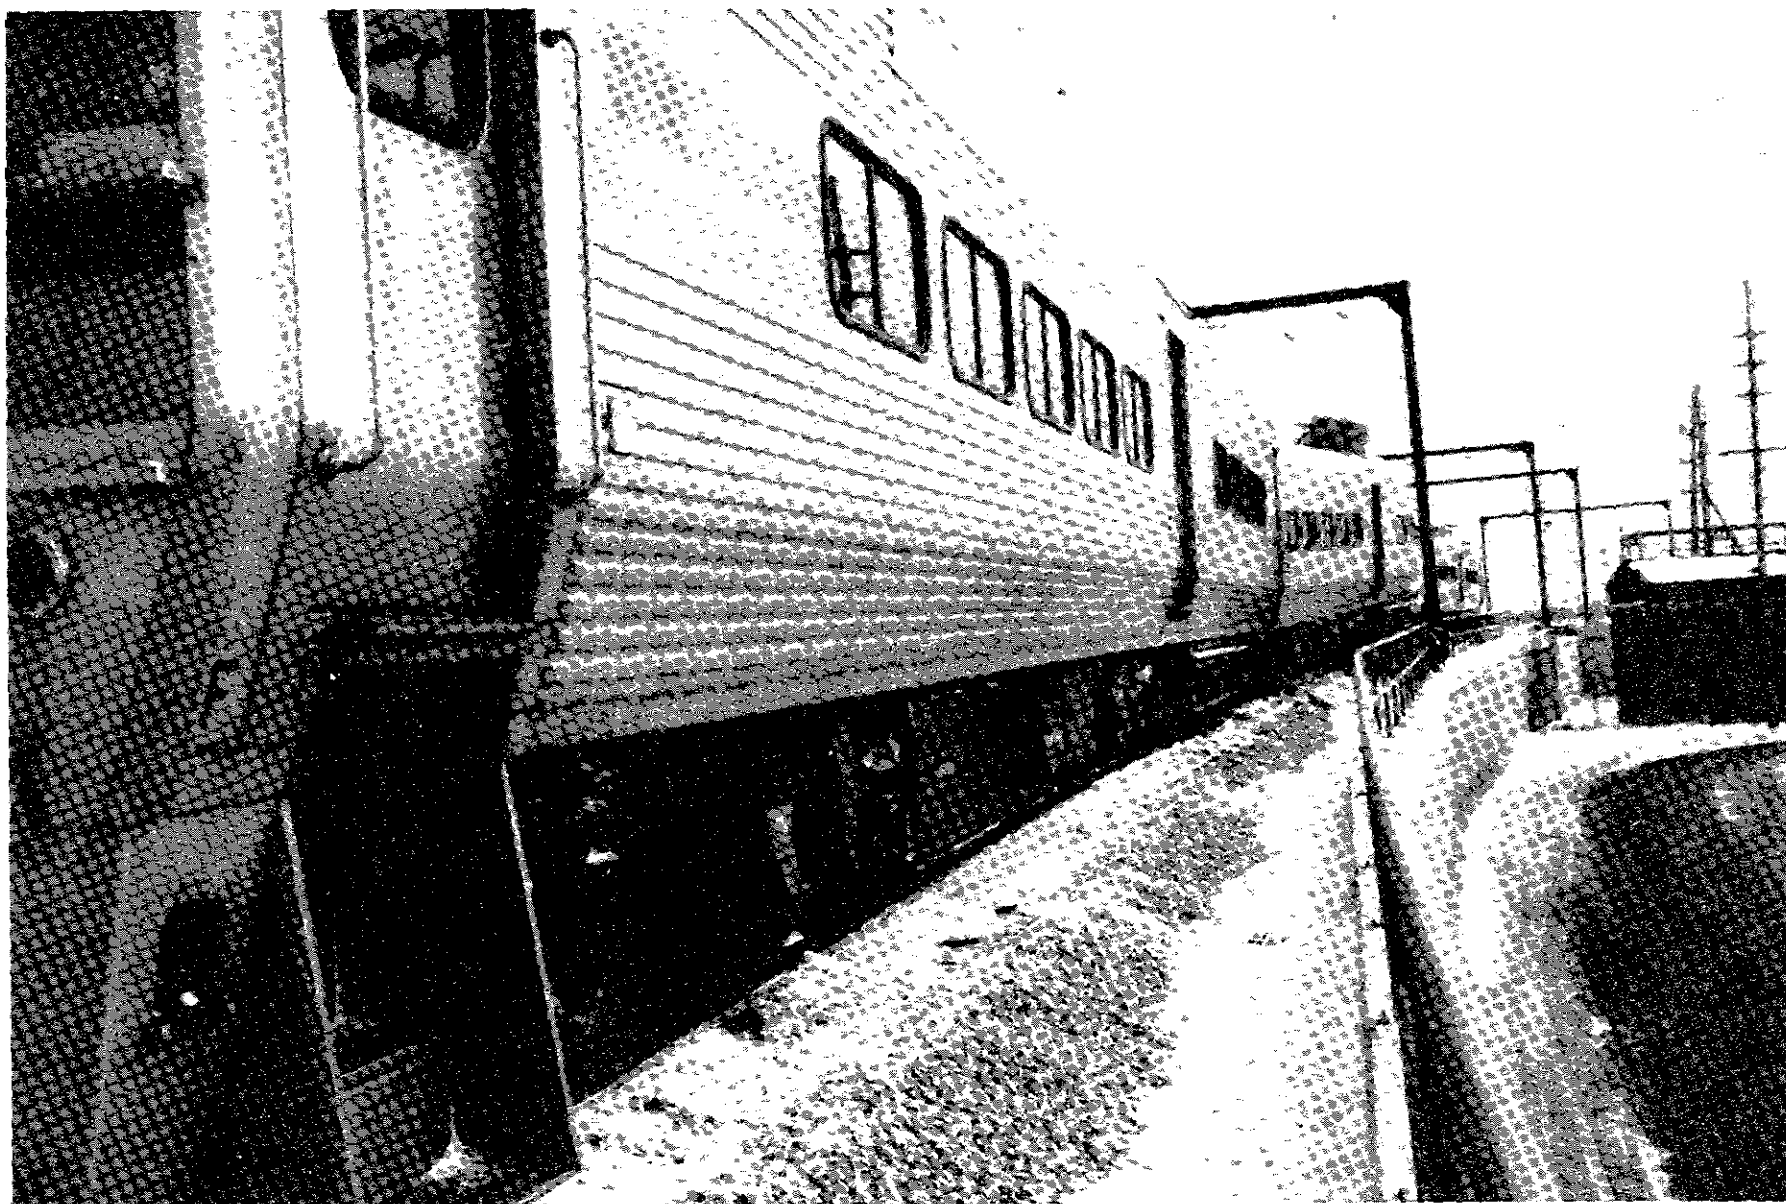
The forward vestibule areas of the two lead cars were crushed on impact. Frame and body deformation was evident to a depth of about 8 feet into the passenger compartment of each unit. (See figures 2, 3, and 4.) The two lead cars were estimated to be a total loss, while the trailing cars received only minor damage. Damage to the track was negligible, and there was no damage to the catenary or signal systems.

Figure 2.--East view of first and second cars of train No. 123 (foreground) and train No. 218 (background).

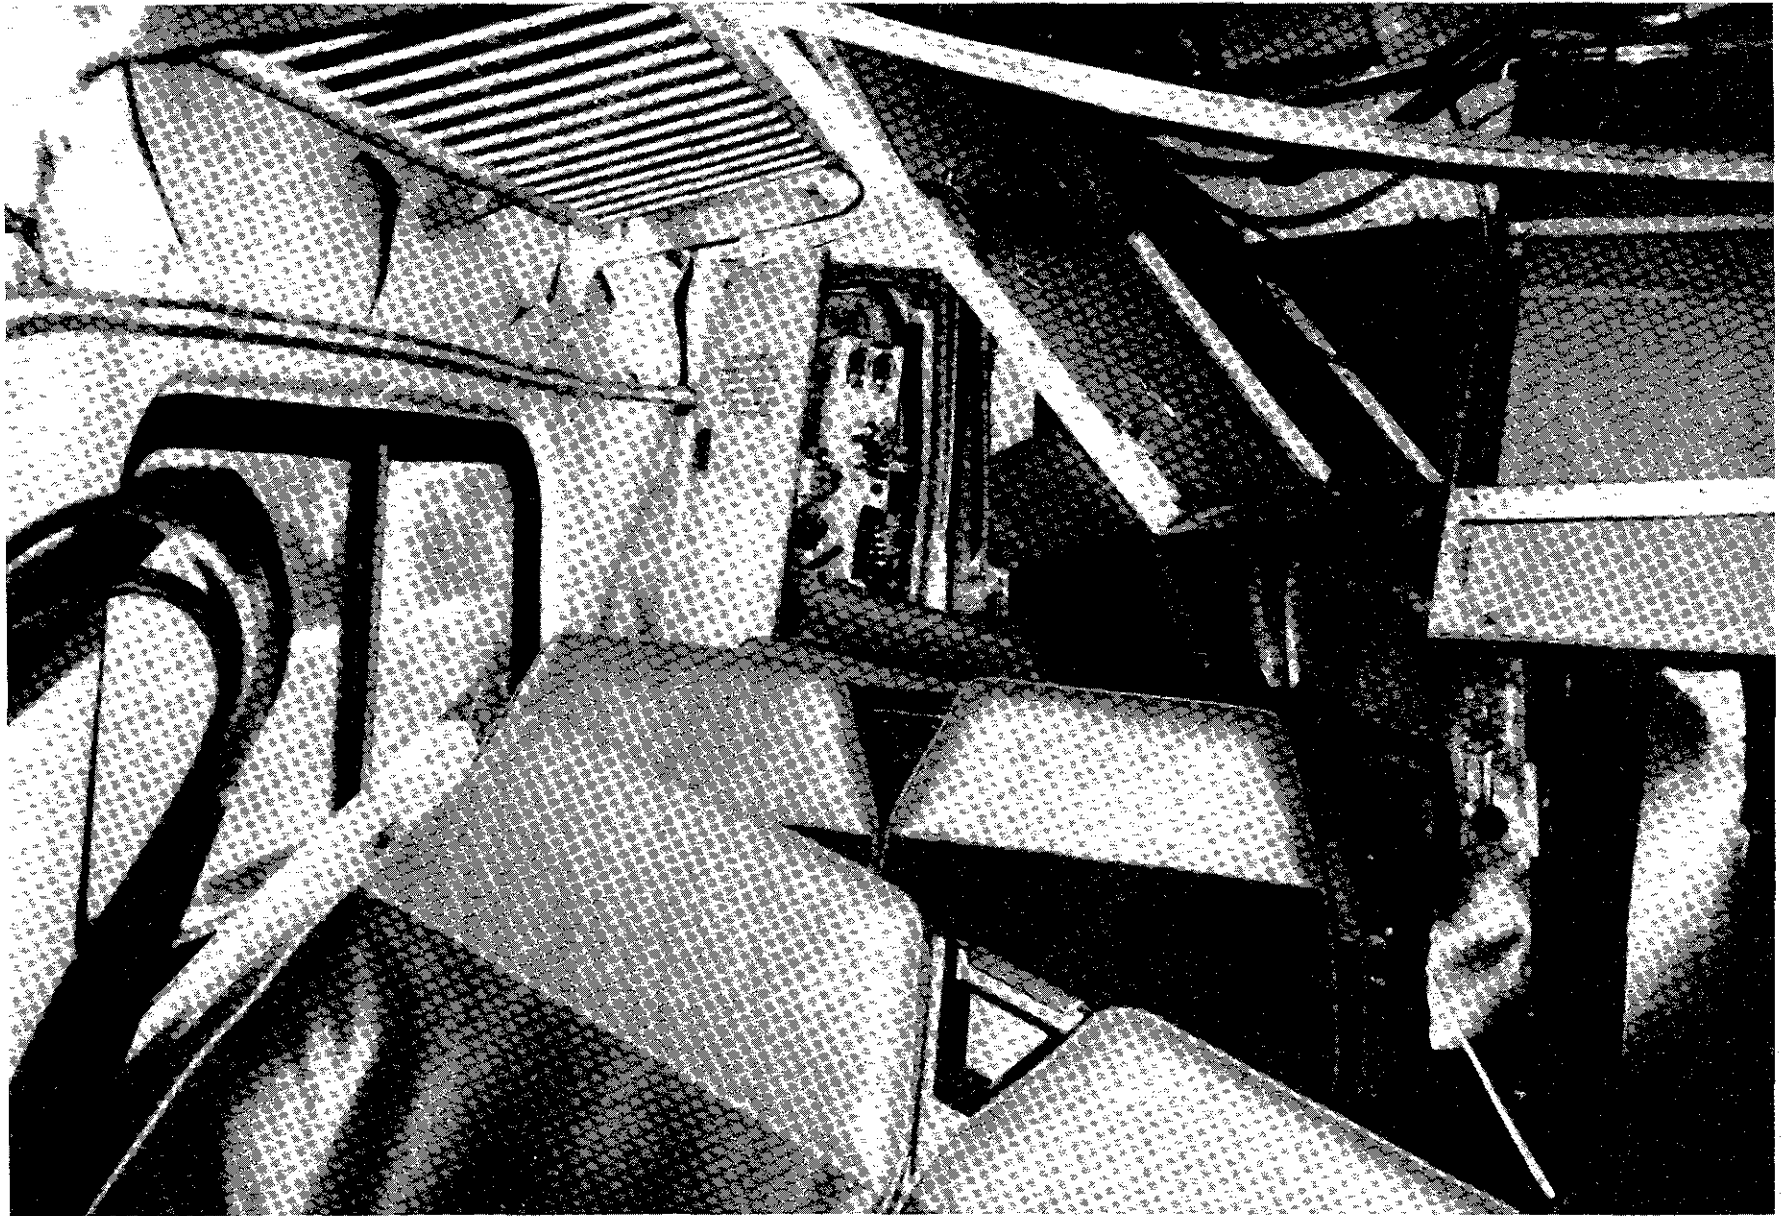
Figure 4.--Interior of lead car of train No. 123.

The forward outside body shell of the vestibule on each lead car was crushed so that the vestibule was compacted. The first rows of seats for a distance of about 8 feet were squeezed together. The sides of the cars bulged outward near the impacted ends. The luggage racks in the forward ends of the cars bent, and some became detached. The seats in the cars, except for those in the crush areas, did not separate from their floor moorings. No seat cushions were knocked loose in any seats behind those affected by the crushing forces. Passengers could not exit through the forward ends of the lead cars, but the doors to the rear and the side doors could be opened manually by following the emergency sequence indicated in the printed information on the coach walls.
