# LANDSLIDE RECLAMATION IN ŠÁRKA VALLEY

MARTIN VANÍČEK

**ABSTRACT.** Housing development in Šárka's valley is situated in former brickworks - borrow pit for brick-clay. On its north side the borrow pit cutting is up to 8m high with main road on top. This slope was suffering from progressive landslide mainly due to weathering and surface erosion. The reclamation works proposed and afterwards executed consisted of stabilizing the slope by combination of soil nailing and connecting reinforced slope with surcharge bench at its toe. The final reinforced soil structure nicely merged into the surrounding environment.

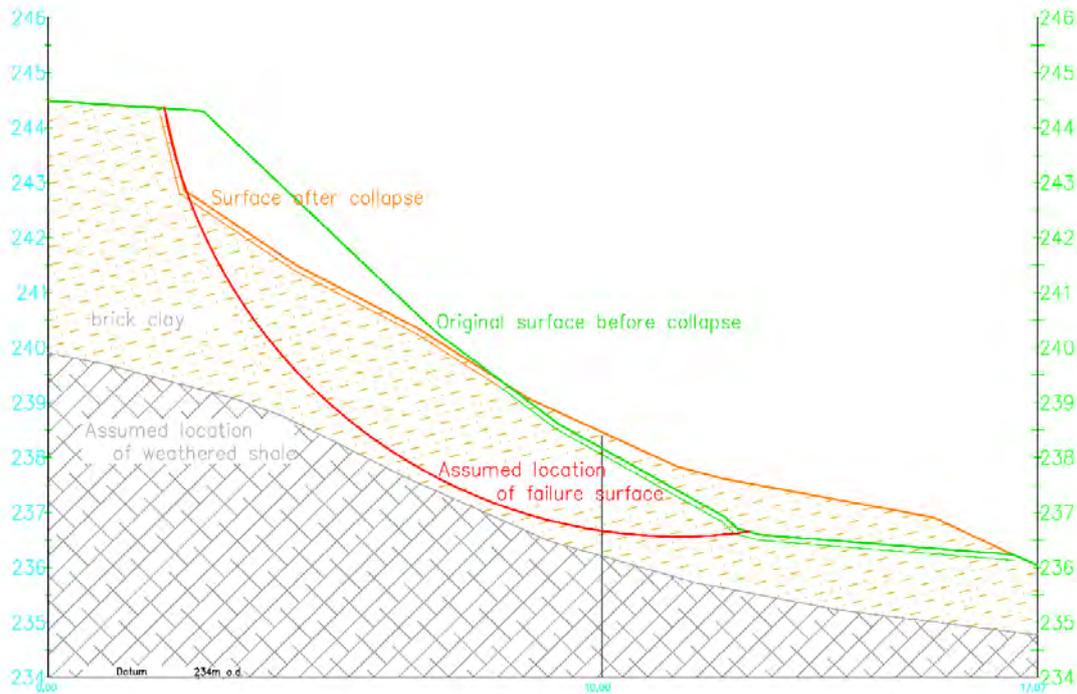
Main task of this project was to design and later to execute the reclamation of landslide below the edge of Horoměřická street. The slope is part of housing development project Top Residence Šárecké údolí. This development project is situated in the area of former brickworks. The slope that has been progressively collapsing was up to 8m height with the slope as steep as 1:1. The progressive collapse was initiated by climatic degradation of brick clay and surface erosion on the steep slope.

Based on above mentioned investigation typical cross section through land slide has been created and assumed location of slip surface together with individual soil layers has been indicated in Fig. 1.

FIGURE 1. Cross section of collapsed slope with indicated assumed geotechnical layers and slipped surface.

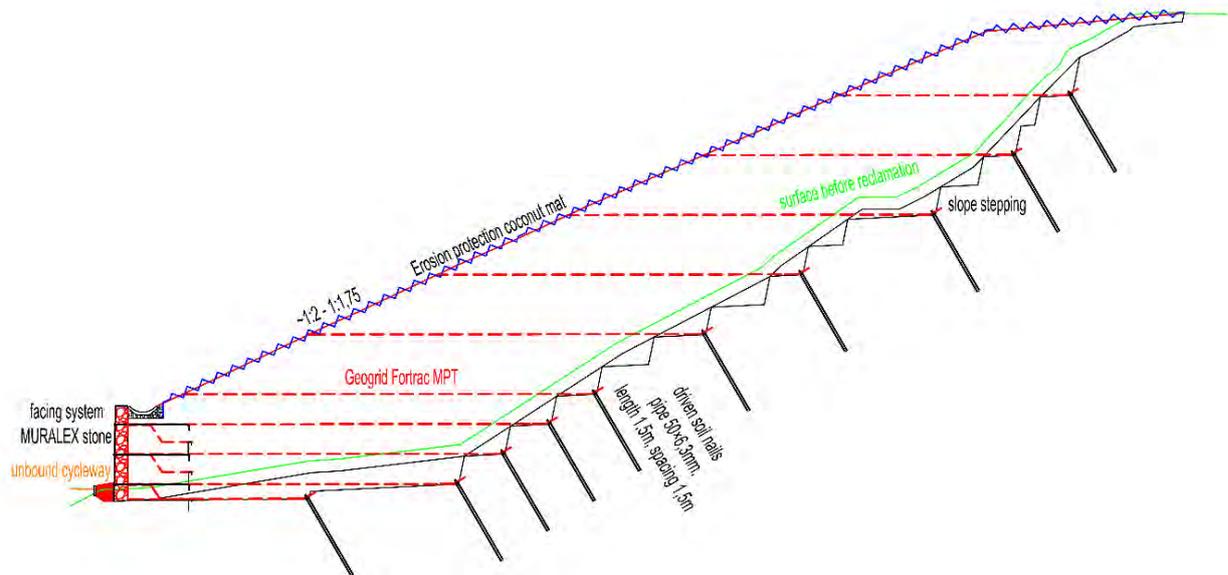
FIGURE 3. Typical cross section through the reclaimed collapsed slope

In accordance with proposed development project the bottom line of reclamation is defined by edge of unbound cycleway. In order to guarantee required stability of the reclaimed slope, it's inclination is proposed at 1:1.75 - 1:2.00 with reinforcement in 1 m spaced layers. Due to limited space, the slope has to be ended by retaining wall with max. height of 1.6 m. Based on main architect requirement the retaining wall should have gabion facing.

At the top edge of the slope, it was not possible to do any large excavations, as there is situated highly trafficked street Horoměřická. In order to cut through the potential slip surface, driven soil nails in 1m vertical and 1.5 m horizontal spacing inclined by 60° from horizontal have been proposed. These soil nails from 50 × 6.3 mm steel pipe with 1.5m length have been located into the steps in existing slope excavations created for better connection with new slope.

Stability of the new slope is maintained by reinforcing geogrids Fortrac® MPT, with vertical spacing of 0.5 m or 1 m depending on the position in the slope.

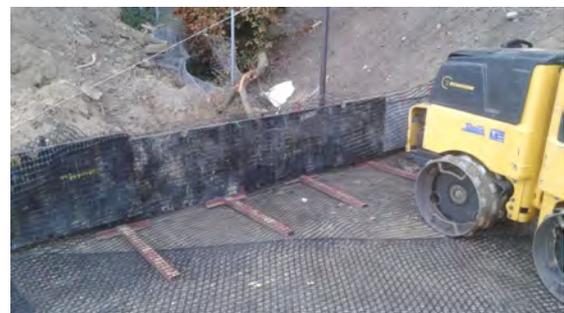
FIGURE 4. Formwork for proper compaction of reinforced soil structure with wrap-around facing in the facing area.

wall from reinforced soil was build using wrap around technique, when individual layers have been compacted against mobile formwork (see Fig. 4). At each geogrid layer, anchoring elements have been installed for future connection of MURALEX® facing elements. At these layers were also installed driven

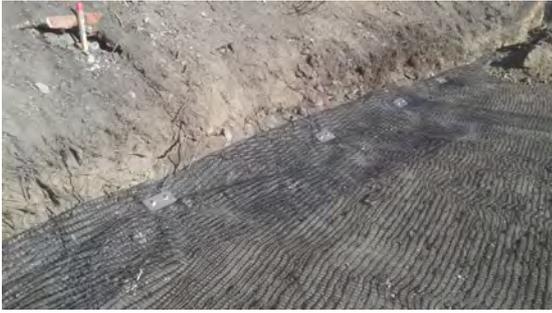
FIGURE 5. Connection of reinforcing geogrids Fortrac® MPT and driven soil nails

soil nails and connected to the geogrids strips with help of nail heads (see Fig. 5). Above the base retaining wall new slope was built with the inclination in between 1:1.75 and 1:2.00 based on space availability. The soil was compacted by plate and ditch roller and compaction quality was tested by light dynamic plate test.

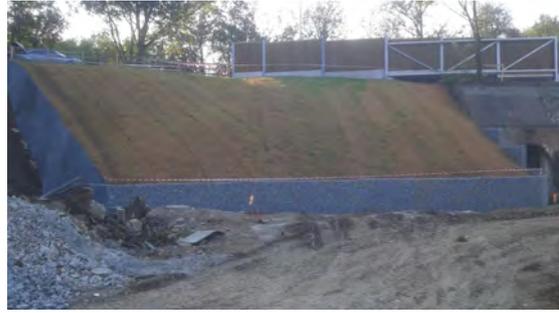
FIGURE 7. Overall view on the finished reclaimed slope, where grassing can be seen

was covered with topsoil and temporary erosion protection mesh from coconut fibres. Afterwards the whole slope surface was covered by grass seeds. Already

after couple of days the slope started to be nicely grassed (see Fig. 7).

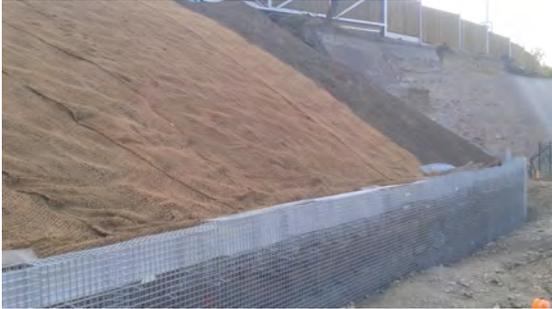
FIGURE 6. Attached front facing system MURALEX® before 63/125 mm stone filling

Once the slope was built and ramp for machinery access removed, attached front facing MURALEX® system was installed (see Fig. 6). In locations with vertical facing, the system was filled with stones 63/125 mm and in locations with 4:1 slope facing, sieved organic soil filling was used. Lastly the slope
