# PROPOSAL FOR SECURING A ROCK MASSIF NEAR BEROUN RAILWAY STATION

**ABSTRACT.** The proposal concerns the securing of a 100 m long section of the rock slope along the lead track at Beroun railway station, where a relatively massive rock block collapsed in June 2016. The rock slope is about 30 m high and its character is mainly determined by the orientation of several discontinuity systems. It was proposed for the most dangerous discontinuities that monitoring elements be used for measuring deformations at least for half a year. Dynamic barriers and protective fences were proposed for the most endangered parts of the slope.

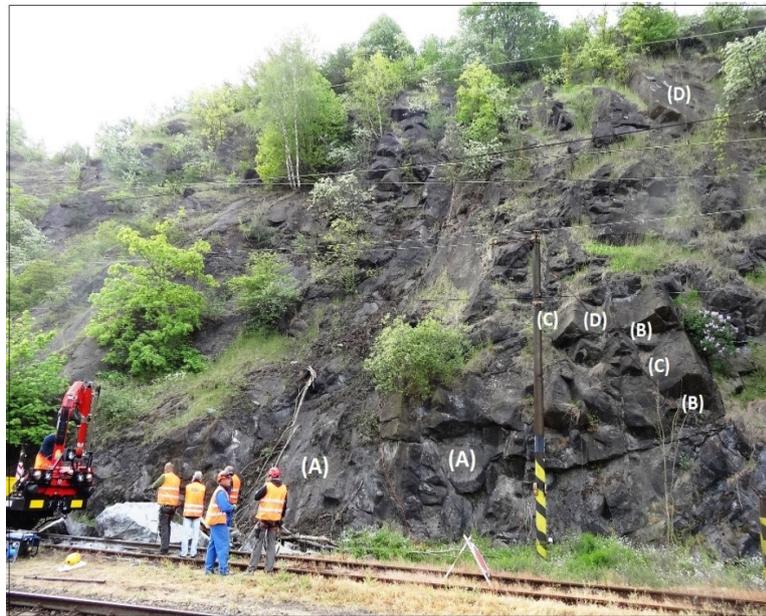
FIGURE 2. Discontinuity systems on the rock wall being monitored.

The rock massif is made up of volcanic rock types of the Palaeozoic age – granulites, altered basalts and their tuffs. These rock types are very hard, resistant to weathering. The rock wall has a general SW – NE trend and four fundamental fissure systems can be distinguished in it (see Figure 2). Fissures (A), trending roughly parallel to the slope base, with the maximum slope line running down the slope, are the least favourable. Fissures (B) dip into the slope and

are perpendicular to the system (A), thus creating potentially unstable blocks. The fissure systems (C) and (D) cut through the previous systems at angles, creating characteristic crests and reducing the sizes of the potentially unstable blocks. The discontinuity surfaces are relatively smooth or maybe in some cases, moderately undulated.

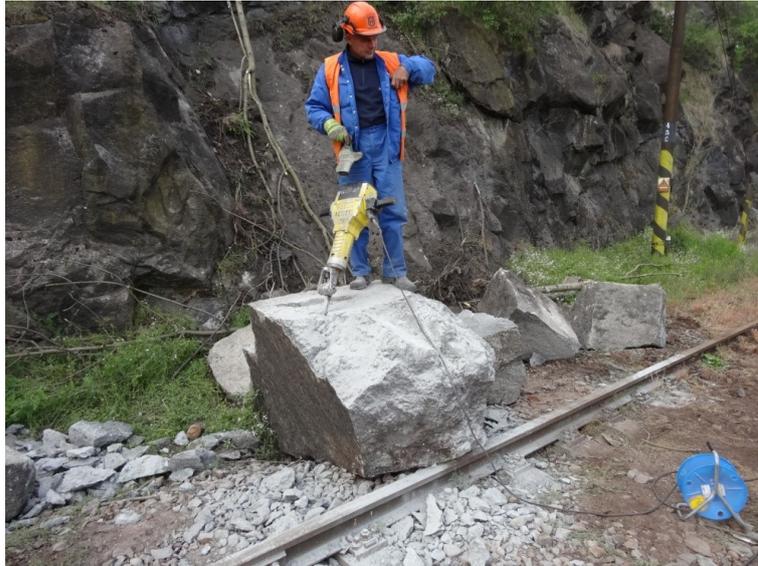
An improving and rehabilitation action, consisted in the execution of a survey, involving the removal of rock debris, some self-seeding bushes and small weathered parts of the rock, was taken in the location of concern approximately five years ago. A block of loosened rock fell down to the space of the lead track at the beginning of June 2016. It made the operation of the track impossible. The liquidation of the extremely strong rock block, hard to drill and therefore difficult to disintegrate, was very exacting (see Figure 3).

FIGURE 3. Fallen rock block after partial disintegration.

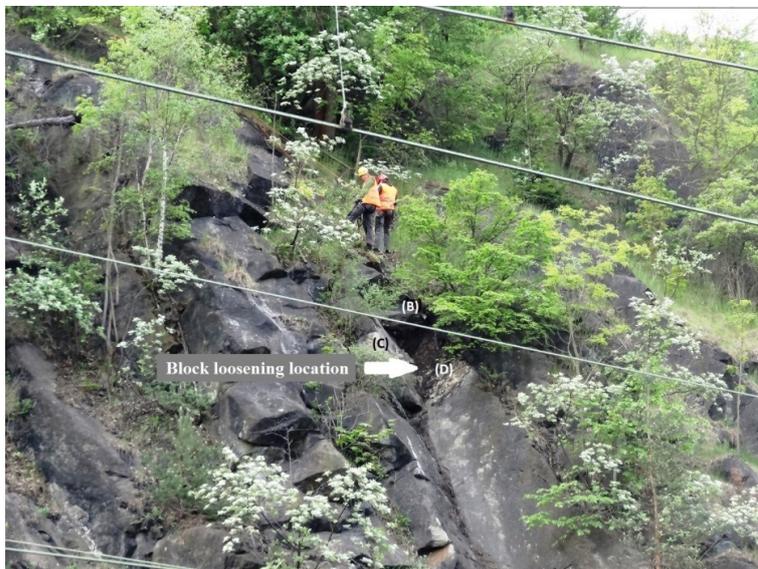
The slope deformation, which happened obviously for the first time in the location of concern, can be characterised as displacement along predetermined discontinuity surfaces, in this particular case along the surfaces (C) and (D), with the block size limited by the discontinuity surface (B) – see Figure 4. It is in substance, the last phase of a long-term creeping movement which, under certain conditions, unexpectedly develops into a rock fall. The usual conditioning factors of the creep and unexpected change in the rate of the movement of the rock blocks comprise the geomorphological disposition of the slope, weathering, the effect of surface water as well as groundwater, and the influence of vegetation and anthropogenic actions. In the majority of cases, this includes general assessment of the location. It is a concurrent action of several effects slowly reducing the shear strength on discontinuity surfaces that triggers the above-mentioned

creeping movement. Over a long time or also in the case of a sudden change in external conditions, the shear strength on discontinuity surfaces is exceeded by the tangential component of the dead weight of the loosened part of the rock massif, which then in fact becomes the immediate cause of the rock fall.

FIGURE 4. The location of a loosening of the fallen rock block.

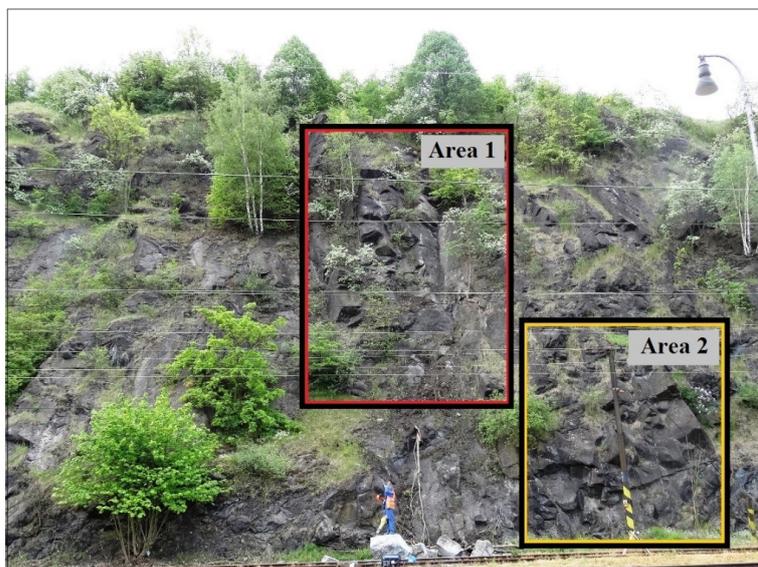
formation monitoring elements was provided during the inspection. The monitoring elements need to be installed on about 10 dangerous discontinuities without any unnecessary delay. They should be observed at around half-year intervals always before and after a climatic change – at the end of autumn and at the beginning of spring. Contingent smaller-extent cleaning of the wall and inspection of the wall condition will be carried out concurrently with the unavoidable climbing checks of the measuring instruments, so that the possibility of the loss of stability of some of the larger rock block can be assessed. Increased attention has to be devoted to areas No. 1 and 2 (see Figure 5), where the danger of loosening rock blocks is greatest. The inspection of the wall and the photographic documentation signal the possibility of some blocks losing their stability in the above-mentioned areas.

FIGURE 5. Dangerous areas of the rock wall.

Taking into consideration the exposed section of the rock slope above the lead track, the author of the assessment contemplated carrying out a design for rehabilitation measures which would reliably ensure operational safety in the railway yard. It would comprise a dynamic barrier under the particular area No. 1, possibly even above the area No. 2, and a protective fence or another type of a solid barrier under this area No. 2.

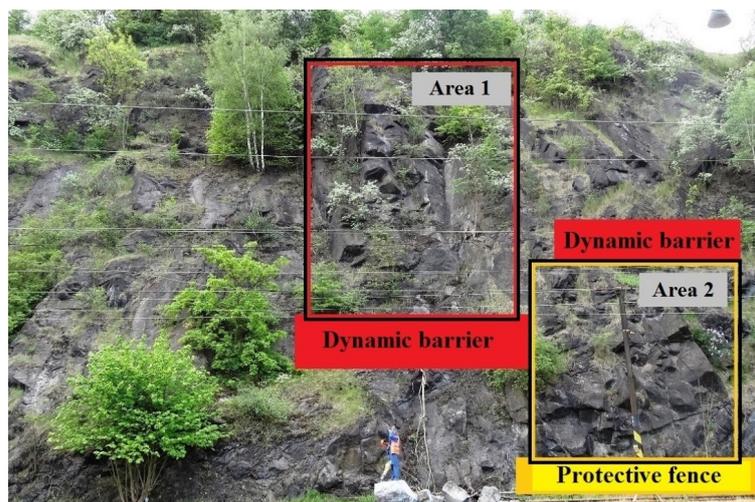
FIGURE 9. Locations for the placement of dynamic barriers and the protective fence in the endangered areas of the rock wall.

It will be suitable to install the dynamic barriers on the rock slope of concern roughly at one third of the height of the wall under the area No. 1 and possibly above the area No. 2, approximately in the middle of the wall height. The barriers will be 2 m up to 2.5 m high. The locations for the placement of the dynamic barriers and protective fence are schematically indicated in Figure 9. All of presented figures were captured during climbing research by [3].
