A RETAINING WALL RECONSTRUCTION IN KUTNÁ HORA

JIŘÍ SVOBODA*, DANA HADAČOVÁ

Pragoprojekt, a. s. (Plc.), K Ryšánce 1668/16, 147 54 Prague, Czech Republic

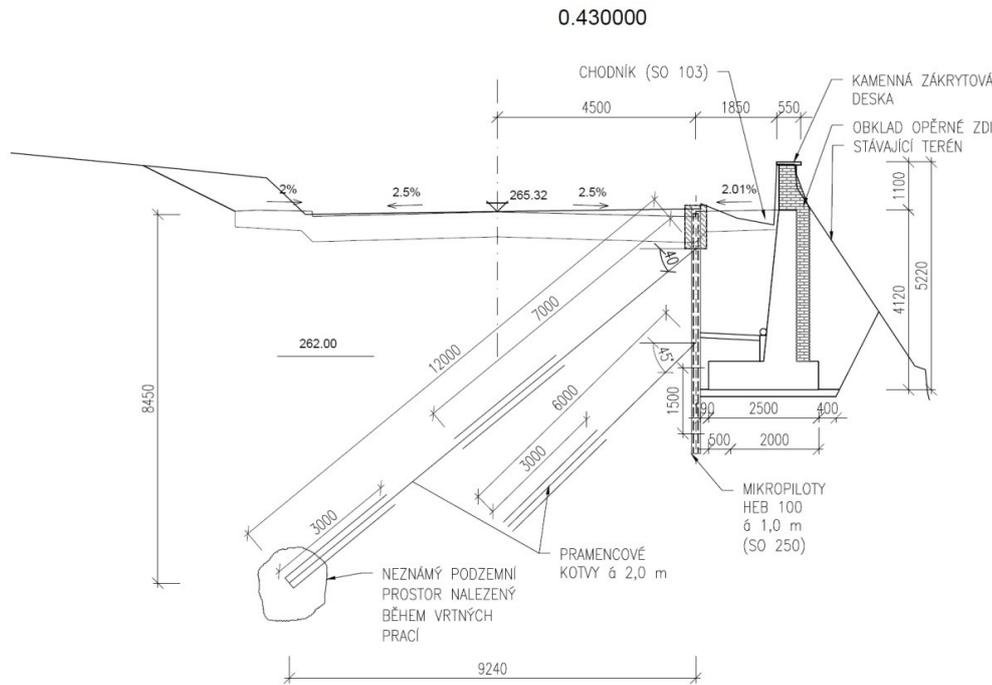
FIGURE 1. Underground space scheme.

The formerly important silver mine Osel is located in the area concerned as is the Osel vein range. In the Middle Ages the mining works were done under the sandstone layers in a zone of clay rocks or geological faults. The foundations of these workings were inadequately carried out, and that is why after the drifts were exhausted and dismantled, the clay rock gradually reduced to mush causing the present cave-ins.

Anchors bond lengths were also located in the mushy surrounding because of the ancient mining. That led to a considerable overconsumption of the injecting material during the anchor bond lengths execution. For illustration, the underground scheme is shown in Figure 1. The view of the original and new wall near St. Barbara's dome is captured in Figure 2. The detail of the wall is depicted in Figure 3.

Two major cave-ins happened on the site during the construction. Right under the carriageway a free underground space of circa 65 m³ was rehabilitated. Some other surveying drills were made to find other free spaces especially under the carriageway. All these caves were filled with cement-ash mixture followed by a low-pressure cement injection.

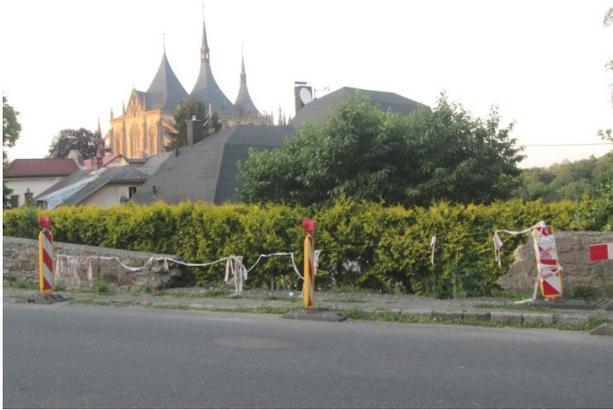
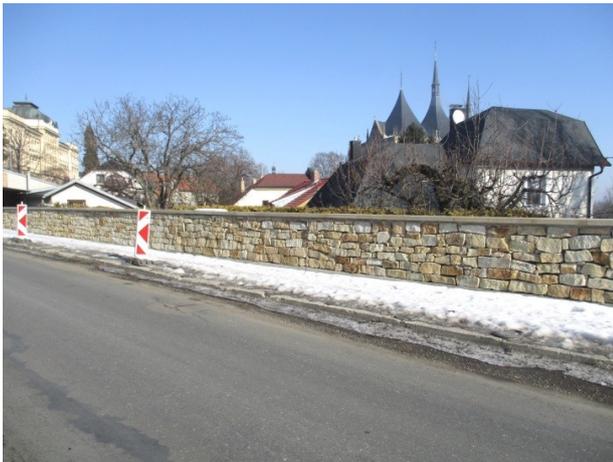
FIGURE 2. View of the original (top) and new wall (bottom) near St. Barbara's dome.

On the basis of the above mentioned sources it was concluded that the major part of the retaining wall was in serious disrepair and the work for its securing and subsequent reconstruction were to start immediately.

After meetings on conceptualisation with the ordering party (Central Bohemia Road Agency – KSUS and Kutná Hora municipality) a basic variant of the retaining wall design was set up. A monolithic reinforced concrete cantilever wall with stone lining was designed to be built in a temporarily supported excavation [1].

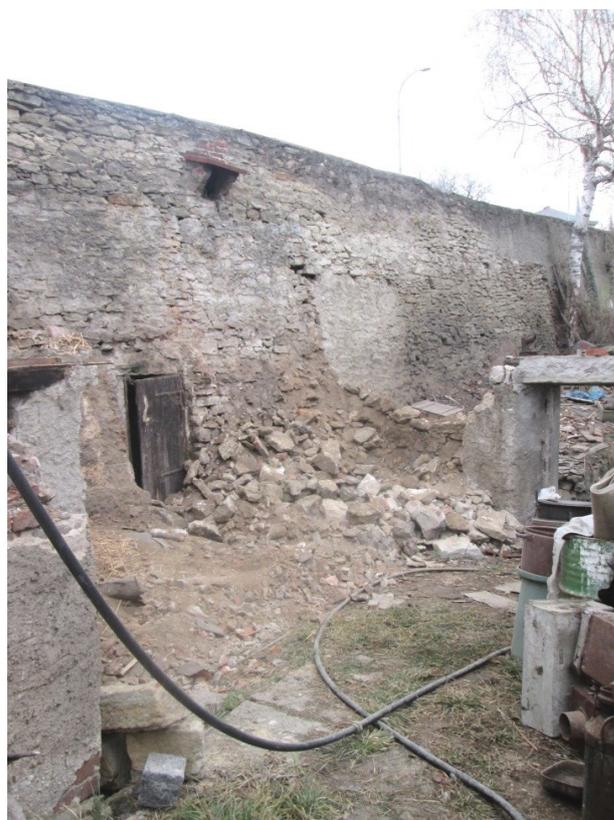
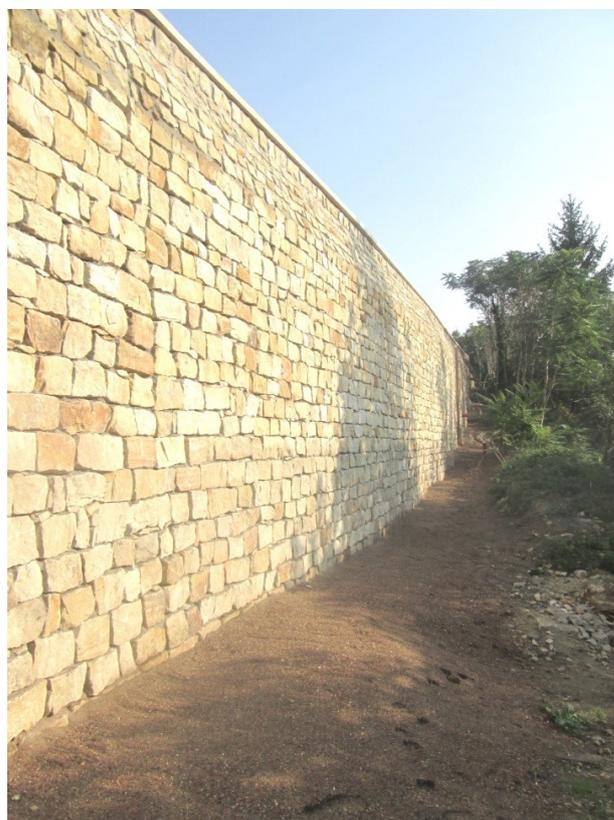
FIGURE 3. Structural condition comparison: the old (top) and the new wall (bottom).

The wall was in serious disrepair and it was necessary for it to be fixed immediately, possibly because of the hazard of accident such as a wall slide, or even a total collapse of the road embankment.

The reinforced concrete cantilever wall itself has a variable height circa 1.5–5.0 m. Its total length is circa 315.0 m. It is founded on an underlay concrete slab 0.15 m thick. The breadth of the footing is within 1.9–2.5 m and the height 0.45–0.65 m. The wall was mainly built in 5–6 m long sections. In some sections, where the geology was unfavourable or where there were additional static reasons, the footing was founded on steel micropiles. The wall back drainage is provided by passages embedded to the stem and the longitudinal drainage system behind the wall.

there was no need to give this stone wall some dimensions as a safety barrier for traffic. The face of the new retaining wall is also walled in with stone. This lining is in the upper part gradually merged with the stone wall structure and capped with a flat stone roof 0.55 m wide. The aboveground stone part and the stone lining are integral parts of the retaining wall static system.
