Explosion of a Circulating Fluidized Bed Furnace for Coal and Biomass

This article describes an incident that occurred on 12th March 2019 in the Solvay factory at Rheinberg in Germany. It caused the explosion of circulating fluidized bed furnace for coal and biomass.

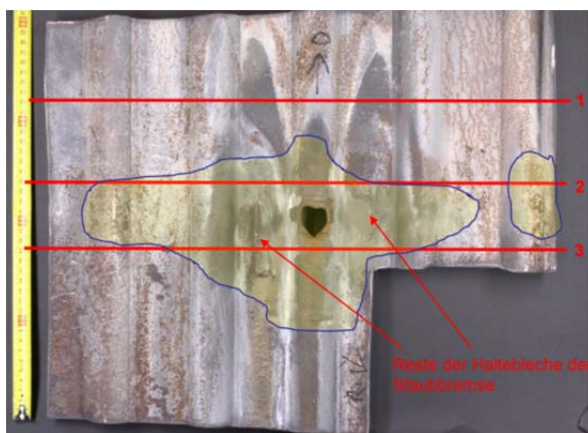
A horizontal tube of the evaporator had a 3 cm diameter hole, as shown in Figures 2 and 3. The metal had thinned, then been pushed outwards, forming a pattern rather like the petals of a flower.

Figure 2: Damaged section (40x60 cm) cut out from the side of the boiler showing the hole in the evaporator tube.

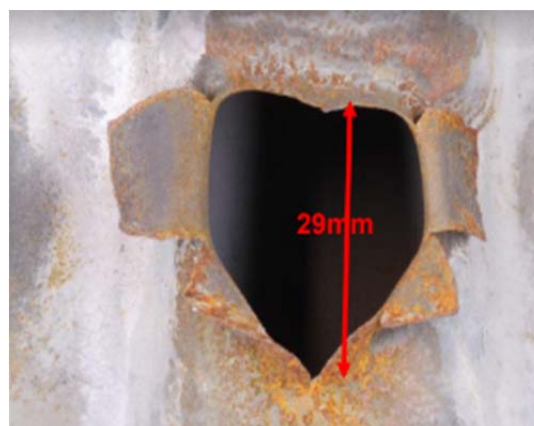
Figure 3: Close-up of the hole in the evaporator tube

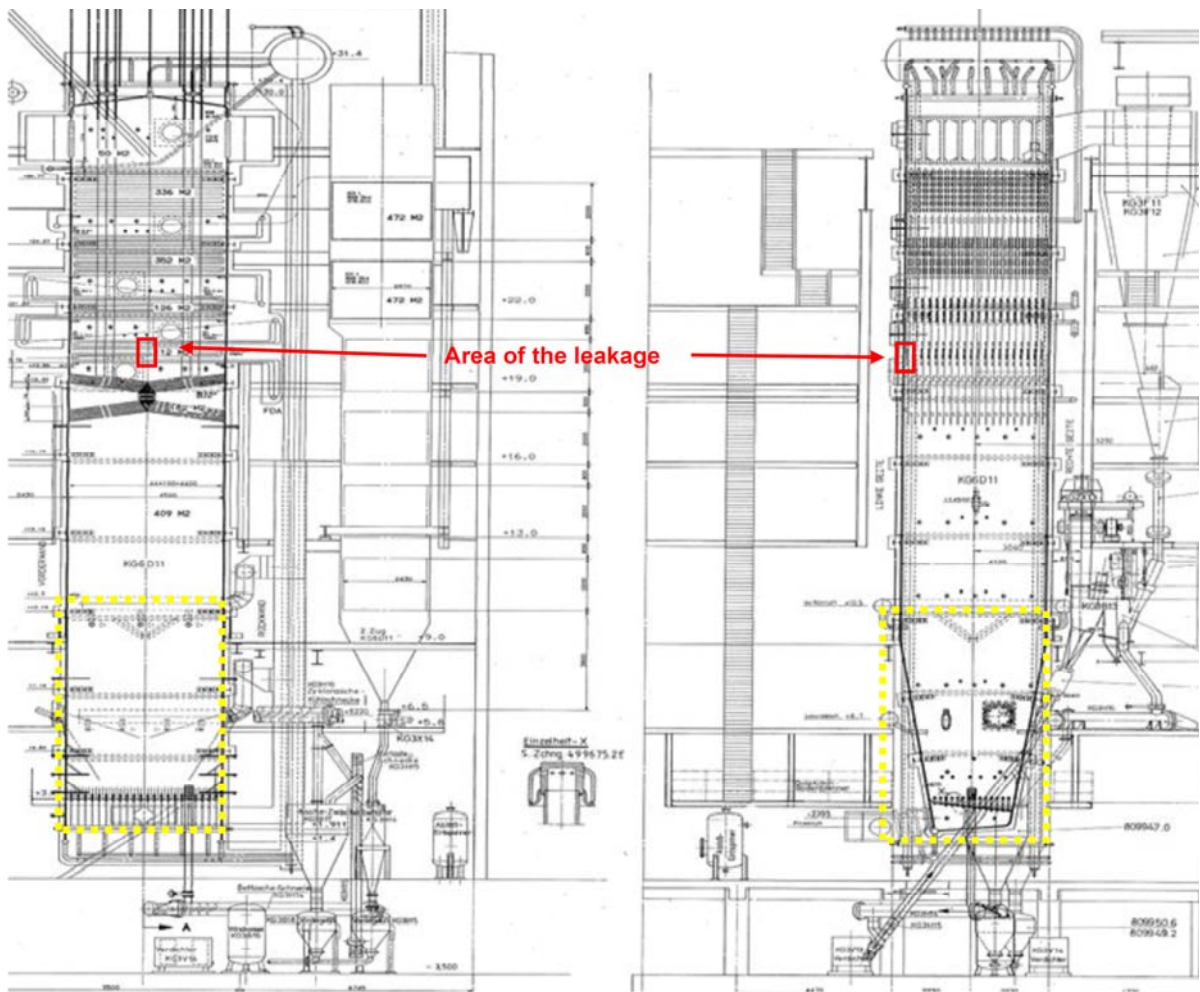
A drawing of the fluidized bed boiler, indicating the position of the fluidized bed and the approximate position of the leak is shown in Figure 4. The leak was at a height of about 20 m in the evaporator tubes forming the left wall of the boiler. It was located just above a soot blower, which is shown in Figures 6 to 8.

Figure 4: Position of the leakage (red) and of the fluidized bed (dotted yellow)

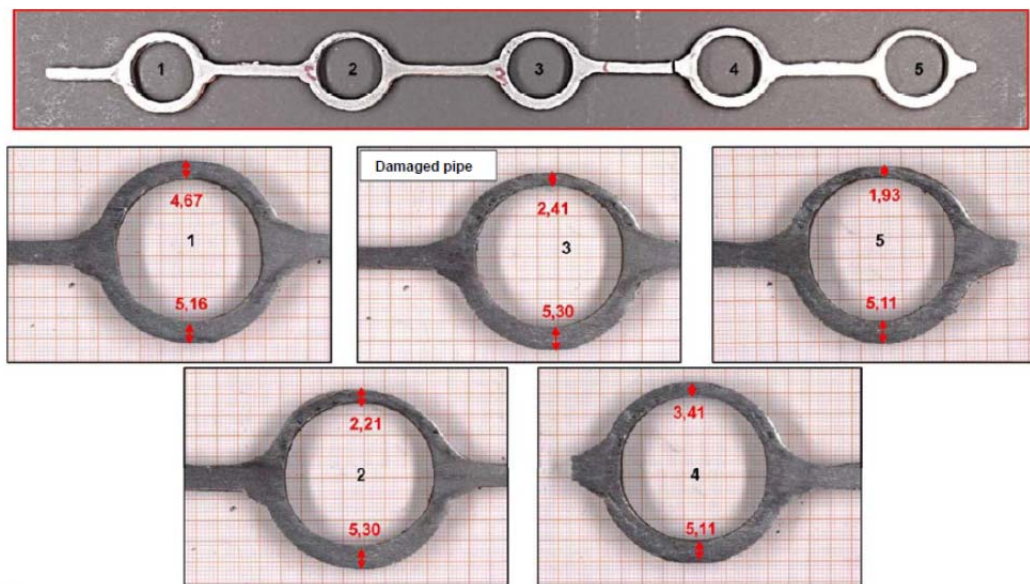
Microscopic examination showed that the metal on the furnace side had been worn away and polished. The reduction in thickness in areas around the leak was as much as 3 mm as shown in Figure 5 (the normal thickness of the boiler tubes was 7-8 mm).

Figure 5: Thickness measurement of the boiler tubes at five points around the leak

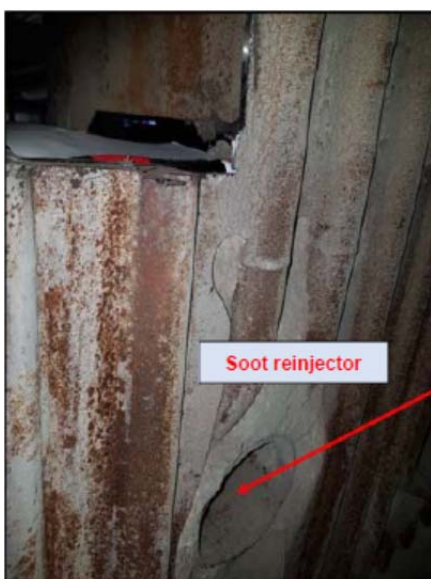
Figure 6: Evaporator wall:

- the area top left, where the leak occurred, has been cut out (see figure 2)
- the red arrow shows the location of the soot blower (see figures 7 & 8),
- the metal of the tubes above the soot blower is thinner than elsewhere.

The examinations carried out indicate that the material of the evaporator wall tubing on the furnace side had been eroded, causing the leak. This thinning of the tubes was localised above a soot blower. Therefore, we believe that a malfunction of the soot blower, such as premature or faulty blowing must have occurred. The investigation revealed no other causes for the higher levels of depletion on the furnace side, such as high-temperature corrosion, overheating or faulty material.

The tube rupture seems to have been caused by problems with a nearby soot blower. Such problems are commonplace in such furnaces and it is essential to carry out regular inspections at suitable intervals and to measure wall thicknesses etc. in order to detect it and to correct it before significant damage occurs. This is a considerable challenge for the maintenance team and we can recommend no simple cheap methods to do it.

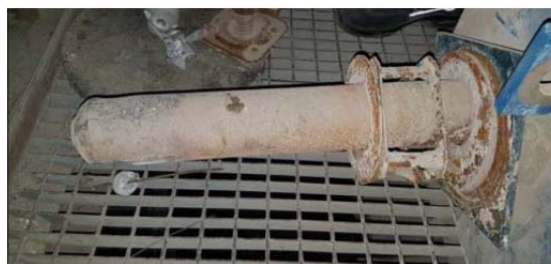
Figure 7: soot blower after removal from the furnace.

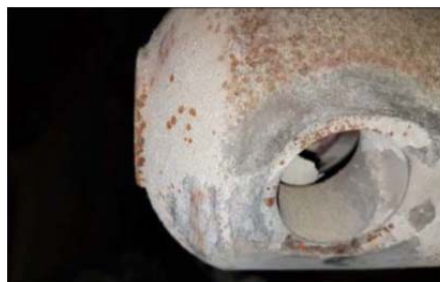
Figure 8: lance head of soot blower shows signs of wear.
