# Analysis of Thermal Defects on Exterior Wall Insulation System

This paper aims to evaluate the damage degree and actual effect of the exterior wall insulation system. For this purpose, the author decided to investigate a typical building with severe damages on the exterior wall insulation system. Then, the variation in temperature and humidity of the wall was measured by embedded sensors, and compared with the results obtained through theoretical analysis. Coupled with thermal image, the contrastive results help to clarify the causes and solutions to defects like exfoliation and leakage. This research provides new insights on the construction, application and repair of energy-saving walls.

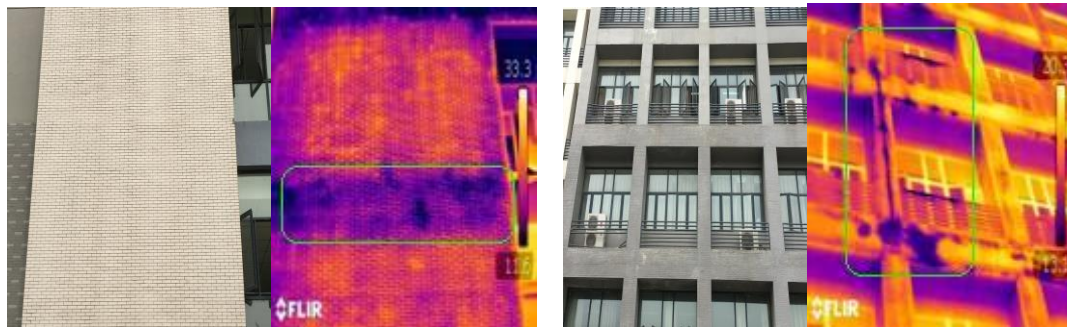
The search for leakages was carried out on a sunny day after three days of raining. As shown in the rectangular purple area of Figure 2, a lot of leakage areas were discovered on the exterior wall. The leakage is a main reason for hollowing, surface cracking and exfoliation (Vemuri and Atadero, 2017).

Figure 2: Thermal and visible images

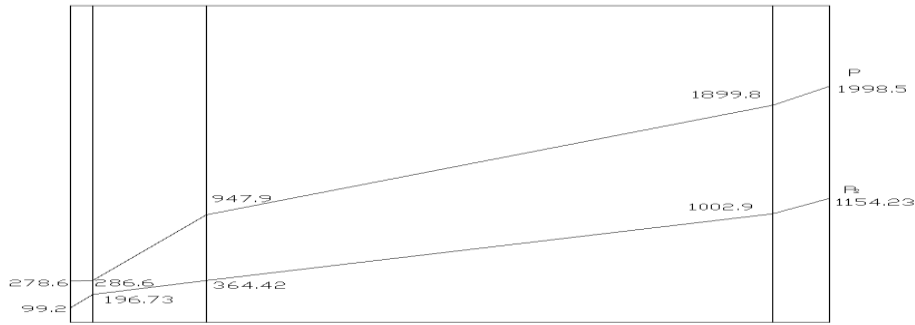
Next, the partial pressure of water vapor ( $P_s$ ) and that of saturated water vapour ( $P$ ) of each layer were computed to determine the presence of leakage. Since there was no intersection between the two distribution lines of  $P$  and  $P_s$  (Figure 3), no condensation occurred in the wall, i.e. the water seepage in the wall must be caused by external factors.

Figure 3: Distribution lines of P and Ps for wall structure of main body

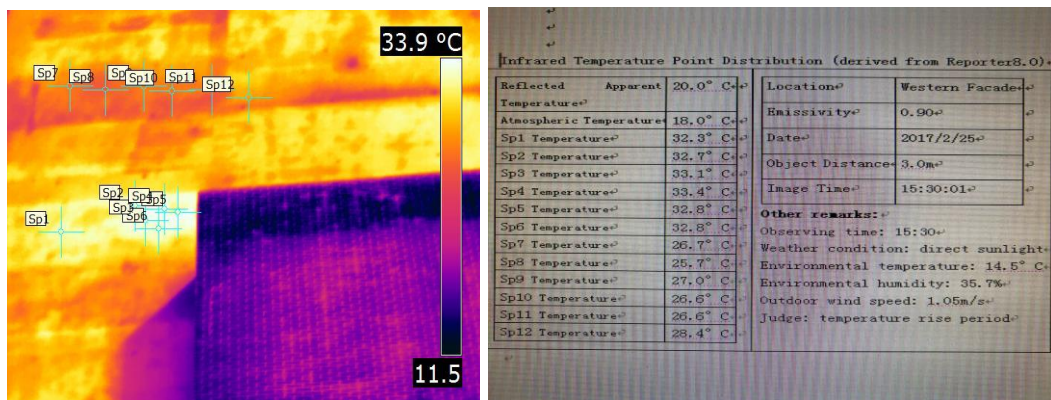
Taking the west façade of the target building for example, the thermal images on exfoliation obtained in the heating and cooling phases were imported to Reporter 8.0(Figure 4). Six temperature points were selected from the exfoliated area (group 1) and six from the normal area (group 2). According to the table generated by the software, the mean values were calculated for each group of data, and the difference between the two means ( $\Delta t$ ) was also obtained to judge the display effect of exfoliation (Cunningham *et al.*,2016). A total of 18 thermal images were taken at different times, and all computations were carried out at the same place. The temperature difference curves were drawn and recorded in Figure 5.

Figure 4: Thermal image and temperature points

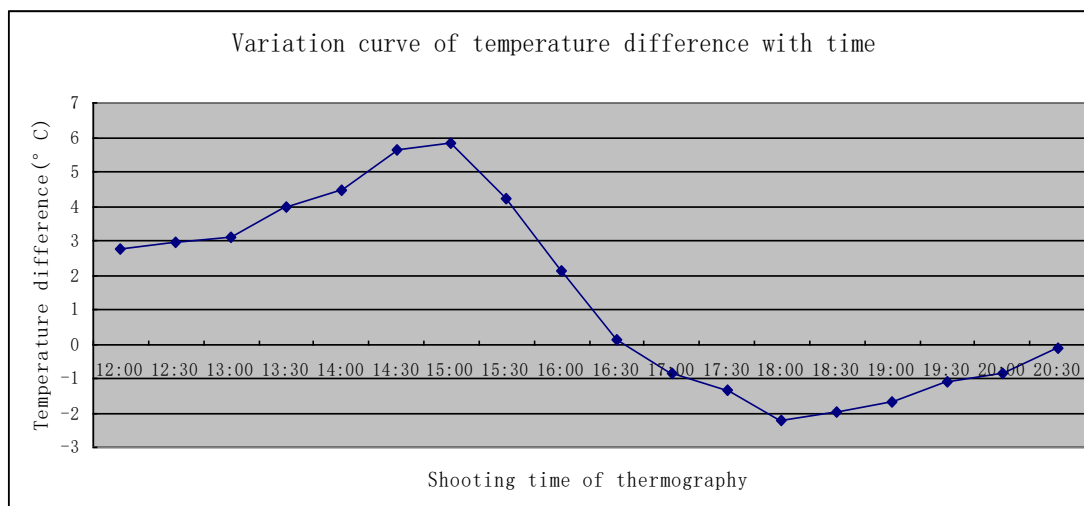
Figure 5: Temperature difference curves

As shown in Figure 5, there was a huge temperature difference in the heating phase. The mean difference of the 9 groups was 3.90°C and the peak temperature reached 5.85°C. The best observation time fell between 14:00 and 15:30. A possible explanation is that the sunshine is stronger in this period during the winter. By contrast, the temperature difference was rather small in the cooling phase. The mean difference of the 9 groups was -1.11°C and the peak temperature was -2.24°C. The best observation time fell between 17:30 and 19:00. This is probably because the temperature varies little when it is getting dark.
