# Emergency Runaway Reaction - What Precedes? What Follows?

Eckhard Fiedler

BASF SE, Ludwigshafen, Process Safety GUS/AA - M 940  
 eckhard.fiedler@basf.com

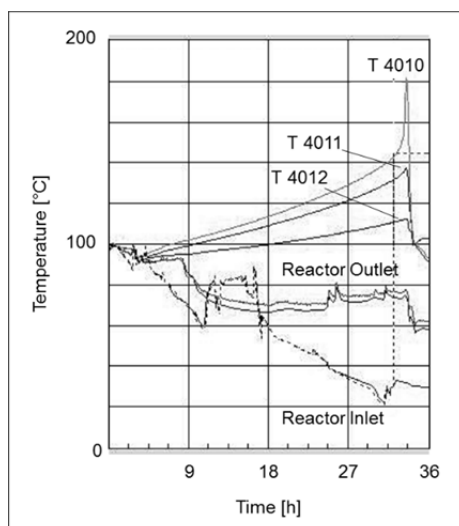
Figure 3: Temperature Profile of Tube Reactor C 400

A flange of a differential pressure measurement was opened using hazmat suits. In the meantime temperature reached 180 °C (Figure 3), close to a final runaway with potential bursting of the reactor.

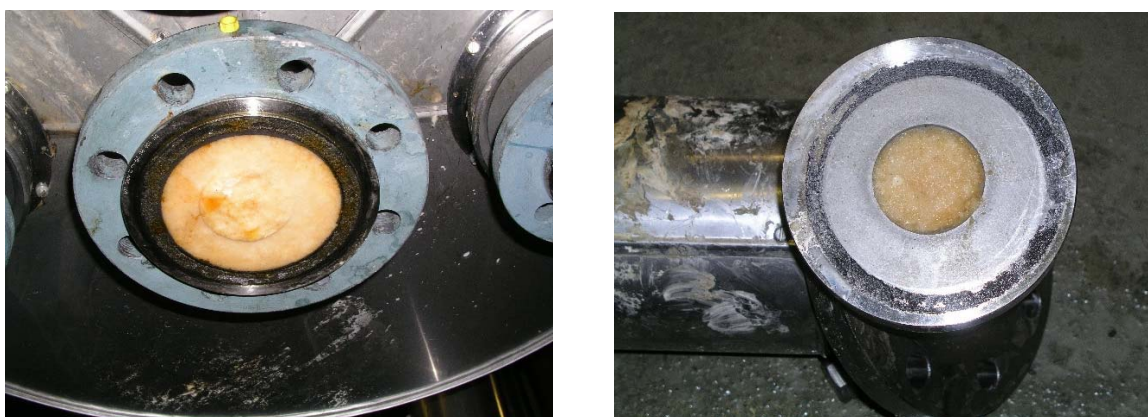
Figure 4: Plugged Reactor Inlet C 400 (left) and Plugged Reactor Feed Line (right)

The reactor was blocked by crystallization (Figure 4). Due to cold feed from reactor R 512 during restart of the tube reactor C 400 the temperature in R 523 decreased below 88 °C. In combination with a higher concentration of Ammonia and Water the Nitrile precipitated contrary to operational experience. Because of massive crystallization all flushing and draining connections were plugged. All attempts for flushing failed. Misleadingly the operators presumed only a blockage in the reactor outlet and an empty reactor. Therefore the temperature high alarms in the tube reactor were interpreted as false alarms and no one informed the plant management.

Due to a confusing report at shift change the subsequent shift crew acted under the assumption that the outlet was cleaned and the reactor was in filling mode. They didn't realize that the inlet was also plugged. In a former HAZOP-study the observed scenario of reactor plugging was considered very unlikely. The HAZOP team assumed that precipitated NTN would be dissolved by heating-up in the steam heated heat exchanger W 402. Therefore only the temperature measurements at the reactor inlet (TZ 4003, TZ 4004) and the reactor outlet (TZ 4008, TZ 4009) were part of a safety instrument function to detect a starting runaway reaction.

After long considerations and discussions it was finally decided to take the tube reactor C 400 out of service and to run the synthesis only with both stirred reactors. Organizational measures were improved in cooperation with the shift supervisors (especially information content of shift handover protocol). Additionally the design of the emergency dump system was modified by low dead zone connections and a drain line in the feed pipe to to now directly connected vessel R 525.

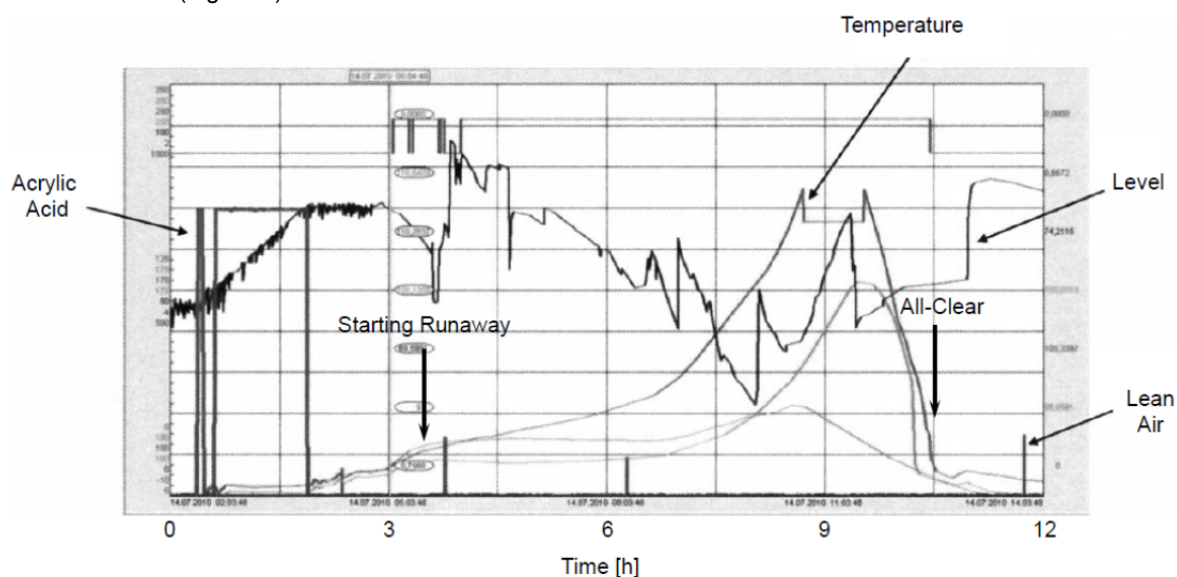
Figure 6: Temperature Profile of BDEA Synthesis in Agitated Vessel

During the batch finishing phase of a trial run an uncontrolled polymerization was observed (Figure 6). Short stopping with additional MEHQ after increase of temperature and viscosity failed due to loss of lean air. After 2.5 h water was added via a meanwhile opened manhole without immediate success. The fire brigade was alerted 30 minutes later. They initiated a partial evacuation of the plant, alarmed the close proximity and ordered shelter-in-place or evacuation of several office buildings on the site. After two additional hours the BASF crisis committee for emergency response was convened. In the meantime the temperature in the reactor increased to maximum 270 °C. Fortunately 5.5 h after starting runaway the temperature in the vessel decreased to 100 °C (normal condition) and half an hour later all-clear could be given.

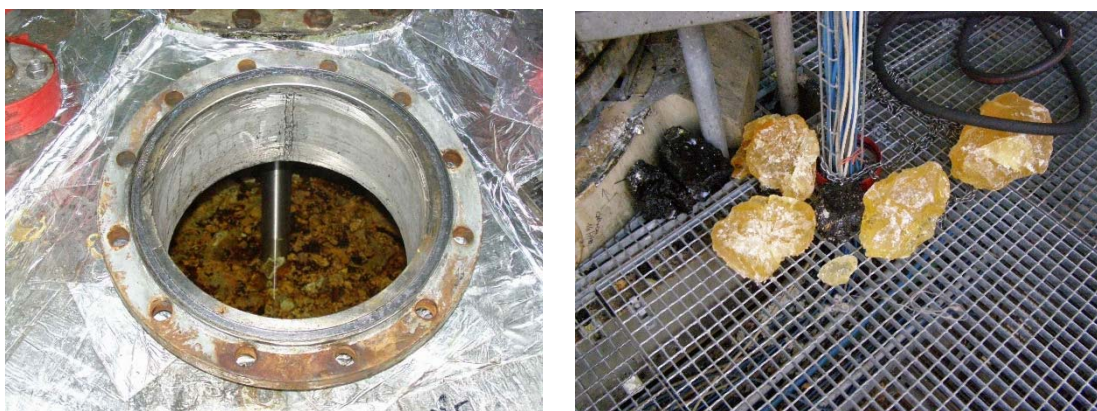
After the incident the upper part of the reactor was filled by polymer, the bottom part showed a liquid phase of unreacted BDE (Figure 7).

Figure 7: View through the open manhole of the reactor after the incident, showing massive polymerization (left) Pieces of Polymer from the reactor (right)

Due to customer request the common stabilizer Phenothiazin was substituted by MEHQ. MEHQ stabilized acrylic systems are requiring a sufficient oxygen supply by lean air to keep the stabilizer in function. In the present case the lean air supply was insufficient. Due to a blocked check valve in the line the lean air flow became low with the consequence of loss of stabilizer activity and subsequent starting polymerization of BDEA after conversion of 90 % acrylic acid. Fortunately the temperature in the reactor didn't exceed the extrapolated maximum temperature of 270 °C (Figure 6) due to evaporative cooling by the added water and depressurizing via the open manhole. Safety data of the reaction system had shown gas forming, self-accelerating decomposition above 300 °C.

At the bottom of the agitator vessel mixing was insufficient. Loss of lean air enhanced this effect with the consequence of additional self-polymerization of unreacted BDE.

Test trials for the synthesis of BDEA were cancelled immediately, no restart of the process until yet. Charging a reactor with the whole amount of BDE, which can polymerize by itself highly exothermic, is very dangerous. Therefore the process has to be redesigned to an inherently safer approach before any restart of the synthesis.

Nevertheless the plant safety concept for handling acrylic systems in the plant concerned was revised. Under design aspects safeguarding of lean air supply was improved to SIL-quality and the short stopping concept in reactive systems was adapted to BASF requirements. Organizational measures and checklists were improved with focus on safety relevant issues and Management of Change process. Personal presence in the plant and control room was amended and knowledge transfer from R&D to production was improved according to BASF regulations.
