The impact of the 6th April 2009 L'Aquila earthquake (Italy) on the industrial facilities and life lines. Considerations in terms of NaTech risk

Stefano Grimaz¹, Alberto Maiolo²

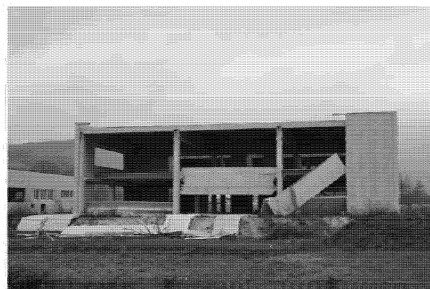
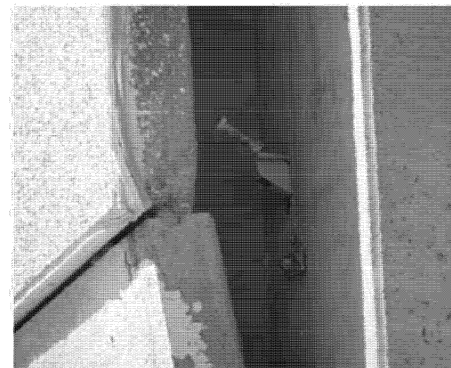
- a) the damage observed was mainly concentrated in nonstructural elements (e.g., partitions and ceiling tiles) and contents. The criticisms were related to connections between the secondary elements and the structure. The collapsed walls of the precast-concrete buildings were a direct result of inadequate anchorage between the wall panels and the roof and floor framing members.
- b) some structural damage to beams and columns was observed. The criticisms were related to the weakness of the joints and in particular to unseating effects (noticeable movements of the beam and column corbel support were observed).

Figure 1. Collapses on precast concrete buildings and weakness of connections between primary and secondary elements.

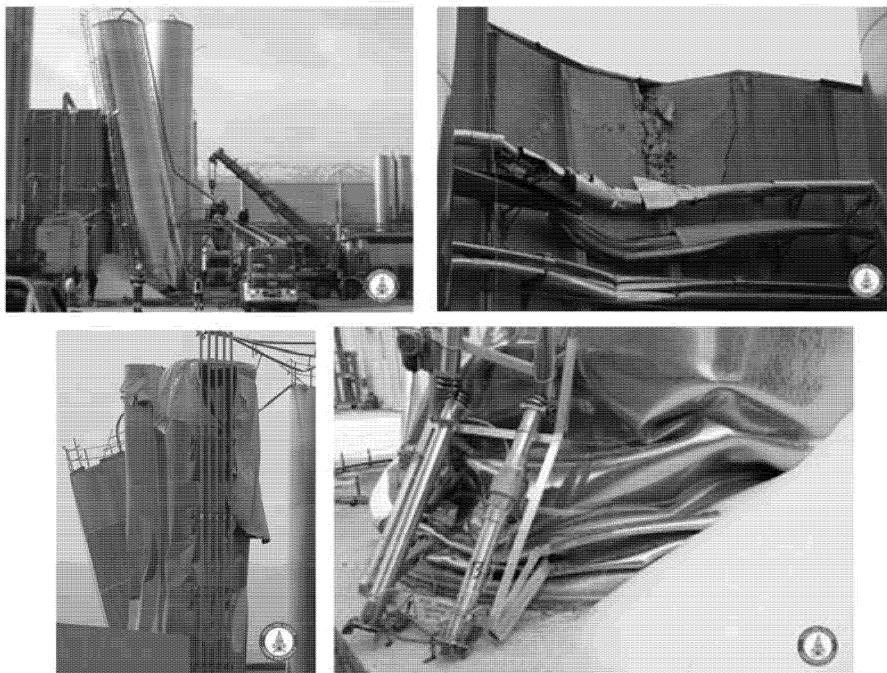
- a) column shear failures, rupture of the column tie reinforcement, cracking and falling of the hollow clay tile infill and collapse of the window wall glass.
- b) in the warehouse, a precast girder collapsed along with one span of roof slab.
- c) three tall steel silos storing polypropylene beads suffered damage.

During the earthquake the three silos which were full, either collapsed or suffered extensive damage. The silos collided with the adjacent precast warehouse partially crushing the concrete wall and leaving an impact imprint. The silos also crumpled at their bases. In addition serious damage was caused to pipelines and electricity cables. Consequently business was completely interrupted.

Figure 2. Damages to, and caused by, silos at VIBAC facility in the Bazzano industrial area, 7 km South of L'Aquila town.

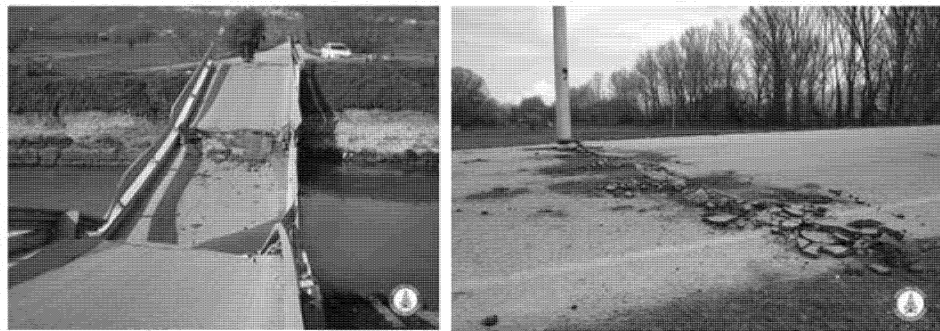
Figure 3 Bridge collapsed on the Aterno river, near Fossa (AQ) and disruption of embankment of carriageway of a road in the affected area.

Observations permitted by the earthquake showed that the criticisms were mainly derived from landslides on carriageway, embankment deformations, bridge or viaduct collapses or disruptions. As consequence the interruption caused by all this damage caused connection and transit difficulties for the emergency rescue services.

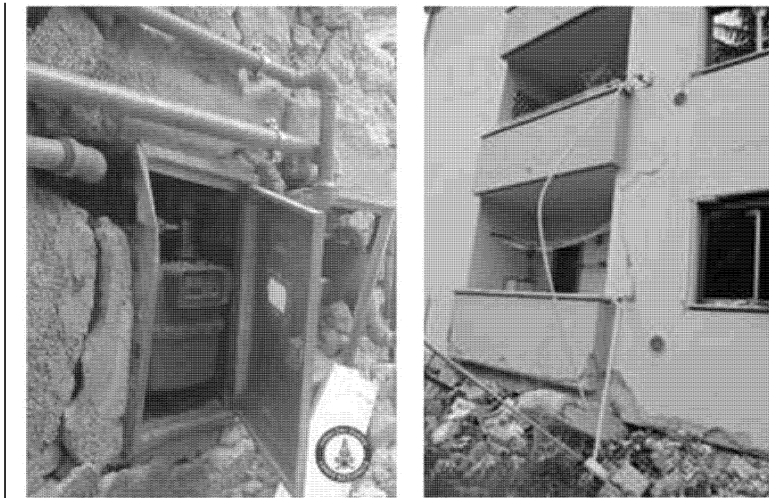
Figure 4 Damage on gas pipelines caused by heavy damage to stone walls (at left) and of RC (at right) residential buildings

The damages observed on life-lines highlighting primary criticisms related to gas distribution. A lot of gas pipelines were damaged or broken because the buildings were heavily damaged. Many RC buildings suffered high deformation caused by the plasticization of the beam-pillar connections, and some of them, with a “soft-story”, collapsed completely.

Since the majority of flats, houses and apartments were served by autonomous boilers a lot of gas pipelines were installed outside the building on the perimeter walls. As a consequence, many of the external gas pipelines were broken or damaged. This caused significant releases of gas, but fortunately, no fires started.

In comparison with the past the probability of release of gas increased and also the possibility of subsequent fires. This suggests the introduction of specific fire precaution measures.
