Properties of weld overlays on regenerated wheel hub of a mining vehicle

Abstract: The paper presents problems related to the regeneration of wheel hubs for mining machinery vehicles carried out with arc welding using the MAG method. Hubs made of medium-carbon cast steel, type LII500, were weld surfaced with filler metal grade of G4Si. The tests were aimed at determining welding imperfections and metallographic properties of the surfacing welds. The influence of heat treatment on the properties of surfacing was investigated. Hardness distributions in welded hubs after various heat treatment operations were determined. Recommendations for the technology of weld surfacing the wheel hubs were formulated.

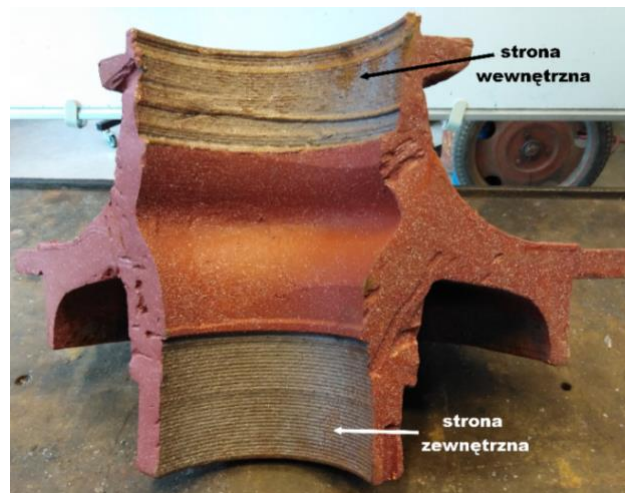
Fig. 2. A fragment of the wheel hub after weld surfacing the seats under the bearing before machining

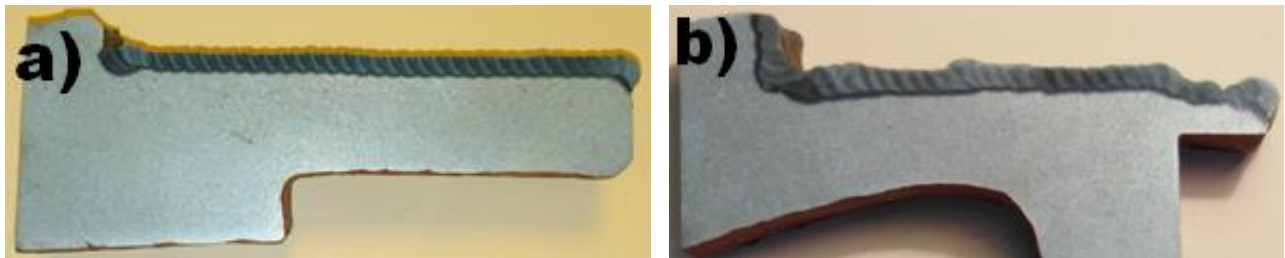
Fig. 4. View of the cross-section of the wheel hub after weld surfacing: a) the outer side, b) the inner side. Etched with 10% nital

Due to the uneven internal wear of the hub, the padding welds have a completely different shape. The hub bore from the inside is subject to greater wear and requires a thicker padding weld to be laid than the outside. Sometimes it forces the creation of an additional layer in order to obtain the proper diameter of the hub before machining. Macroscopic tests confirmed greater unevenness of the layers and showed the need for proper preparation of the hub bores before the regenerative deposition process. Regeneration layer, created on the outside, is characterized by high uniformity of the surface and evenness of the amount of heat introduced. The internal side requires additional regeneration processes increasing costs and extending the repair time, in addition there is a higher probability of cracks due to the inhomogeneous amount of heat introduced.

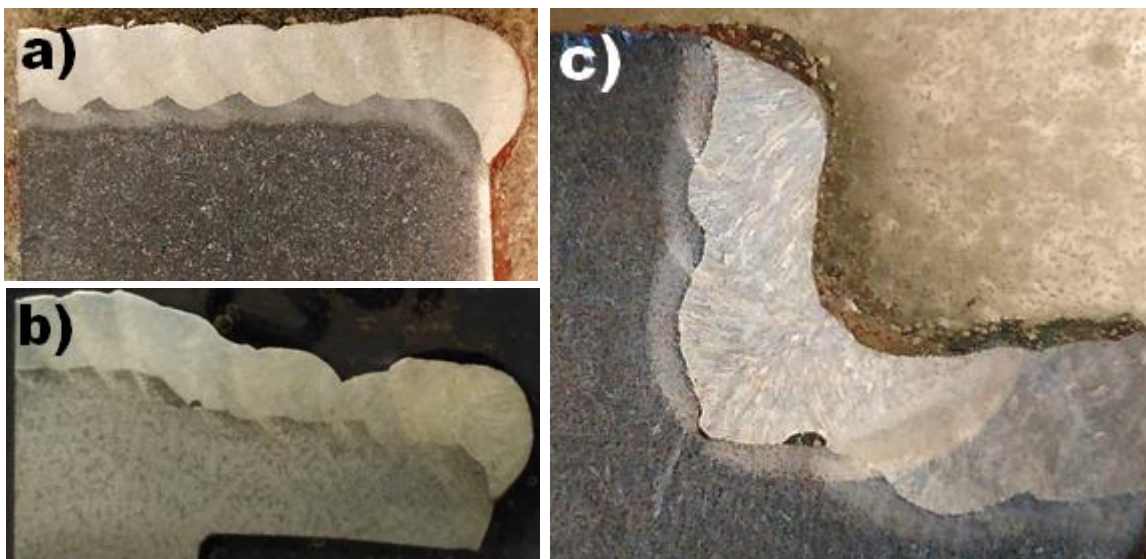
Macroscopic examinations additionally revealed some shortcomings in the hardfacing technology, i.e. blister at the fusion border (Fig. 5), lack of fusion and emptiness in the corner (Fig. 14).

Fig. 5. View of the cross-section of the wheel hub weld surfacing in selected places of padding welds: a) outer side – end edge, b) inner side - end edge; c) inner side - internal corner. Etched with 5% nital.

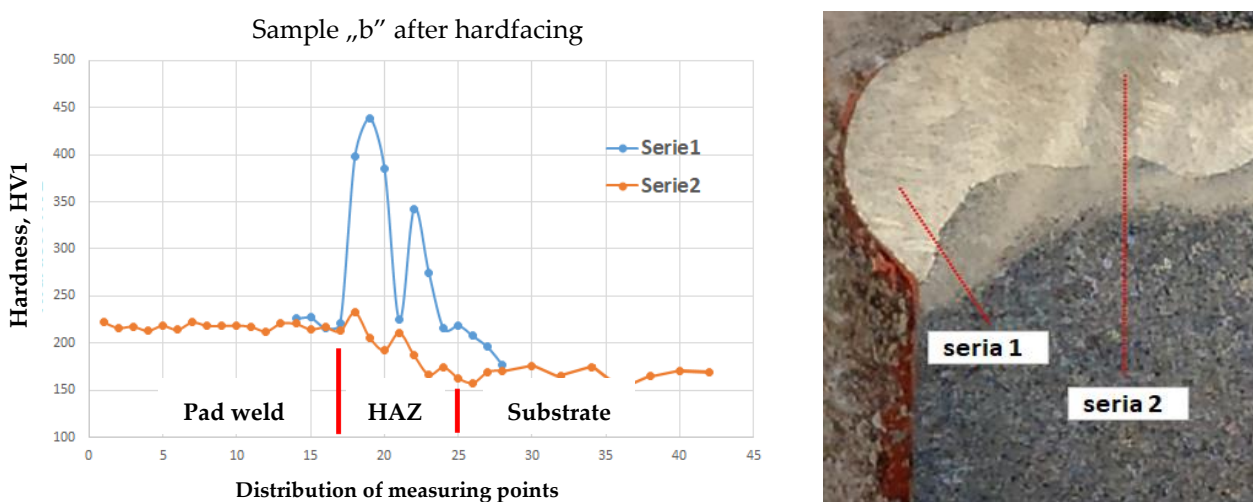
Hardness measurements showed that samples in the raw state after hardfacing were characterized by a sharp increase in hardness of up to 536 HV1 in the HAZ under the last bead (series 1 in Fig. 7). On the other hand, underneath the earlier beads there was a decrease in hardness caused by the thermal effect of the next bead. In the case of padding weld, the hardness was about 220 to 255 HV1, while the hardness of the material of the hub was between 150 and 175 HV1. Due to the fact that the welding of the hub was carried out without preheating, additional tests were carried out to determine the impact on the material structure and its hardness of possible post-weld heat treatment, including stress relief annealing and normalizing annealing.

Fig. 7. Distribution of hardness on the cross section of the sample of the hub in the state after weld surfacing. Sample "b" from the outside of the hub

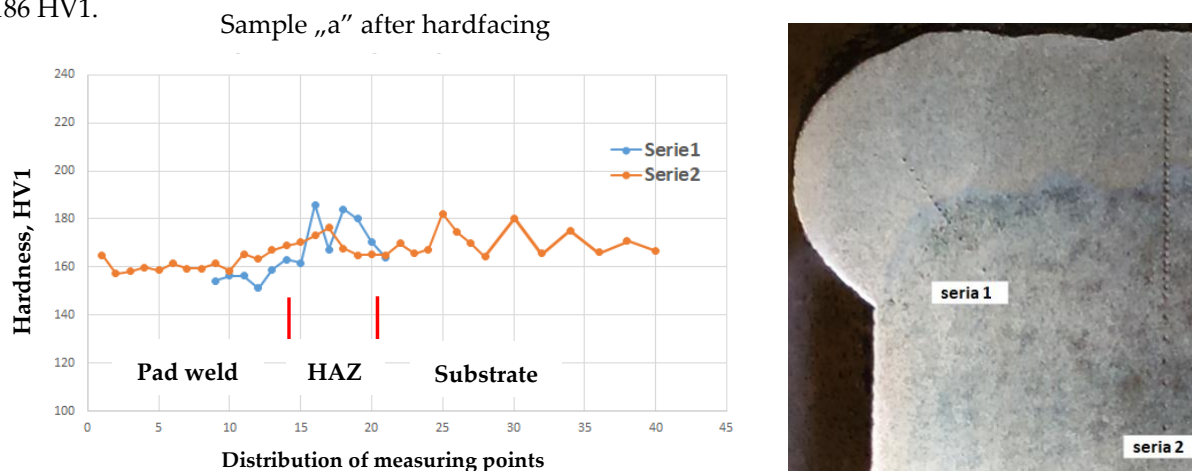
However, normalizing annealing at 920 °C resulted in complete softening of the material and alignment of hardness in the entire area of padding weld-HAZ-hub (Fig. 8). Hardness varies from 155 HV1 to 186 HV1.

Fig. 8. Distribution of hardness on the cross-section of the sample of the hub in the normalized annealed condition after weld surfacing. Sample "a" from the outside of the hub

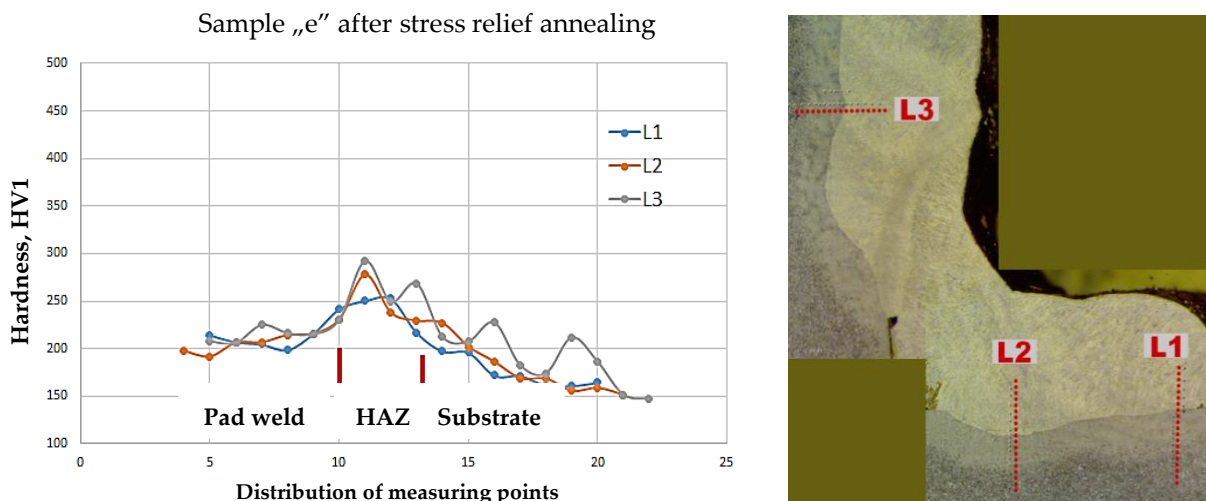
Examination of the samples after stress relief annealing at 600 °C showed a significant decrease in the hardness of the HAZ under the last bead from approx. 536 HV1 to 293 HV1 (Fig. 9). There was a slight decrease in the hardness of the padding weld and the native material of the hub by an average of about 20 HV1.

Fig. 9. Distribution of hardness at the cross-section of the sample of the hub in the stress relief annealed condition after surfacing. Sample "e" from the inside of the hub

Due to the fact that machining after the hardfacing process releases stresses, which may result in deformations or cracks, it would be advisable to carry out stress relief annealing. As a result of such annealing, the shape and dimensions of the hub will stabilize, and removal of the surplus of the padding weld's layer by cutting will not cause deformation of the hub bore.

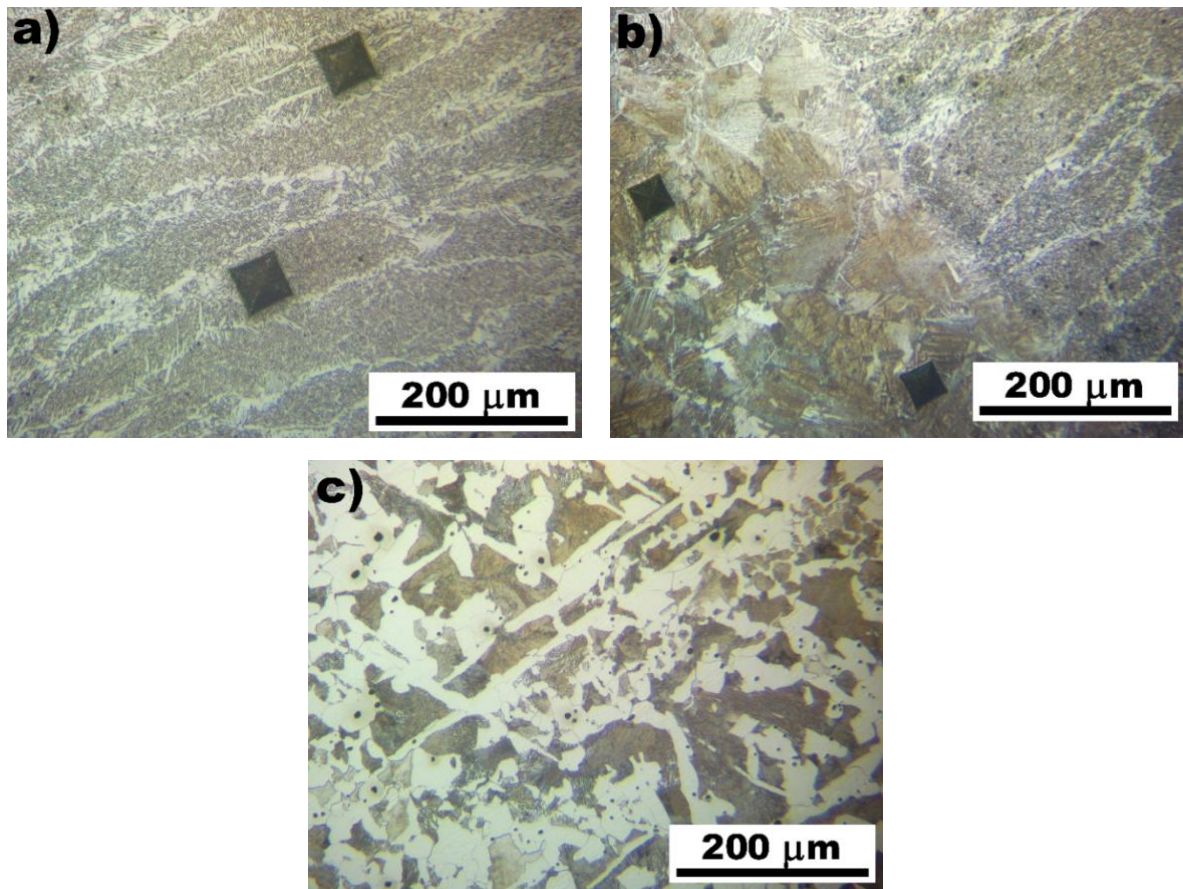
Figure 10 shows the padding weld microstructure in the raw state after hardfacing - sample "b". There is a dendritic ferritic structure with a direction of grain in accordance with the direction of heat dissipation in the padding weld (Fig. 10a), there is a martensitic structure in the HAZ (Fig. 10b), whereas in the material of the hub (Fig. 10c) there is a ferrite-perlitic structure with the participation of ferrite in Widmannstätten system. Inside the material of the native hub, the occurrence of local hot cracks can be seen (Fig. 14), which, however, do not reach the surface of the material and do not combine with the padding weld.

Fig. 10. Pad weld: a) last stitch, b) HAZ + last stitch, c) base material of hub Mag. x200. Etched with 5% nital

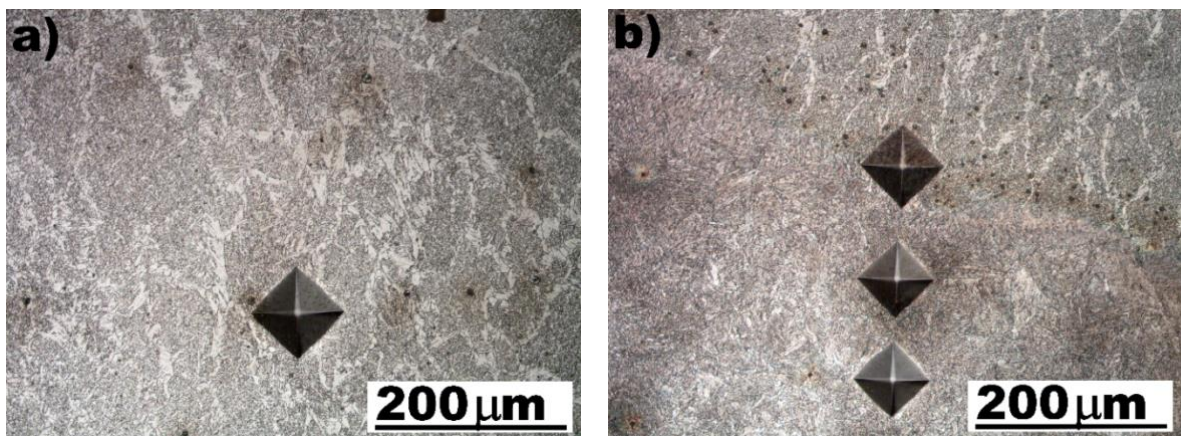
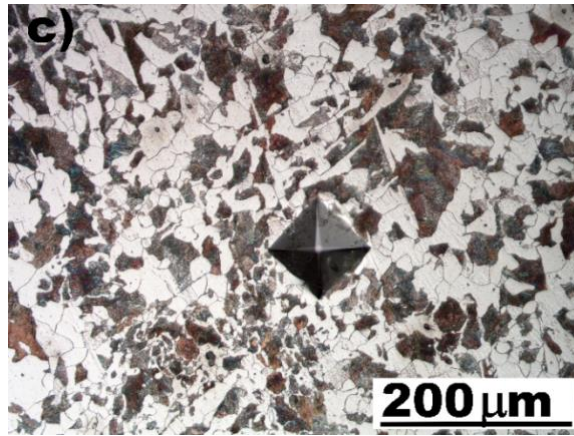
Figure 11 shows the microstructure of the hardfaced hub after stress relief annealing. No major changes were observed in the structure of individual hub material zones. However, the hardness distribution (Fig. 9) shows that stress relaxation caused by hardfacing occurred and the hardness decreased to below 300 HV1 level in the HAZ zone.

Fig. 11. Weld overlay after stress relief annealing: a) last stitch, b) SWC + last stitch, c) base material of hub. Mag. x200. Etched with 5% nital

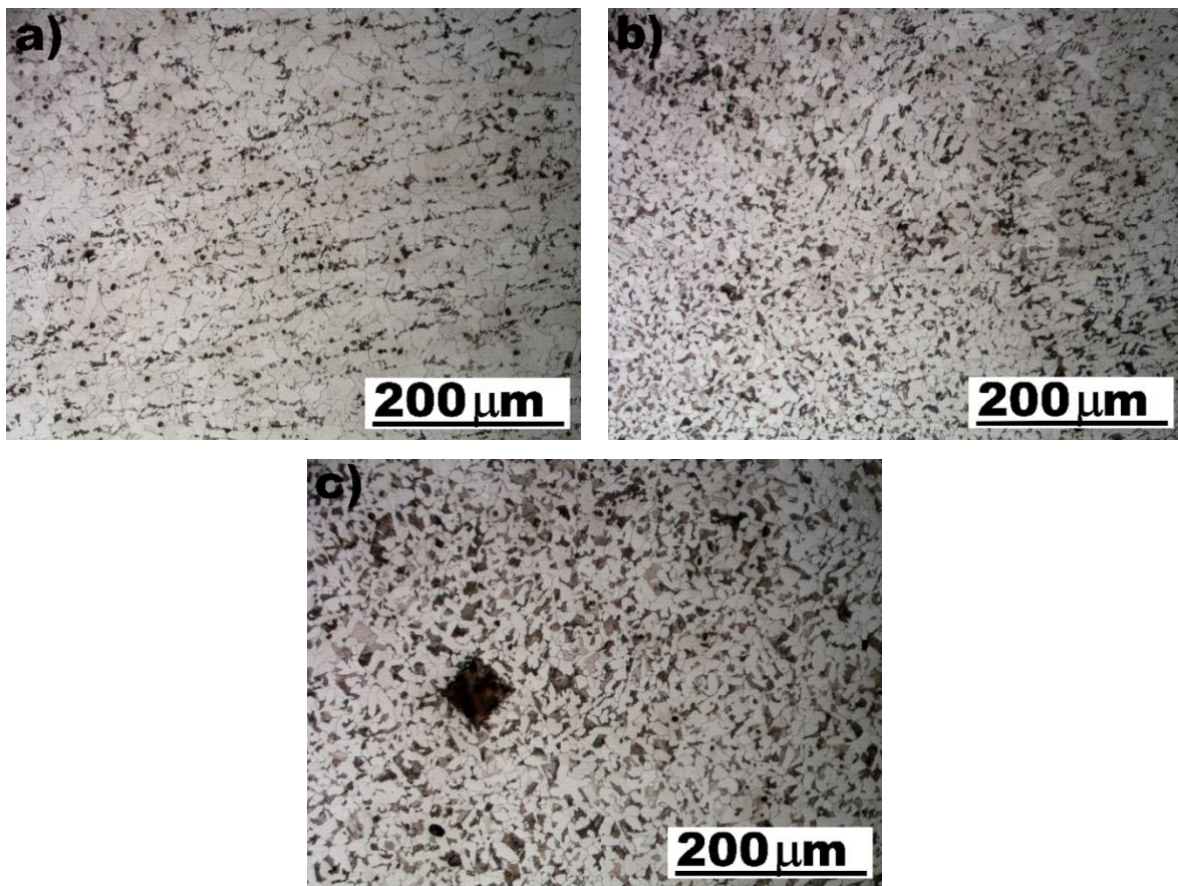
From the microscopic observation of the native material of the hub in the raw state, it follows that the casting was not subjected to heat treatment by normalization, and Widmannstätten's structure size indicates that it was also not stress relief annealed. In the case of steel castings, not only normalizing annealing is used, but also thermal improvement aimed at improving mechanical properties [6]. For testing purposes, the comparison of structures and properties of the hub material, depending on the heat treatment, stress relief and normalization annealing of welded samples was performed. The appearance of the sample structures after normalization is shown in Figure 12. The fragmentation of grains after heat treatment can be seen.

Fig. 12. Weld overlay after normalizing annealing: a) last stitch, b) SWC + last stitch, c) base material of hub. Mag. x200. Etched with 5% nital

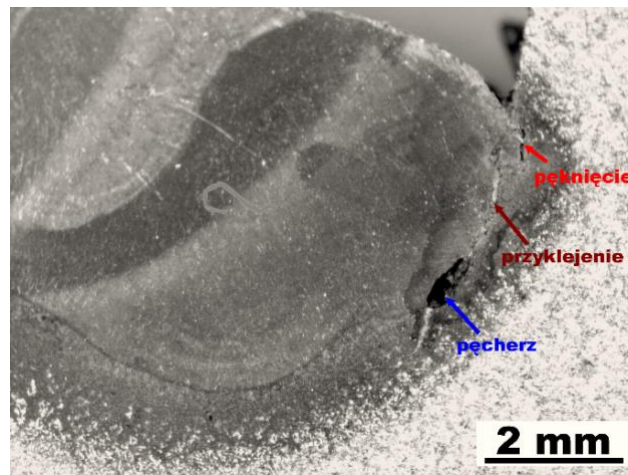
Despite the lack of preheating of the hub before hardfacing, no cracking in the padding weld or in the HAZ was found. However, the lack of such heating was the reason for welding incompatibilities when

laying the first bead on the cold hub (cracking, lack of fusion, blisters) (Fig. 13). The avoidance of such incompatibilities is possible by increasing the linear energy of the hardfacing in the first weld bead.

Fig. 13. Weld overlay as welded in the first stitch. Mag. x33. Etched with 5% nital

The research results indicate that in order to reduce the occurrence of nonconformities, in the future, the preheating of the hub in the range of 150÷180 °C should be included in the hardfacing process.

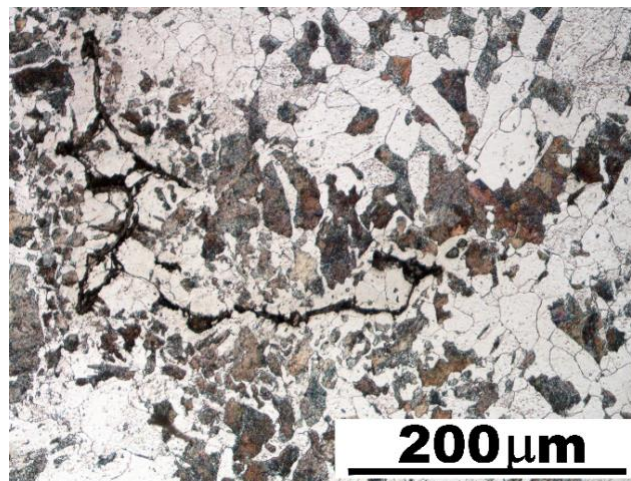
Noteworthy is the high content of phosphorus in the cast steel, which may be the reason for high sensitivity to cracks in the padding weld and in the mixing layer. However, the presence of such cracks in the padding weld areas was not found, but hot cracks were noted in the material of the hub, as shown in figure 14.

Fig. 14. The base material of the hub in the raw state. View of a hot crack. Mag. x200. Etched with 5% nital

Noteworthy is the unfavourable phenomenon of the presence of hot cracks (Fig. 14) in the native material of the raw casting, caused by the high content of phosphorus in the material (Table I).
