# Case studies of steel and their welded joint failures caused by liquid metal embrittlement LME

Analiza przypadków pęknięć stalowych złączy spawanych wywołanych obecnością cieczy metalicznej

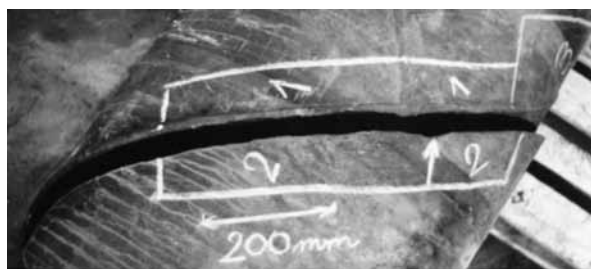
In this case (spirally welded pipe OD 720x8 mm) 1.8 m long crack was running along the spiral weld (Fig. 1). The initiation point was in the place where the spiral weld meets the tie strip weld. The spiral weld which exhibits very high misalignment of both linear and opposite runs is shown in Fig. 2. The crack was initiated by LME (liquid metal embrittlement) of remelted copper during repair weld-

**Fig. 1.** A crack along the spirally weld joint  
**Rys. 1.** Pęknięcie wzdłuż spoiny spiralnej rury

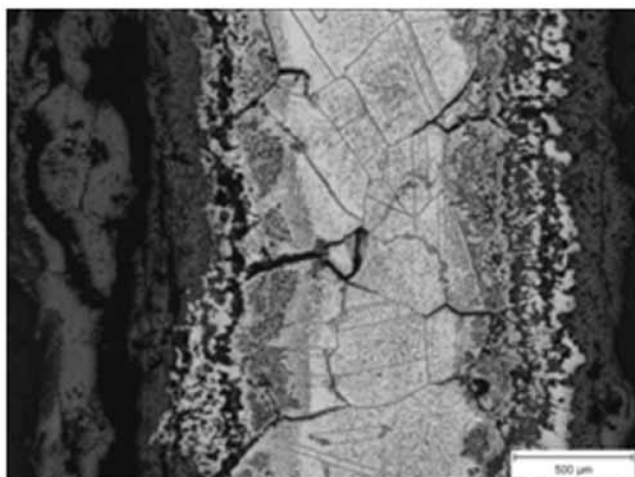
Shortly after combustion of new wastes (pneumatic tyres, plastics) the shell plates of the cement furnace were expressively attacked by hot temperature corrosion [6]. The steel AISI 310 (1.4841 by EN) was concerned (Table II).

An original wall thickness of 4 mm was reduced almost to 0,4 mm (Fig. 3).

**Fig. 3.** Wall thickness reduction  
**Rys. 3.** Redukcja grubości ściany na skutek erozji

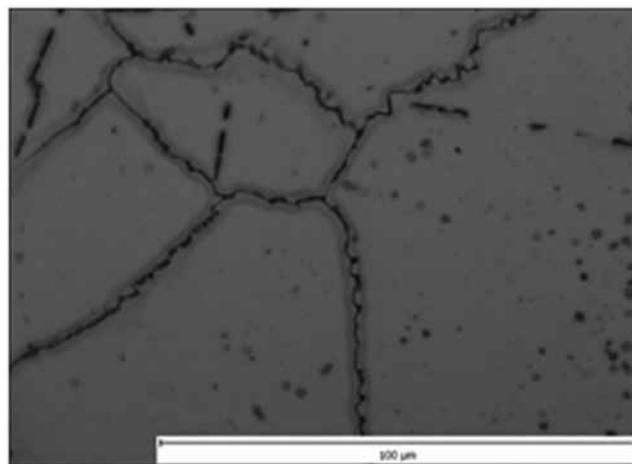
Grain coarsening of the plate surface ( $d_{ST} = \max. 1000 \text{ nm}$ ) and grain boundary liquation are visible in Fig. 4. A scale thickness reached almost  $900 \text{ }\mu\text{m}$ . An EDX microanalysis of the corrosion products showed very high content of S and P (Fig. 5). Both are present like compounds of the nickel sulphide and the iron phosphide.

The AISI 310 is a heat-resisting steel up to  $1100 \text{ }^\circ\text{C}$  (tolerance loss of thickness is  $2 \text{ mm}/104 \text{ hours}$ ), but the steel is not suitable for the reduction gas medium, which contains S, where its range of application is reduce down to  $644 \text{ }^\circ\text{C}$ , what is a solidus temperature of  $\text{Ni}_3\text{S}_2$  (LME attack).

**Fig. 4.** High temperature attack of AISI 310 steel  
**Rys. 4.** Wysokotemperaturowa degradacja stali 310 wg AISI

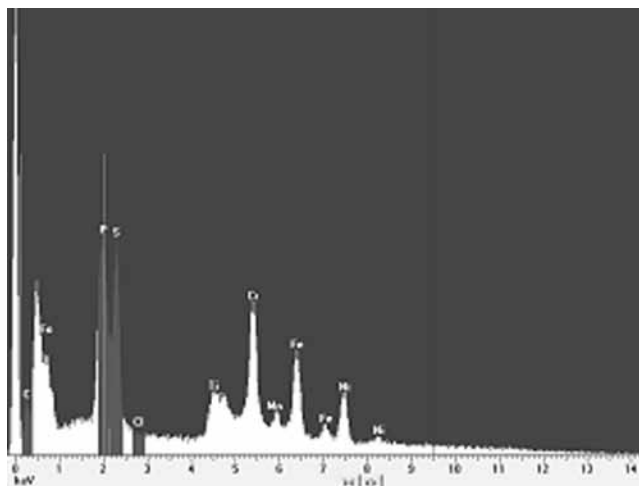
**Fig. 5.** EDX microanalysis of corrosion products  
**Rys. 5.** Analiza EDX produktów korozji

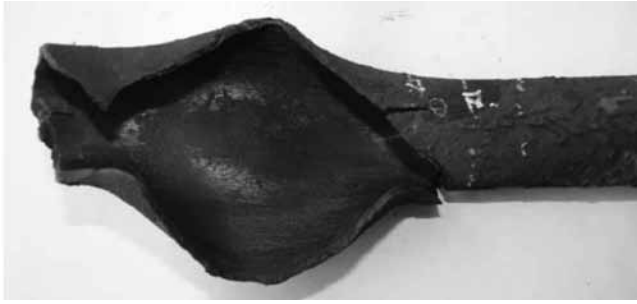
Boiler tubes OD  $33,7 \times 5 \text{ mm}$  made of 10CrMo9-10 steel (see Table III) are concerned [7]. The tube broke after 8200 hs exposition at  $575 \text{ }^\circ\text{C}$  and 11 MPa pressure (Fig. 6). As a fuel of the boiler was used a black oil (mazout).

**Fig. 6.** Failure of the tube  
**Rys. 6.** Awaria rurociągu

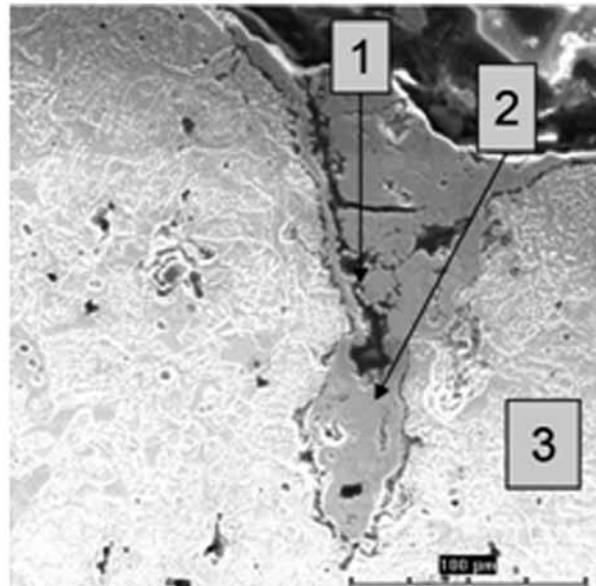
Eutecticum temperature of  $6V_2O_5-Na_2SO_4$  system is about 600 °C, but some mixed oxides like  $5NaO-V_2O_5-10V_2O_5$  melts at 545 °C [8]. Molten salts at operation temperature penetrate to the steel mostly intergranularly.

So the vanadium corrosion has features of LME. See a crack in Fig. 7 and 8 with EDX microanalysis in Table IV.

**Fig. 8.** Crack of vanadium corrosion  
**Rys. 8.** Pęknięcie wywołane oddziaływaniem wanadu

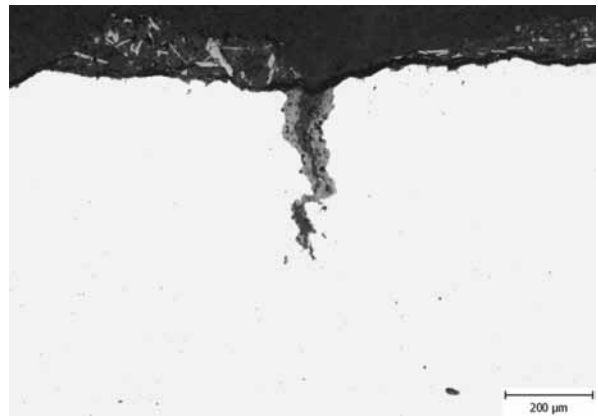
**Fig. 7.** Crack on fire side of tube  
**Rys. 7.** Pęknięcie płomiennicy od strony paleniskowej
