MICROSCOPIC EVALUATION OF THE QUALITY OF DENTAL REPLACEMENT

KEYWORDS: metal-ceramic crown, dental replacement, microstructure.

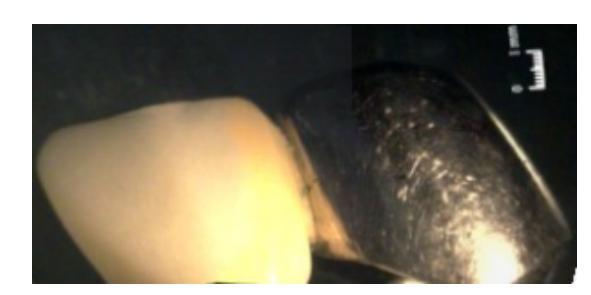
The main scope of the performed microscopic observations was to identify the initiation stimulus for rupture of a tooth replacement – the child patient's crown, which was used as tooth replacement after the injury. In relation to the given metal-ceramic crown (of the type seen in the 1), there was the rupture of the ceramic layer and its subsequent delaminating. The crown was supplied without any specific information (producer, chemical composition, life duration, etc.)

FIGURE 1. Metal-ceramic crown, detail.

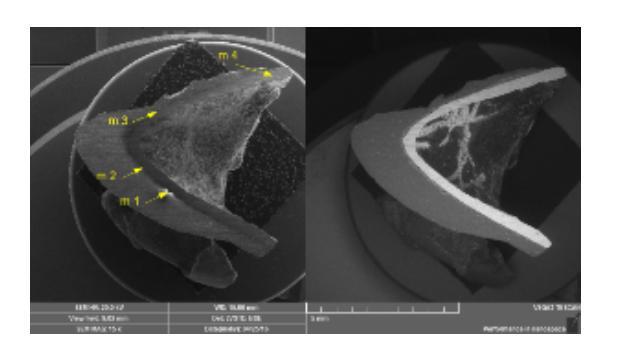
FIGURE 2. Metal-ceramic crown - detailed image.

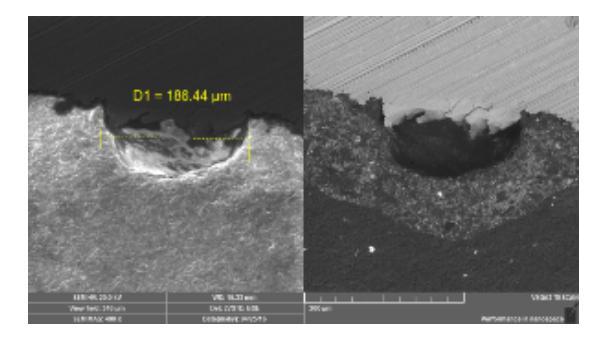
According to the fact mentioned herein before, the precise investigation of ceramics and metal microstructure were carried out. The detailed images (Fig. 3) revealed the sites with the altered roughness. The occurrence of cavities was identified in sites where the metal was in contact with the ceramic layer and it led to the rupture of the ceramic layer.

FIGURE 3. Rupture in the site of the metal-ceramic material contact.

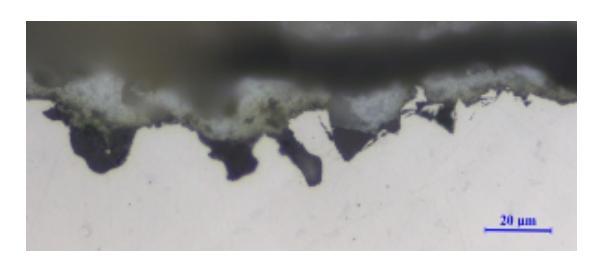
Based on the microscopic observations, the penetration of ceramic material into the irregular areas of metal originating from the manufacturing process has been identified. That led to the deteriorative effect in relation to the metal – ceramics contact (Fig. 4).

FIGURE 4. Penetration of ceramic material.

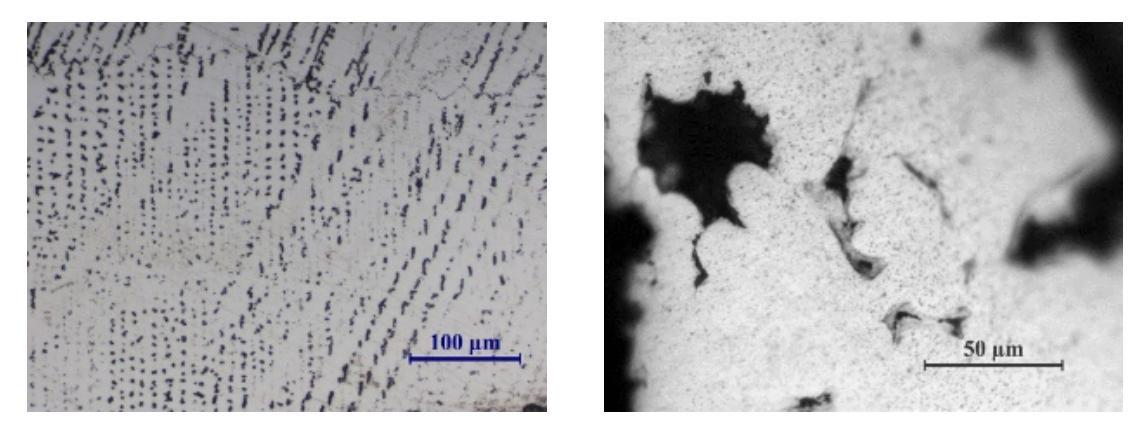
The microscopic observation of the metal alloy quality revealed that the low-quality heterogeneous metal alloy was used for manufacturing of selected metalceramic crown which caused defects in contact layer between metal and ceramic material during manufacturing. Besides the distribution of individual phases,

the low quality of materials was confirmed by chemical composition. The character of the microstructure (Fig. 5) exhibits the imperfect primary crystallisation of Co-Cr alloy with the occurrence of undesired phases. [5–8].

FIGURE 5. Microstructure of Co-Cr alloy
