Moisture Safety  
in Prefabricated  
Roof Renovations:  
Causes and  
Strategies

**Georg-Mihkel Kodi, Kristo Kalbe\*, Peep Pihelo**

Journal of Sustainable  
Architecture and Civil Engineering  
Vol. 2 / No. 35 / 2024  
pp. 68–83  
DOI 10.5755/j01.sace.35.2.35825

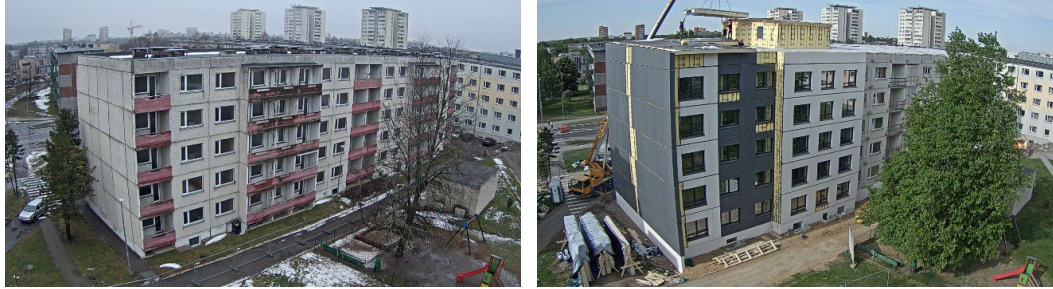
**Fig. 1**

Overview of the case-study building before (left) and during nZEB renovation with prefabricated timber-frame insulation elements (right)

The case-study building is a typical five-storey large concrete panel apartment building (series 111–121, total area 4318 m<sup>2</sup>), constructed in 1986 (Fig. 1) and renovated as a nearly zero energy

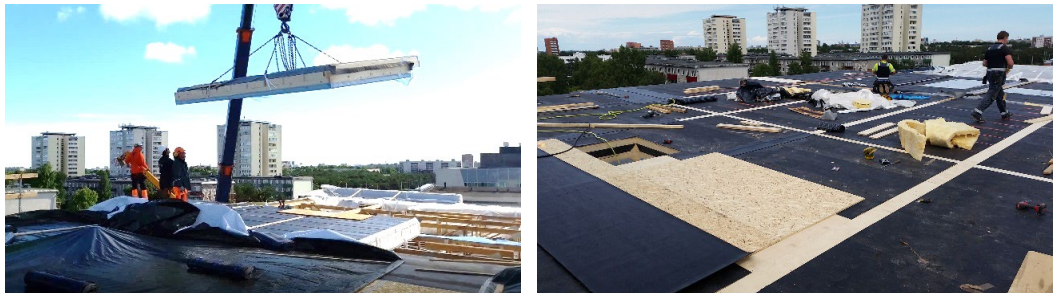
**Fig. 2**

Installation of roof insulation elements

Installation of roof insulation elements (Fig. 2) was done on a sloping timber frame because the original roof had an inward slope and a parapet. Therefore, a 0.6–1.2 m high attic space was formed between the old and the new roof (Fig. 3), providing a space for technical appliances (e.g. heat exchangers, ventilation ducts, automatics equipment, etc.). The roof elements (Fig. 4) consist of a timber frame and a 340 mm mineral wool insulation between the beams. The frame is covered with an air and vapour barrier on the internal side and a roof underlay membrane on the external side. The roof is ventilated by outdoor air through a 95 mm high channel between the roof underlay membrane and the roof covering (SBS (Styrene Butadiene Styrene) elastomeric waterproofing membrane).

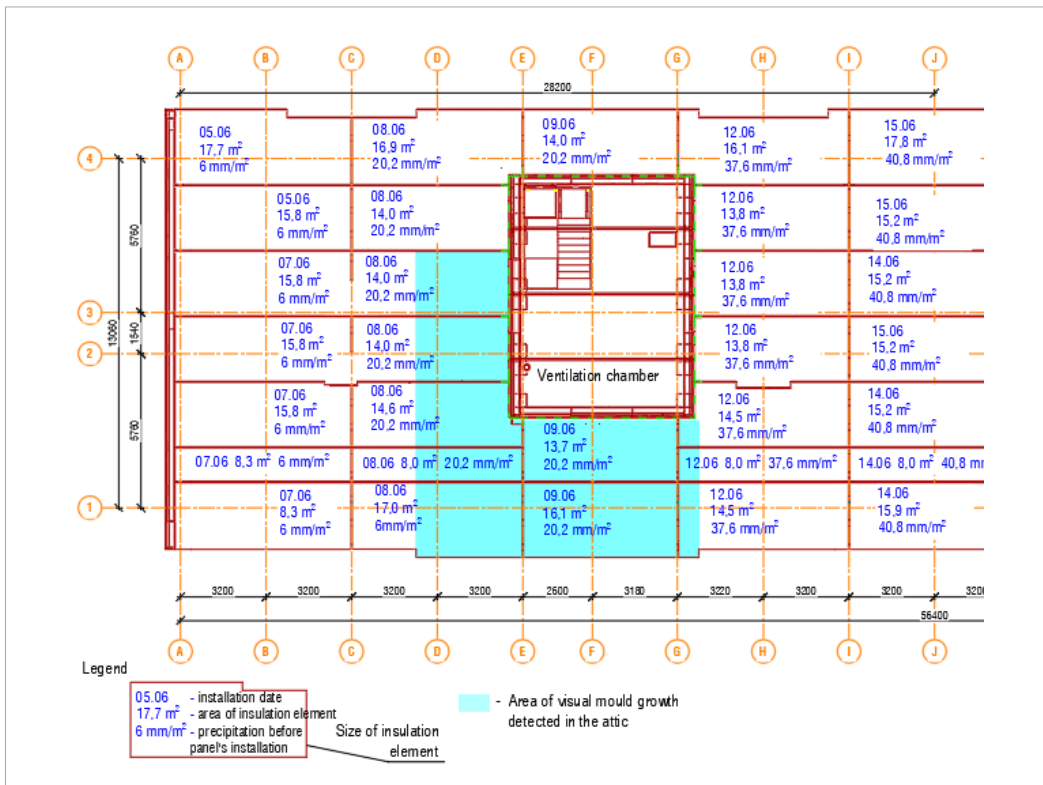
Fig. 5  
Location of roof insulation elements and precipitation intensity during installation (only one half of the building's roof is shown)

During the construction of the roof, rainwater accumulated in the mineral wool on the attic floor. After the completion of the roof, the water started to evaporate into the attic, causing high relative humidity and mould growth on wood, especially on the interior surface of the roof elements. For the location of roof insulation elements and the corresponding precipitation intensities, see Fig. 5.

floor and in timber-frame structures that became wet due to rain (see precipitation intensity during installation in Fig. 5) started to evaporate and the sun heated the dark outer surface of the roof. The increased RH in the attic could also have been caused by night time clear sky radiation, which has been shown by several studies to be a contributing factor in other cold climate regions (Hagendoft & Kalagasidis, 2014; Harderup & Arvidsson, 2013; Jensen et al., 2020). However, the thermal transmittance of the newly installed roof is quite low ( $U_{\text{roof}} = 0.10 \text{ W}/(\text{m}^2\cdot\text{K})$ ), which should minimise the temperature drop on the inner surface of the roof.

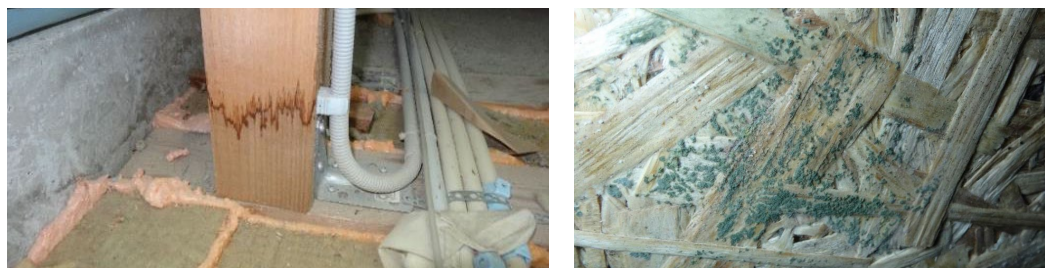
**Fig. 7**

Moisture damage signs on the roof's timber frame (left) and on the inner surface of the roof (OSB) (right)

Visual signs of high water level on the attic floor during construction as well as mould growth were detected during the first month after the end of construction (Fig. 7). The highest mould growth was observed in the area where rainfall intensity on the day of installation was ~2 cm/day (see Fig. 5). In locations where no visual mould growth was evident, microscopic analysis still showed mould growth (see Table 5). Mould started to grow mostly on oriented strand boards (OSB). The main mould genera detected were *Aspergillus*, *Penicillium*, *Cladosporium*, *Aureobasidium*, *Phoma* and *Chaetomium*, most of which are fungi indicating a moisture problem (Mahooti-Brooks et al., 2010). OSB has been shown by laboratory measurements to be a very favourable surface for mould growth (Kallavus et al., 2017) and therefore requires especially careful handling during construction to prevent its wetting.

To eliminate the risk of creating health issues to the residents as a result of spreading of mould spores from the attic to the living rooms, all materials affected by mould were replaced and repeat measurements of surface contamination were performed in 2021. Four years later the attic ceiling surfaces were mainly free from mould growth. Although no samples showed any mould 4 years after the construction, a few old, degraded hyphae were still detected. This indicates how sensitive mould sampling can be. It is not always possible to make sure that a surface is clean from contamination. Therefore, it is preferable to prevent the occurrence of critical hygrothermal conditions.

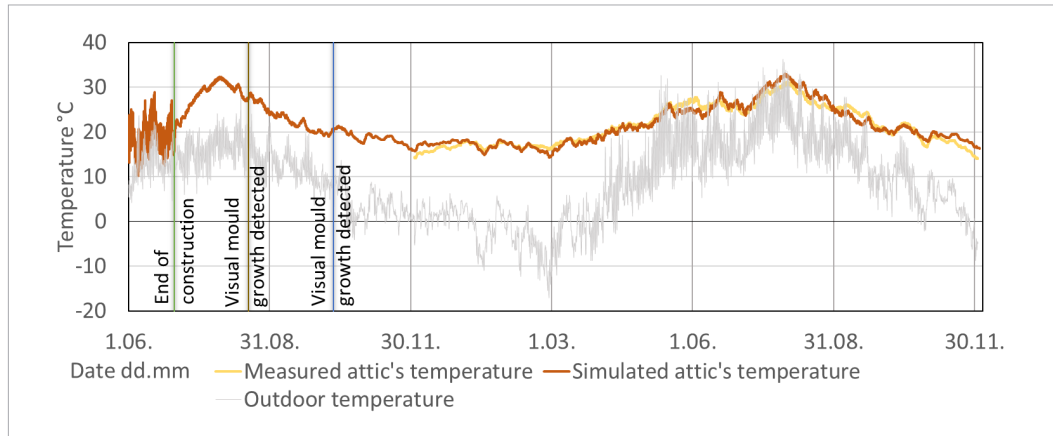
Fig. 8

Measured and modelled attic and outdoor air temperature

The measured and modelled temperature and humidity conditions show good agreement (Fig. 8, Fig. 9, Fig. 10) throughout the whole 1.5 year observation period. This allowed to estimate the hygrothermal conditions for the period between the end of construction and the start of measurements (temperature and humidity measurements in the attic started after visual mould growth was detected).

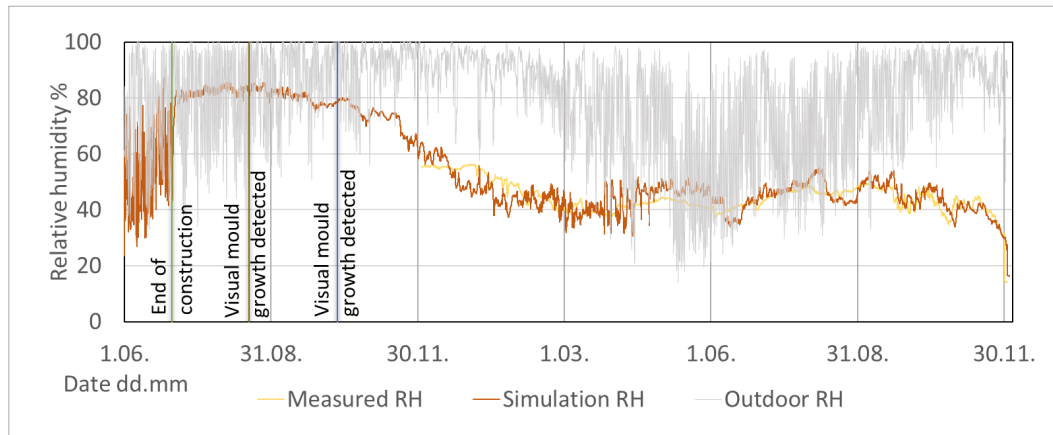
Fig. 9

Measured and modelled attic and outdoor air relative humidity

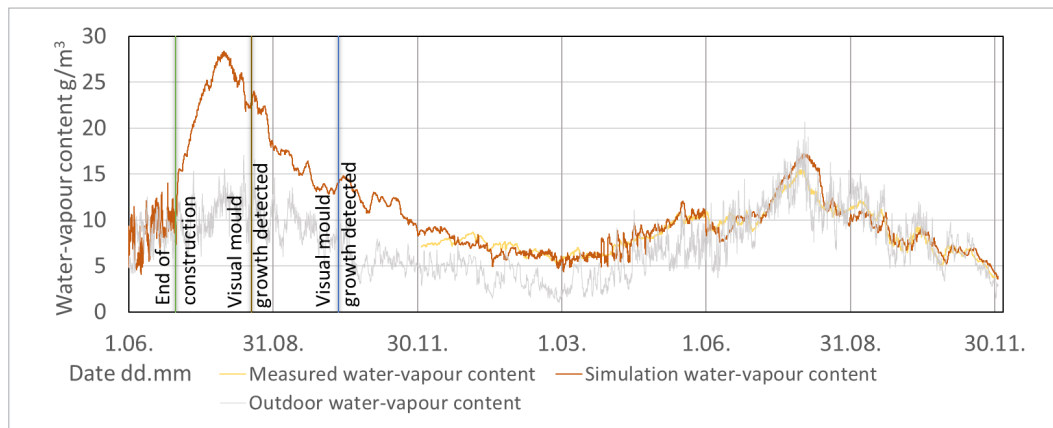
Fig. 10

Measured and modelled attic and outdoor air water vapour content

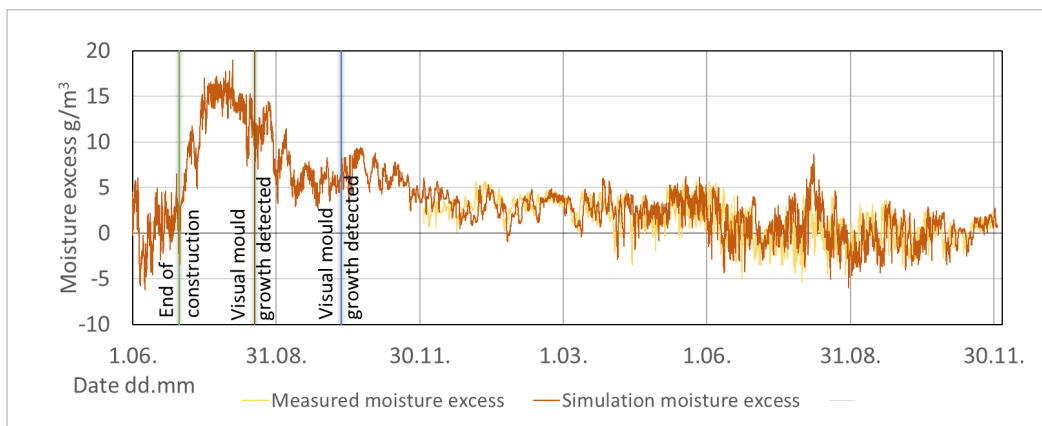
Fig. 11

Measured and modelled attic moisture excess (the difference between attic and outdoor air water vapour content)

After the end of installation of roof insulation elements and closure of the attic, the moisture that dried out from the mineral wool on the attic floor and from timber-frame structures caused high moisture excess in the attic:  $\Delta v \geq 15 \text{ g/m}^3$  (see Fig. 11). This moisture excess represents moisture loads that are higher than even in swimming pools and other rooms with very high water use and evaporation rate (Dietsch et al., 2015; Janssens & Hens, 2003; Shah, 2014). After mould growth was detected and the attic air had dried, the moisture excess dropped to a level similar to that in common living rooms with low occupancy:  $\Delta v \geq 3\text{--}4 \text{ g/m}^3$  (Ilomets et al., 2017; Vinha et al., 2018). The importance of controlling moisture excess in rooms with wooden surfaces has been pointed out by Arumägi et al. (2015), who have shown that if the moisture excess  $\Delta v \geq 6 \text{ g/m}^3$ , the number of mould spores in the indoor air is expected to exceed the acceptable level of  $500 \text{ cfu/m}^3$ . Although the attic was not ventilated with outdoor air during the use of the building, the moisture excess remained close to zero after the construction-related moisture had dried out, because there was no moisture production in the attic. As air leakages from living rooms can also result in increased moisture in the attic, it is essential to ensure that the design and construction of the interface between the uppermost storey ceiling and the attic floor is such that good airtightness is achieved (Kalamees & Kurnitski, 2010). Airtightness of the structures of the uppermost storey of multi-storey buildings is extremely important because these structures work under positive indoor air pressure (Kalamees et al., 2010).

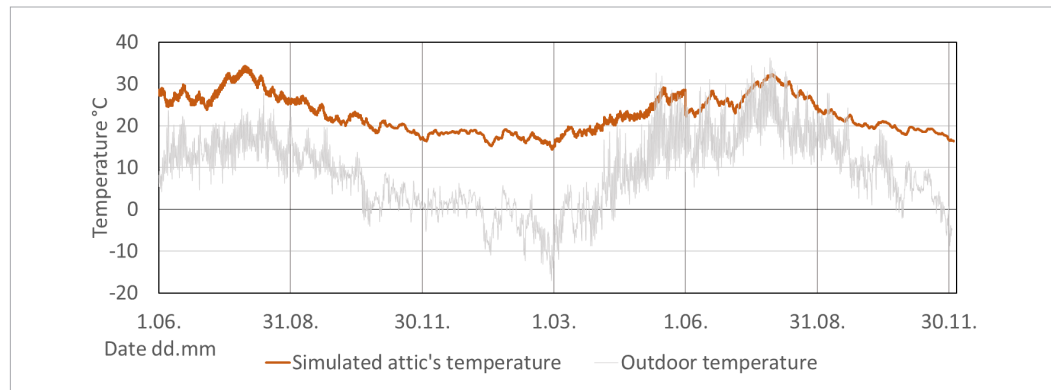
Fig. 12

Modelled attic and outdoor air temperature in the case of using a total temporary roof during construction

Calculations for the case of constructing in dry conditions were done without a precipitation load, i.e. assuming that installation is done during periods without rain and the old bitumen roof is covered with mineral wool only after the roof is in place. In this scenario, the temperature (Fig. 12) and relative humidity (Fig. 13) in the attic do not exceed critical levels and no mould growth is observed (mould index  $M \leq 1$ ). Fluctuation of the value of moisture excess ( $\Delta v$  in the range of  $\pm 5 \text{ g/m}^3$ ) is caused mainly by a time lag in the equilibration of the indoor air water vapour content with that of the outdoor air because there is no active mechanical ventilation in the attic.

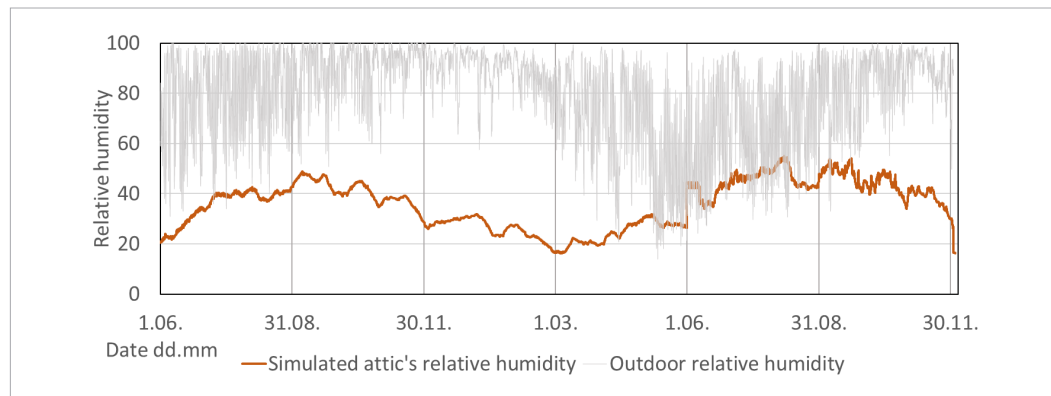
Fig. 13

Modelled attic and outdoor air relative humidity in the case of using a total temporary roof during construction

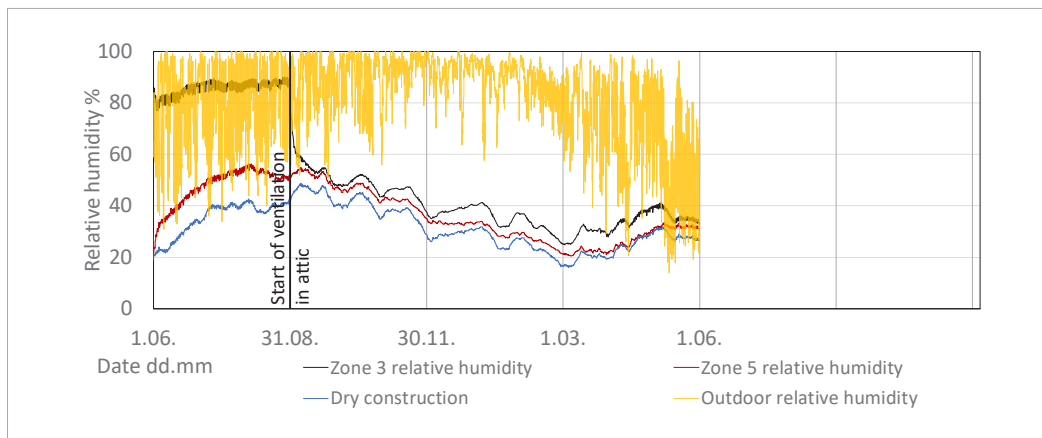
Fig. 14

Modelled attic and outdoor air relative humidity in the case of local water damage in the attic

The modelled RH is higher than in the case of dry construction (moisture safety strategy described in section 3.2.1) in all zones, but the problem is especially evident in the zone above the water damage (Fig. 14).

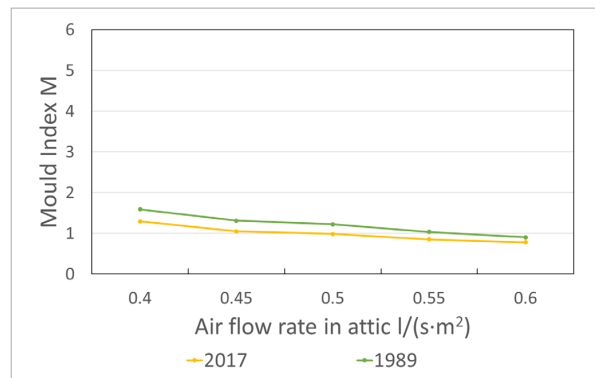
Fig. 15

Calculated maximum mould index at different outdoor ventilation air flow rates in the attic

Based on the modelled temperature and RH values, mould index was calculated for the inner surface of the attic roof at different air flow rates (Fig. 15). According to the calculations, there would be no mould growth in the case of constructing in dry conditions and the same holds true for zone 5 in the water damage scenario, while in zone 3 the maximum mould index in the water damage scenario would stay below 1 (no mould growth) at a ventilation airflow of 0.5–0.55  $l/(s \cdot m^2)$ , depending on the outdoor climate.
