Vol. XXV No. 1 June 2008

Forensic Engineering: Highway Construction Work Zone Accidents

by Robert T. Hintersteiner, P.E. (NAFE 327F)

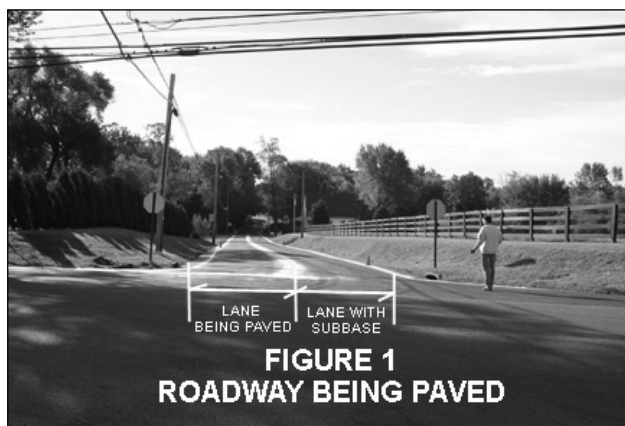
The subject accident occurred within the intersection of a County Road and a Town Road. The Town Road was under construction with an asphalt base course placed in the left lane only. The right lane had only a gravel subbase for a distance of 600 feet, and it stretched back

from the intersection and around a bend (Figure 1). There were no advance warn-

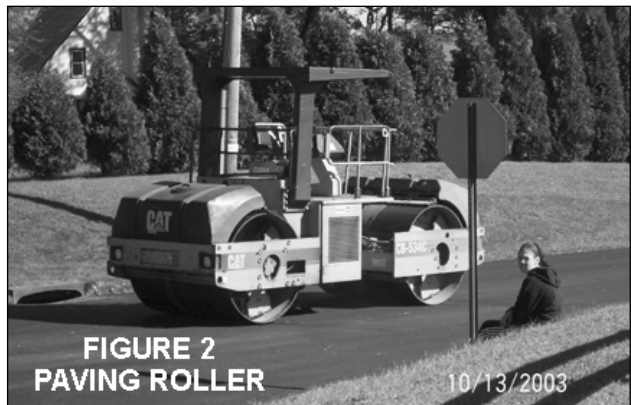
Figure 2 shows the pavement roller just before the intersection three days (on a Monday) after the accident.

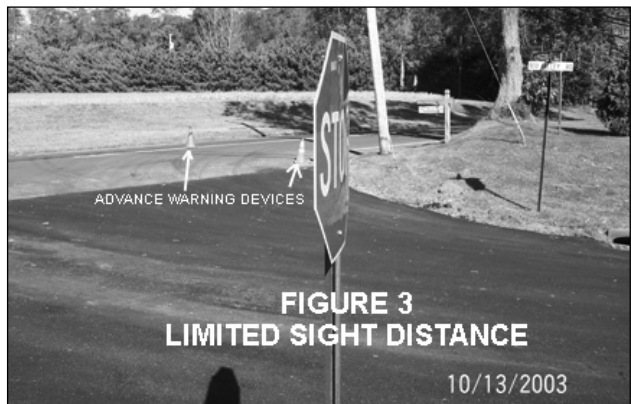
Figure 3 shows the intersection and traffic cones, the only advance Temporary Traffic Control Devices used to warn motorists during the placement of the asphalt top course. During the subject accident, the owner of the contracting company was acting as a Flag Person, and he was standing next to the Stop Sign directing the roller operations.

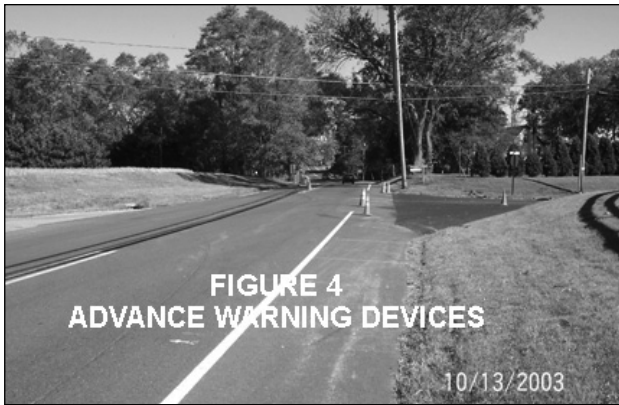
**FIGURE 4
ADVANCE WARNING DEVICES**

Figure 4 shows the intersection and the placement of the Temporary Traffic Control Devices. This was the extent of the Temporary Traffic Control Plan.

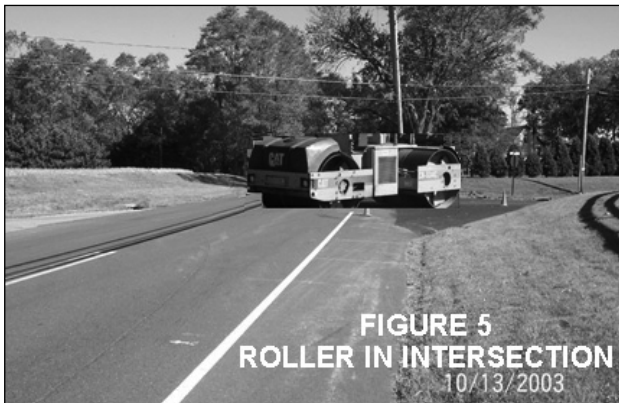
**FIGURE 5
ROLLER IN INTERSECTION**

Figure 5 shows the sight distance problem created by the pavement roller in the middle of the intersection during the subject accident

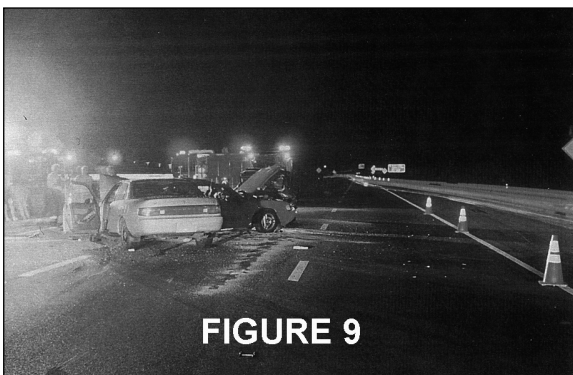
The subject accident location was in the center lane at the ROAD WORK 1 MILE sign (Figure 9). Route I-495 starts to curve left at the I-95 Exit ½ MILE overhead directional sign, not shown.

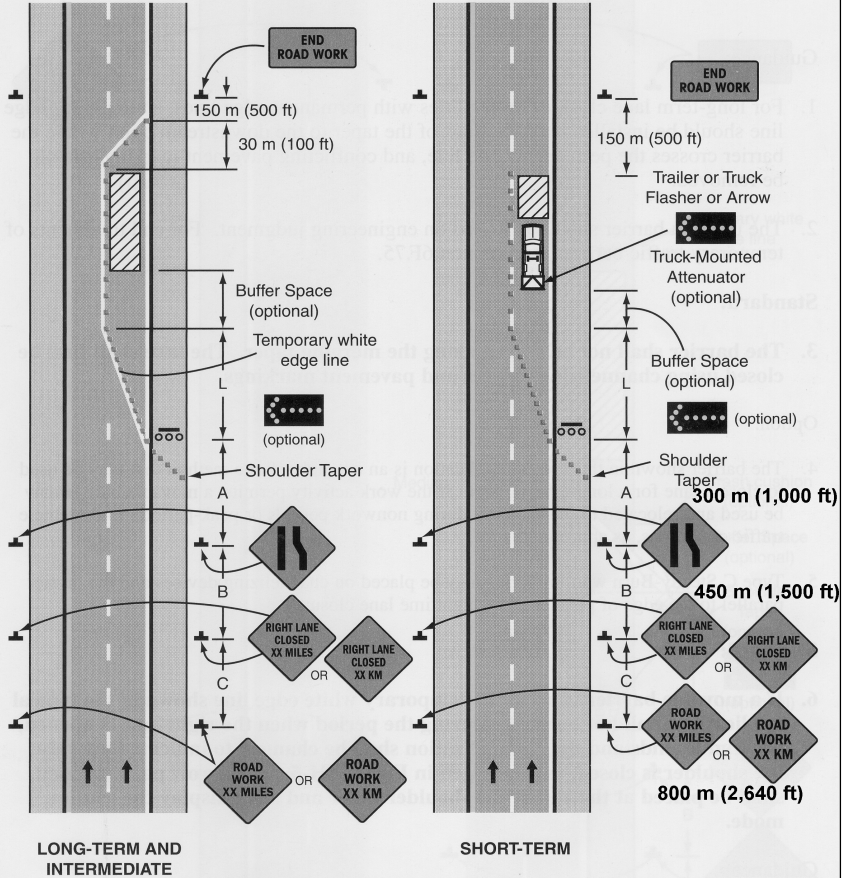
Figure 6H-33. Stationary Lane Closure on Divided Highway (TA-33)

The Federal Manual on Uniform Traffic Control Devices (MUTCD) 2000 Edition [Figure 6H-33 Stationary Lane Closure on Divide Highway TA-33] shows a standard lane closure plan for a short (daily) term operation. The placement of the Right Lane Merge sign should be 300 m (1,000 ft) from the start of the lane merge. The placement of the Advance Right Lane Closed ½ Mile sign should be 450 m (1,500 ft) in advance of the Right Lane Merge, at the crest of the hill. The placement of the Advance ROAD WORK 1 MILE sign should be 1,600 m (1 mile) in advance of the Right Lane Merge. The placement of a second Right Lane Closed ½ Mile sign should be located another ½ mile from the first right lane merge. The right lane closure came before the center and left lanes shifted to the left. At that point, the left lane closure came into effect. A motorist could only see the right lane closed less than 30 m (100 ft) ahead, and traffic had to merge into the center lane. The two left lanes then shifted to the left lane with no additional warning signing. At this point, traffic was using the two left lanes. During the lane shift, the Contractor closed off the left lane, forcing all the left lane traffic into the center lane during the shifting operation.
