Ambiguous evidence: earthquakes and ancient building techniques in an alpine example (4th-7th centuries)

Sara Santoro Bianchi

Dipartimento di Archeologia, Università di Bologna, Italy

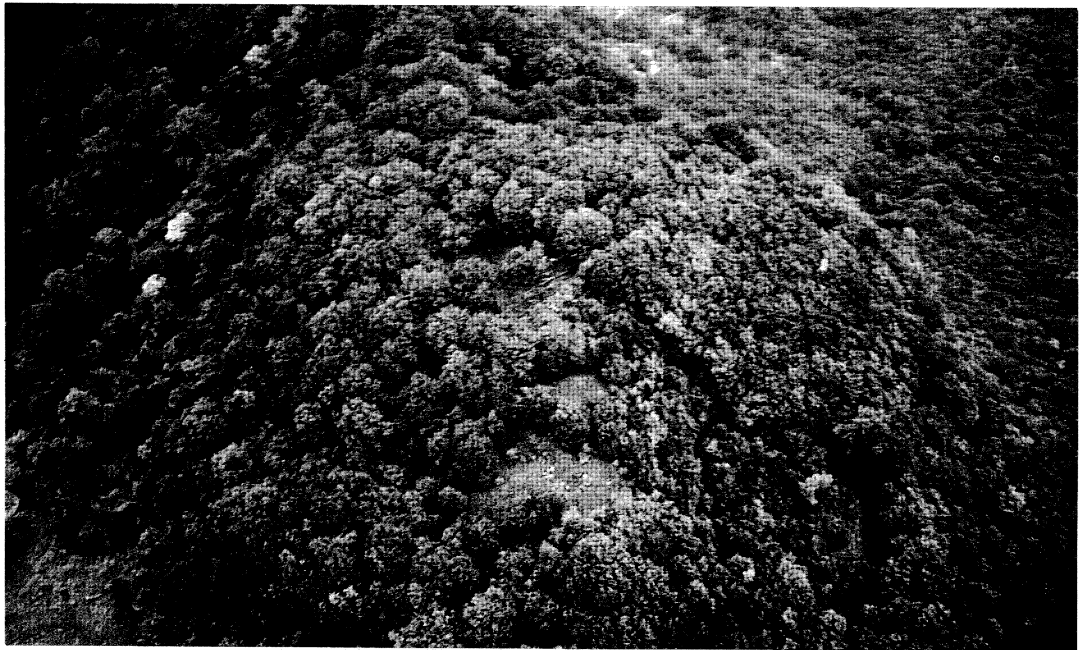
Fig. 2. Aerial photograph taken at low altitude from south-east of the Zuc 'Scjaramont (Castelraimondo) between the valley of the Tagliamento (left) and Val d'Arzino (right). The structures of sector V are visible.

A large building intended for residence, but also for public and perhaps religious functions (building V) went up at the highest point close to a small fault escarpment running across the hill from east to west at this point. Here is a further instance of that attraction between settlements and earthquakes that has been so brilliantly recalled at this conference. In our case, a useful space had been created over time by the faulting and the subsequent colluvial prism: a small natural plateau, well sheltered from the cold north winds channelled from the Arzino

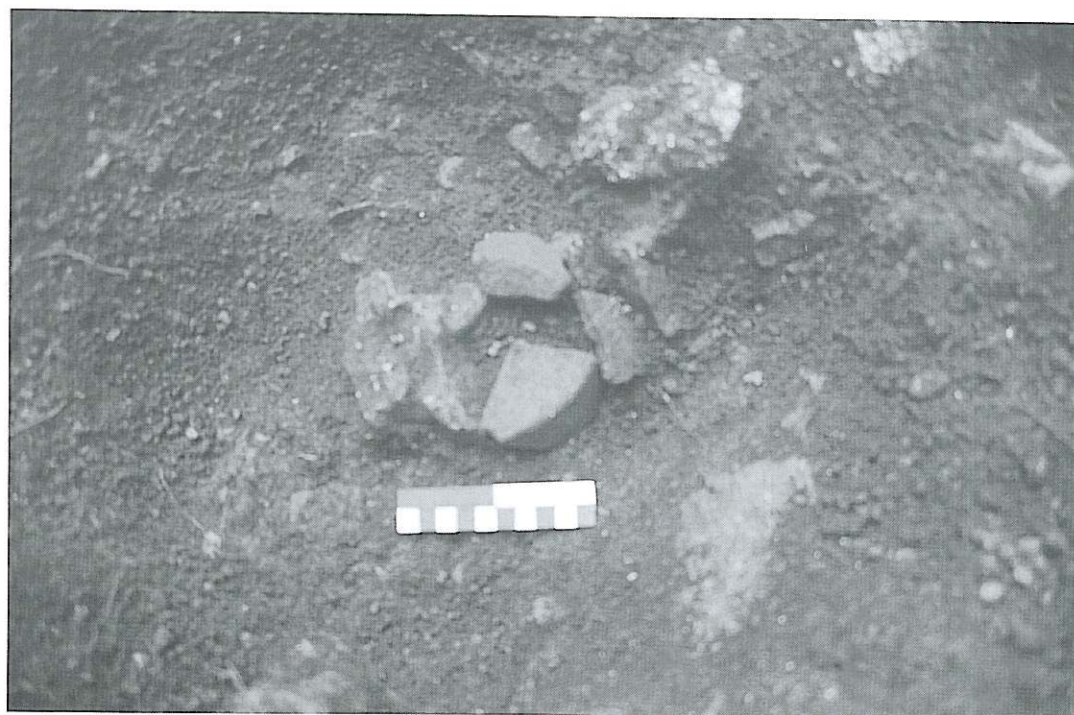
Fig. 8. Sector VC: fall of a vase (overturning) crushed by wall elements.

the consequence of a gale that had torn off the roof of the lookout post, but the same event also damaged the walls of tower IV and caused part of its covering to collapse. Other residential buildings, constructed with traditional techniques, also suffered. In particular, the roof of building IVter, made of sandstone flags set on a wooden lattice, fell in, and, in falling, the flags smashed some terracotta vases: the house was therefore inhabited. In building V, too, we found a small vase that had been overturned in falling from one of the shelves attached to the wall (fig. 8).
