# Evidence of a seismic event on Thracian tombs dated to the Hellenistic period (Sveshtari, Northeastern Bulgaria)

Diana Gergova<sup>(1)</sup>, Ilija Iliev<sup>(2)</sup> and Vincenzo Rizzo<sup>(3)</sup>

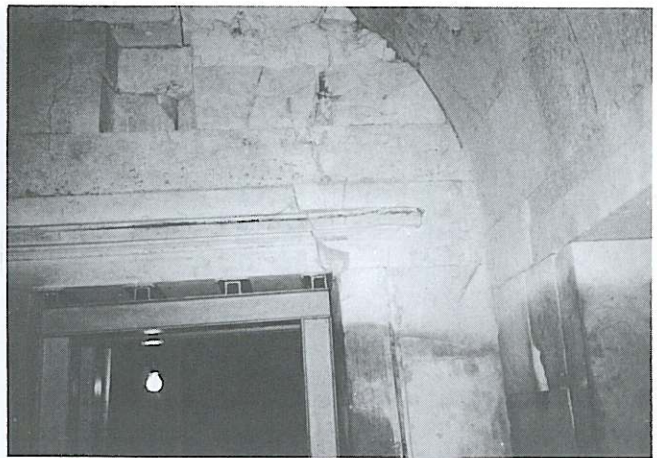
The remaining two tombs, which have been completely preserved, bear traces of block shifting, cracks and shock deformations, which occurred after the tombs had been built, very often with similar orientations to the ones observed in the tombs previously described. Displacements of the blocks of the walls and fissures up to 1.2 cm in width, actually in monitoring, are observed in the tomb below the Ginina Mogila mound (fig. 5a,b). On the southwest wall of the lateral chamber of this tomb there are not only horizontal displace-

**Fig. 5a,b.** Open fissures in monitoring by vibrating-wire sensors (a) and other serious damage (b) in the tomb inside Ginina Mogila (UNESCO National Monument).

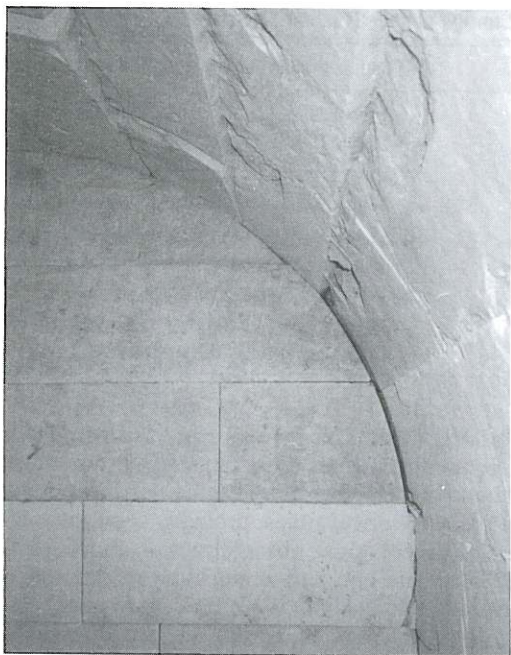
The situation is similar in the tomb below tumulus No. 13. Apart from the displacements reaching up to 2.2 cm, much of the blocks show symmetrical and systematic flaking as a consequence of a sudden high vertical pressure

**Fig. 7.** Flaking of stone blocks as a consequence of the high vertical pressure that they had undergone in tomb No. 13.

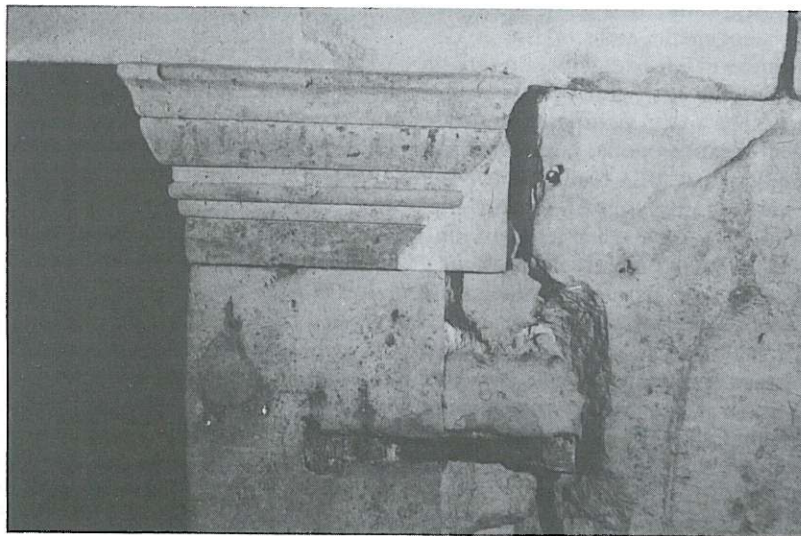
(fig. 7). The eastern pilaster at the entrance to the burial chamber of this tomb shows that an iron brace had been pulled out of place by horizontal strength (fig. 8).

**Fig. 8.** Eastern pilaster at the entrance of tomb No. 13. The iron brace had been pulled out of place by horizontal strength.
