Earthquake destruction of adobe villages in Iran

*(Effect of the earthquake of 31st August 1968 on the villages
of the Nimbluk Valley)*

J. S. TCHALENKO - N. N. AMBRASEYS (*)

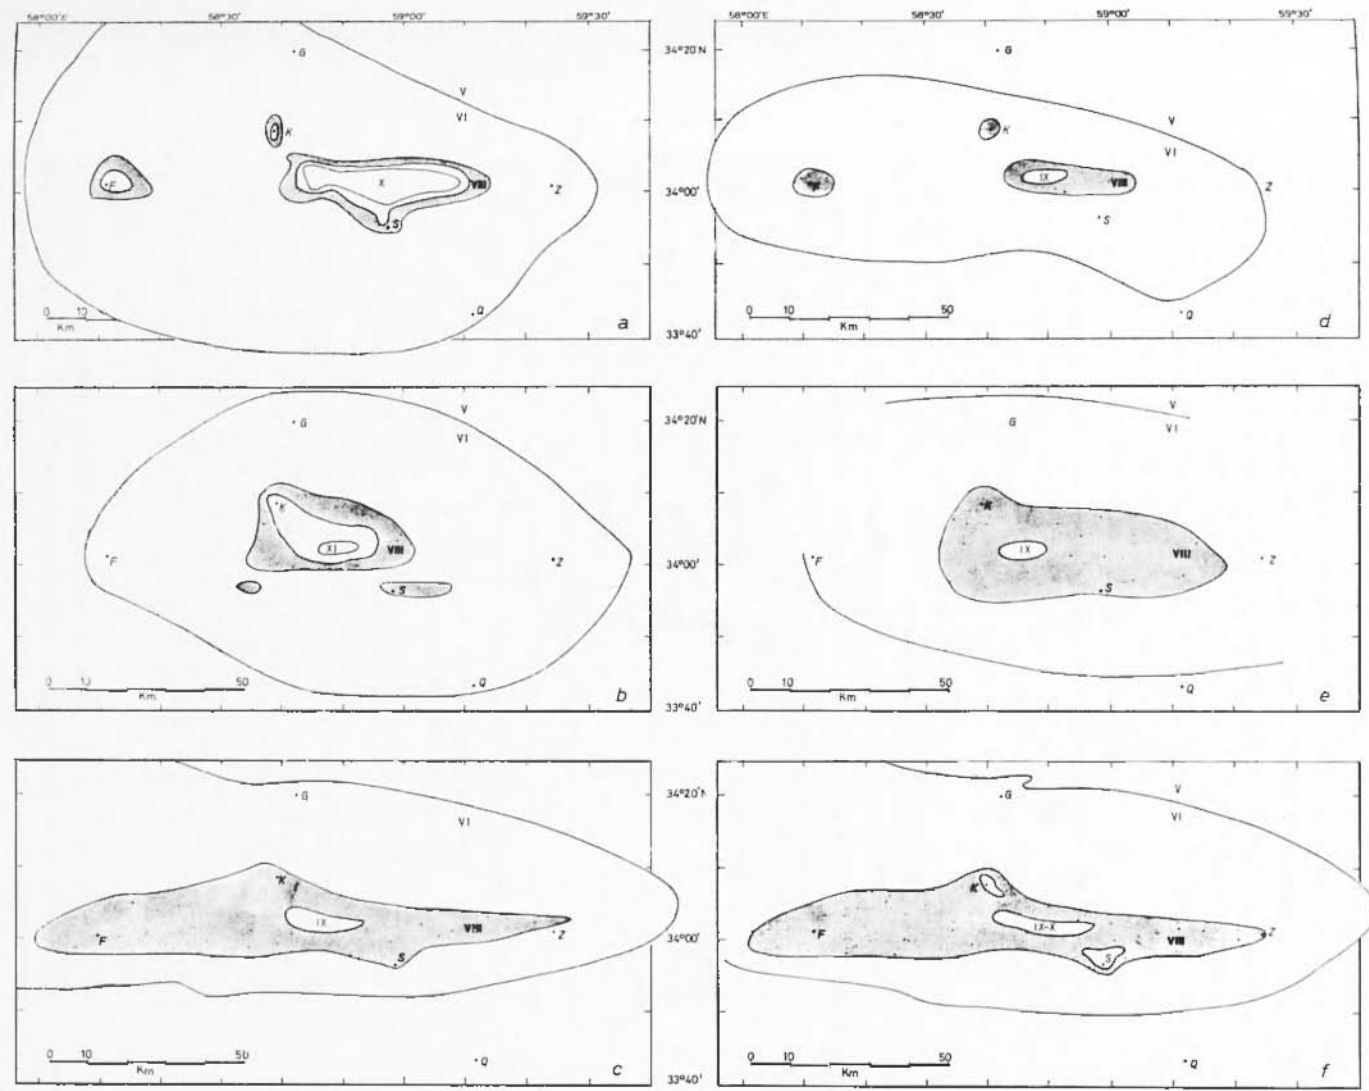
Fig. 6 - Comparison of isoseismal maps for the Dasht-e Bayaz earthquake — a) Bayer, Henckreth and Karim, 1969. b) University of Tehran, 1970. c) Eftekhar-Nejad, Hagnipoor, and Davoudzadeh, 1968. d) Pakhdaman, 1968. e) Moinfar, 1969. f) Gansser, 1969. Outer limit is between isoseismals V and VI. Shaded area is from VIII to IX. Central figure is maximum intensity proposed. (F = Ferdows, G = Gonabad, K = Kakhk, Q = Qayen, Z = Zigan).

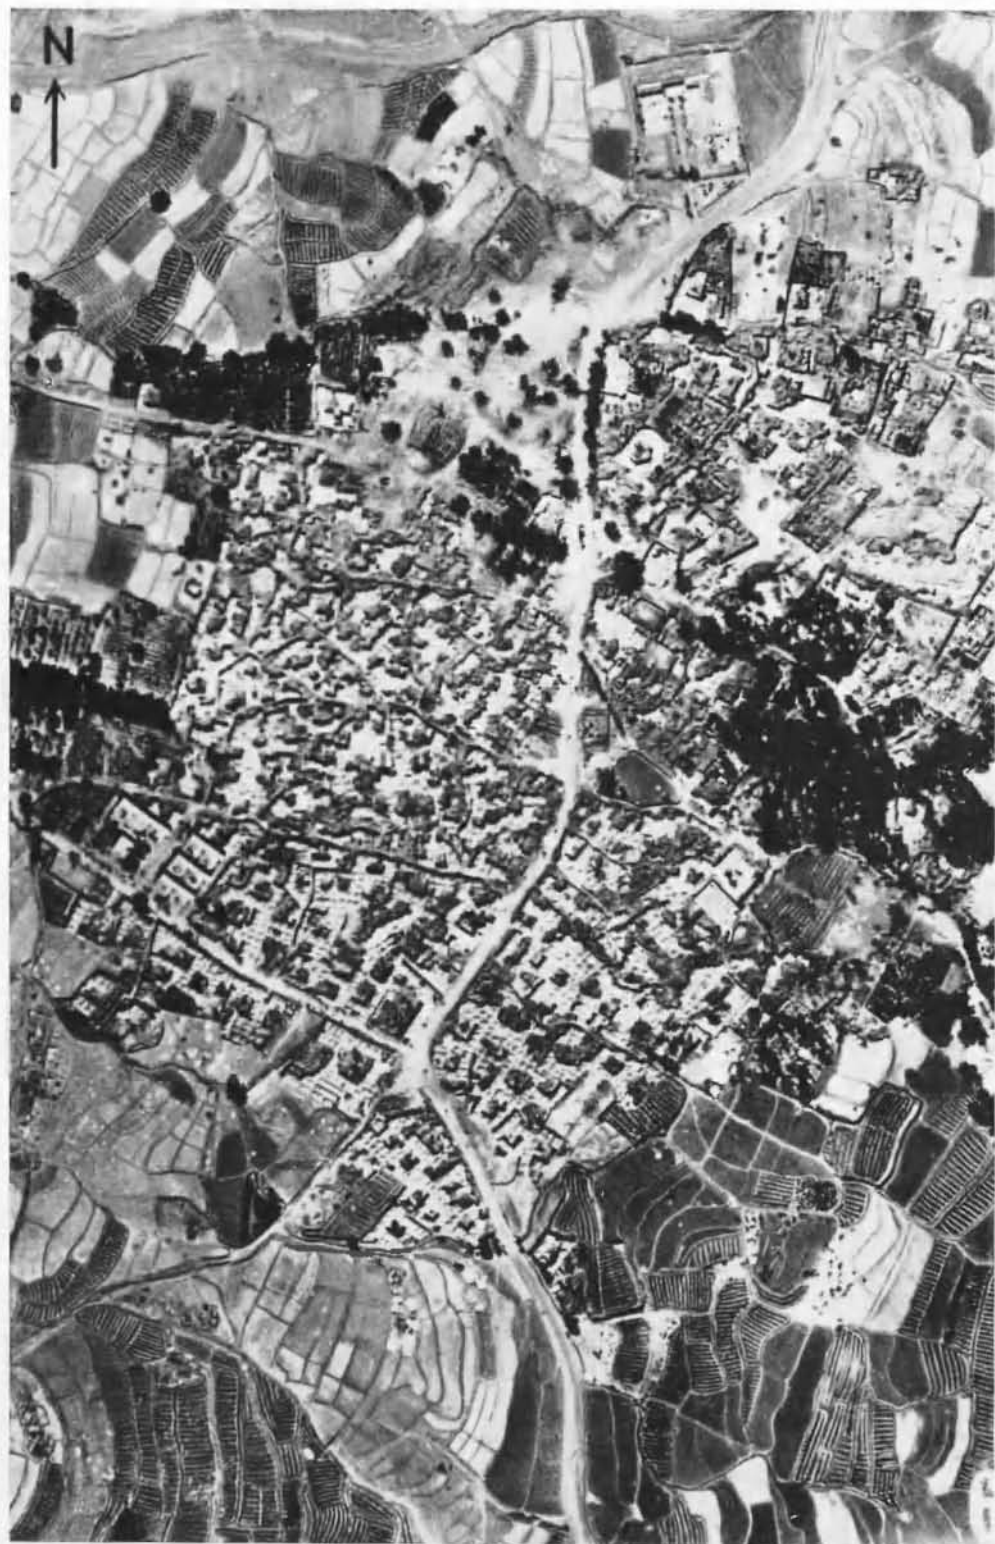
Fig. 8 — Khezri — Aerial photograph taken after the 1968 earthquake. The northern entrance west of the road is being bulldozed. Damage is sporadic throughout the village. At the western edge of the village, Government houses built from kilnbricks are standing undamaged. Note the narrow winding streets and compact structure of housing.

Taking into account such cases of "explained" irregularities, and using only the villages having more than 10 domes, the relation between number of collapsed domes and distances from the fault shows a definite trend (Fig. 9). The majority of the data is for the more heavily and more lightly damaged villages for which it can be said that those where 95% to 100% of the domes collapsed were all within 5 km of the fault, and that those where less than 15% of the domes collapsed were further than 11 km from the fault. There are fewers villages in the intermediary range, but as the data obtained by the method of counting domes on enlarged aerial photographs is con-

sidered to be particularly reliable, those villages for which data is available can be used with confidence. They show that, with the exception of the anomalous cases mentioned above, damage decreases approximately linearly with distance from the fault. It must be stressed however, that this trend should be considered as specific to the case of the Nimbluk Valley during the 1968 earthquake, and that it does not necessarily hold for other regions or other earthquakes. The usefulness of the graph presented in Fig. 9 is that it points out

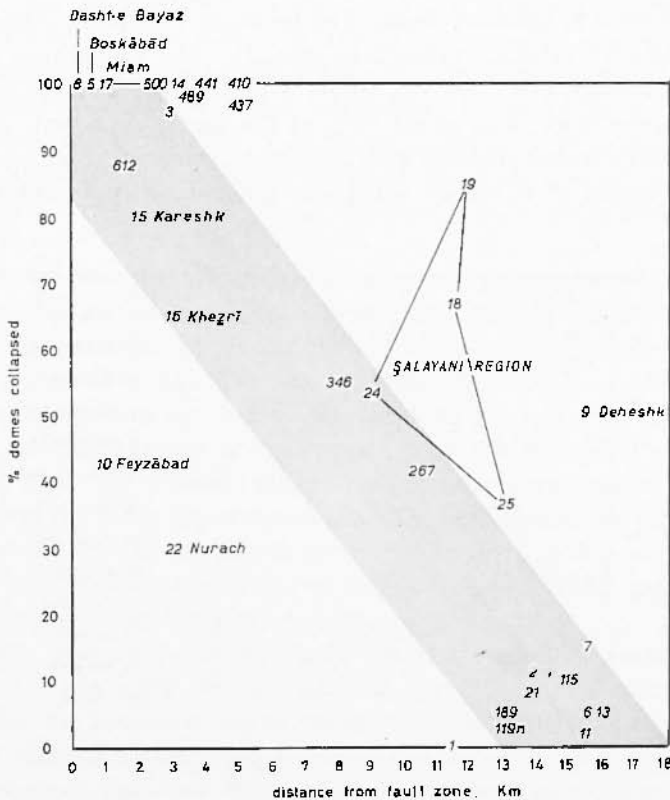
Fig. 9 - Relation between damage and distance from fault zone --- Numbers refer to Table 2. For analysis, see text and Fig. 10.

the villages which behaved anomalously and which are therefore worthy of special attention. For example, in the case of Nurach and Khezrī described above, it shows that it was Nurach which showed

exceptionally light damage whereas Khezri was well within the average for the earthquake. It also points to the exceptional behaviour of the Salayani region and of Deheshk which will now be seen in greater detail.

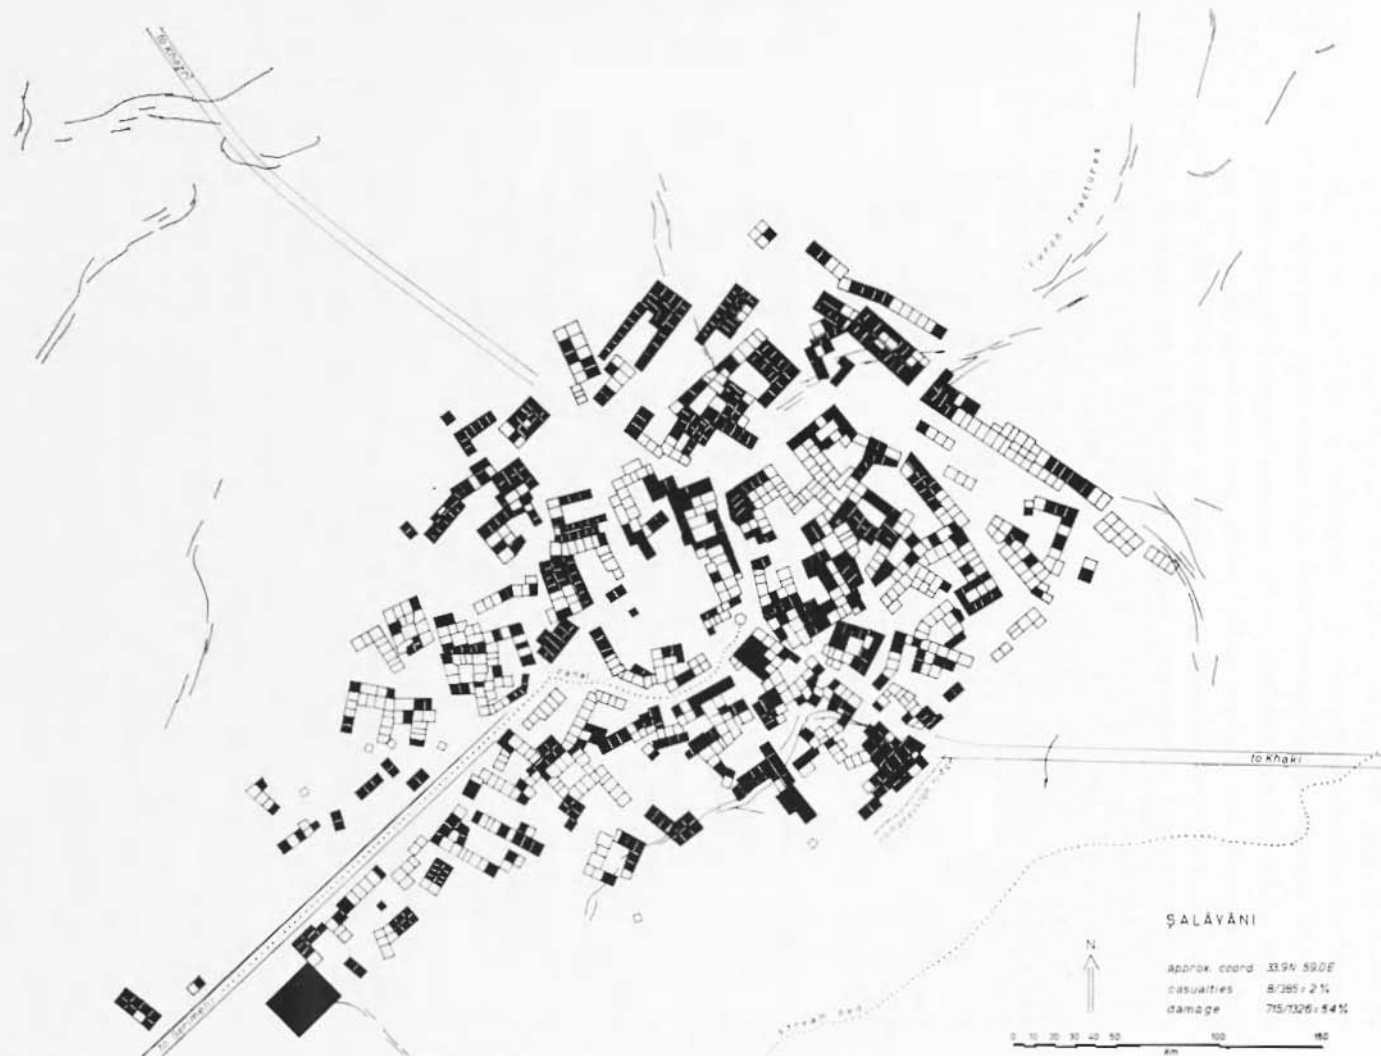
Fig. 11 - Şalāvāni — Maximum damage in the village seems to be associated with lurch fractures. Large structure at the Gerimonj entrance is a school, completely destroyed. Collapsed domes shown in black.

Salayani was the village of the Nimbluk Valley situated nearest to the centre of the plain where water and climate conditions were the least favourable. In plan it showed a very open structure unique for the region (Fig. 11). The earthquake caused 54% of the domes to collapse, but the number of people killed (8) was well below the average for this amount of destruction. On the ground it could be observed that the houses collapsed essentially there where ground fractures of the lurch type crossed the village. As these fractures have not been described in any length by previous papers on the earthquake, and because of the uncertainty of their origin and their importance to the damage, they are given below in some detail.

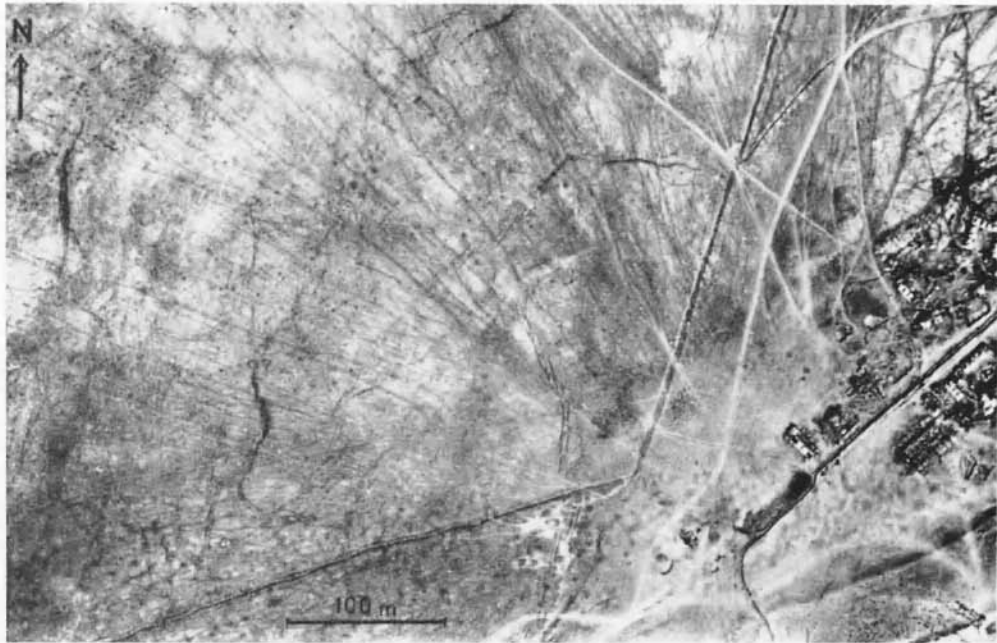
Fig. 12 -- Lurch fractures at Salāyāni -- Southwest entrance to the village (see plan, Fig. 11). Note sinuous and discontinuous trace. Lines converging on village are cattle tracks.

Lurch fractures were generally found grouped in zones a few metres wide and a few tens of metres to several hundred metres long. Each zone was formed by up to about one dozen sub-parallel fractures showing vertical displacements only. Throws of all the fractures in a zone were in the same sense which, for curved zones, was usually concave side downwards. The slabs of soil between the fractures of a zone were often tilted towards the fracture scarp. The vertical throw of a fracture could vary from a few centimetres to about one metre but was compensated by this tilting in such a manner that the net vertical movement of one side of the zone with respect to the other seemed to be nil or insignificant. In plan, most zones were arcuate or sinuous (Fig. 12), and a few examples were found of closed

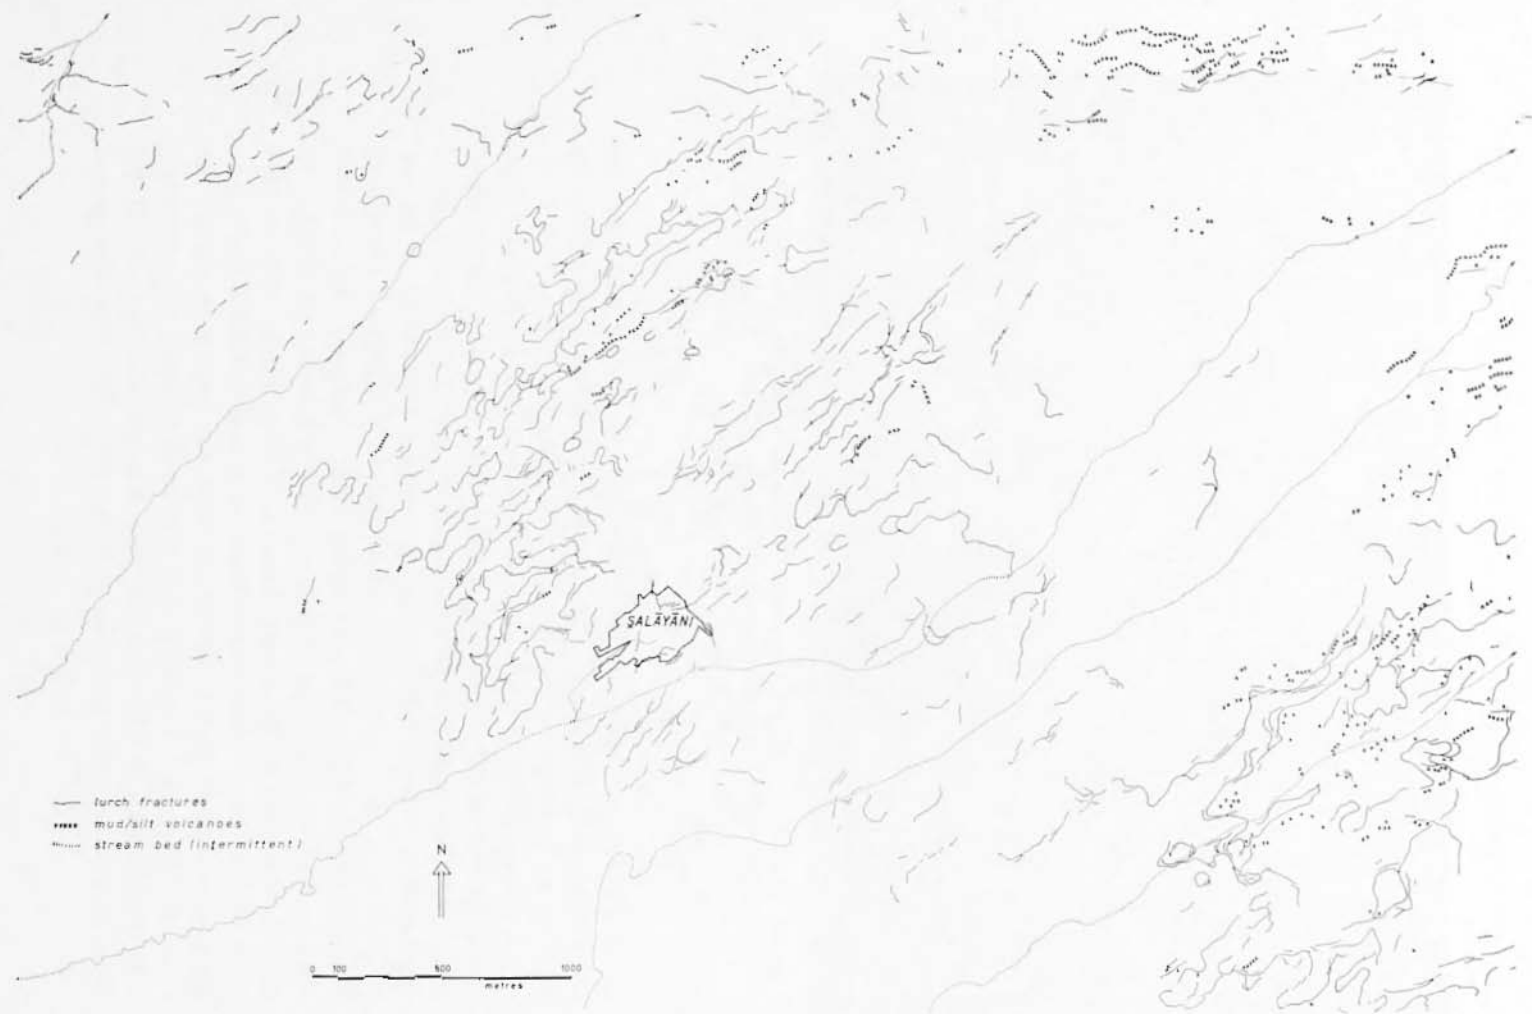
Fig. 13 - Lurch fractures in the Salāyāni region — Note parallelism of general fracture direction with stream bed, and "footprint" structures about 1 km North of village. (After uncontrolled aerial photographs).

A great number of lurch zones were formed in the Salayani region, especially to the north and east of the village (Fig. 13). Their orientation is on average north to northeast. Several of these zones passed through the village, causing various degrees of damage to houses. For example, the school at the southwestern entrance to the village was completely destroyed. In other cases, however, houses which were cut by fractures collapsed only partially or even not at all (Fig. 14).

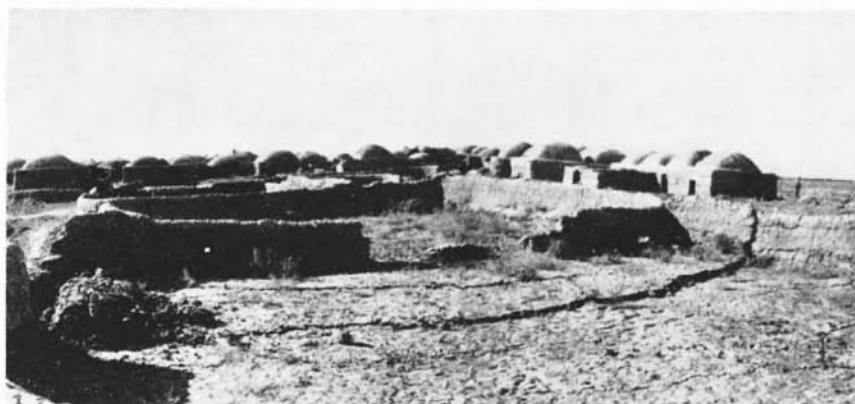
Fig. 14 - Salayani - - View of the easternmost houses of the village (north of Khaki road, see plan, Fig. 11). Lurch fractures in the foreground cross mud walls and houses with only partial collapse of the latter.

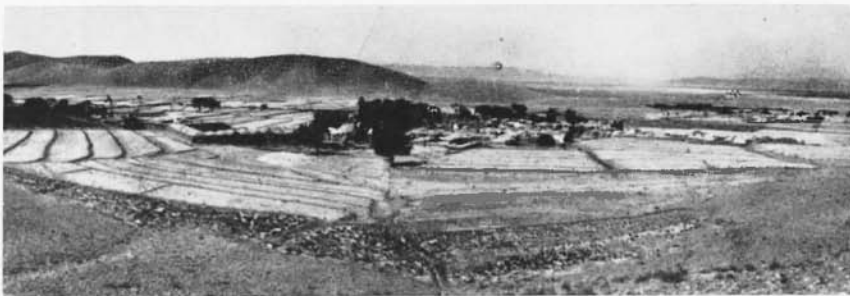
Fig. 17 - Deheshk — View from the south. The neogene spur behind the village separates the subsidiary valley from the Nimbluk plain in the background. Maximum damage occurred directly below cluster of trees which mark the village pond. Right background, Boznabad. Photograph taken July, 1970.

and to the Nimbluk plain (Fig. 17). The central part of Deheshk was slightly lower than the rest of the village, but unlike Kareshk, the valley was wider here and all the houses were built on the river gravel. The earthquake damage in Deheshk was remarkable on two accounts. Firstly, although the fatalities were minimal (1 person killed), the damage was exceptionally high compared to the other villages of the area: in Deheshk about 50% of the 600 domes collapsed, whereas in the next village of Boznabad less than 500 m downstream, fewer than 5% collapsed. Secondly, the damage distribution in Deheshk showed a central section completely destroyed, and most of the undamaged domes located at the edges of the village (Fig. 16, insert). The undamaged houses were in a good enough condition to be reoccupied soon after the earthquake. The origin of the unevenness of damage distribution was here, however, different from Kareshk. Irrigation of the fields immediately upstream of Deheshk had produced a small pond, and resulted in extensive waterlogging in the centre of the village. Consequently poor foundation conditions seemed to have been the main cause of exceptionally high damage to the houses which were located downstream of the pond.

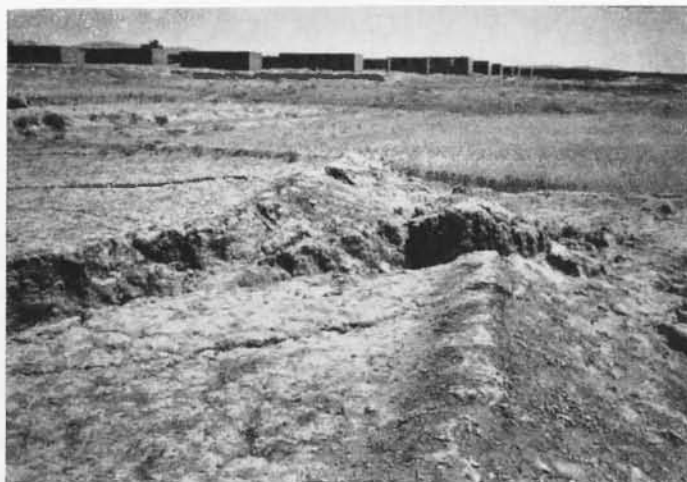
Fig. 18 - New village of Dasht-e Bayaz --- In the foreground, a fracture of the 1968 fault zone, displacing field boundaries. Total displacement was here 270 cm left-lateral and 160 cm South side (observer) down. Photograph taken July 1970.

Towards the end of 1970, the construction of modern-type kiln-brick bungalows was nearing completion in five centres in the Nimbluk Valley. The largest of the upper and lower fan villages which were destroyed by the earthquake were reconstructed individually at their previous locations (Fig. 5). New Dasht-e Bayaz is situated between the old village and the fault zone (Fig. 18); new Kareshk
