Special Issue: Earthquake geology

Rock-falls and liquefaction related phenomena triggered by the June 8, 2008, $M_w=6.4$ earthquake in NW Peloponnesus, Greece

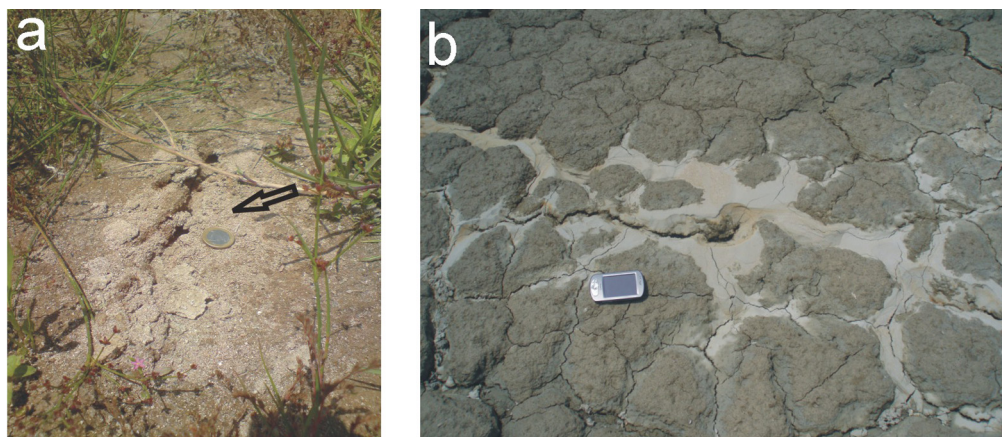
Figure 5. (a) Ejection of sand-water mixture at the banks of Pinios River; (b) ejection of sand-water mixture at the shore of Pinios Lake (site Kalivia).

uefaction-induced ground failures appeared to be concentrated in areas characterised by alluvial deposits (Figure 1). In particular, at the banks of the Pinios River, small-scale ground cracks were observed and granular material was ejected while 1-2 cm-wide opening features were generated towards the river (Figure 5a). Close to this site, in Kalivia village, fine-grained material was ejected from ground fissures as shown in Figure 5b.

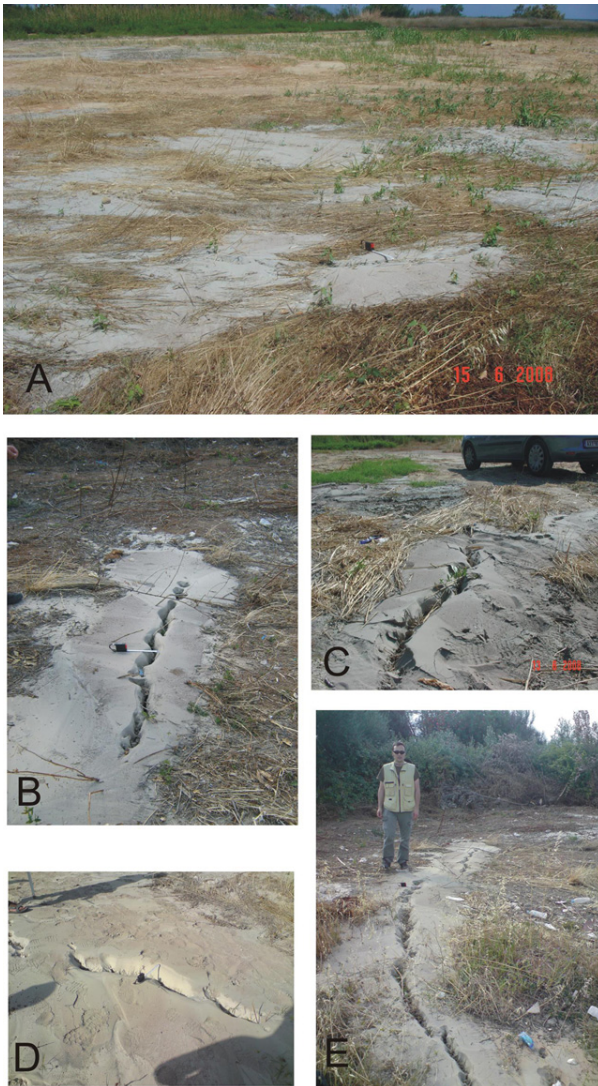
Figure 7 (left, top to bottom). Liquefaction manifestations at the sea shore of the village Kato Achaia. (a) General view of the area; (b,c,d) examples of vent fractures with 12, 20 and 30 cm-width, respectively; (e) formation of a 4 m-long vent fracture.

Liquefaction phenomena occurred also at several sites located north of the epicentre. The most impressive ones were mapped along the sea shore near the village Kato Achaia, at an epicentral distance of ca. 20 km (Figure 7), where ejected sandy grey material formed vent fractures from 50 cm- to 4 m-long and up to 22 cm-wide as well as sand volcanoes up to 8 cm in diameter. Furthermore, ejection of grey sand was observed at a distance of 600 m from the coast line (offshore).

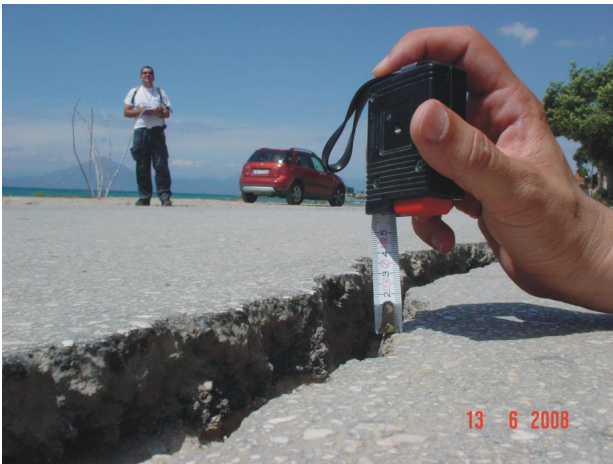
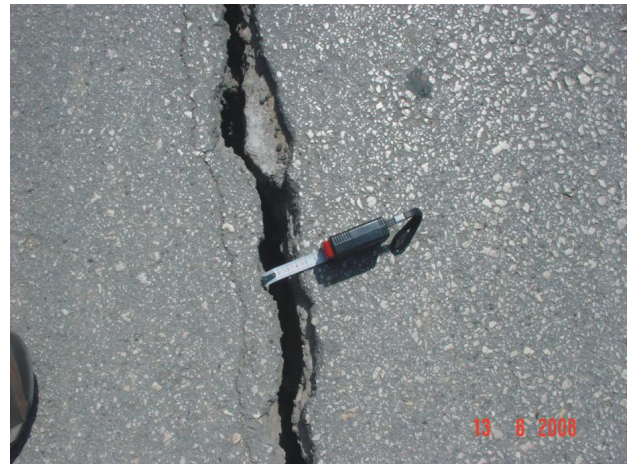
Finally, structural damages that were possibly caused by differential soil subsidence, are documented at the waterfront area of the village Vrachneika, at an

epicentral distance of 25 km. In this area, the pavement was cracked and buried water pipes were damaged. The mean direction of the cracks was parallel to the coastline while their measured length was up to 500 m. The horizontal displacement ranged from 3 to 7 cm while in some places a throw of 3 cm was also reported (Figure 9). It should be noted that no evidence of liquefaction phenomena such as ejection of material from the cracks and/or creation of sand volcanoes was observed at this area.

Figure 9. Structural damages at the waterfront area of the village Vrahneika. Examples of failures on pavement with both throw and opening components (left: throw = 3 cm and opening = 2 cm; right: opening = 4 cm).

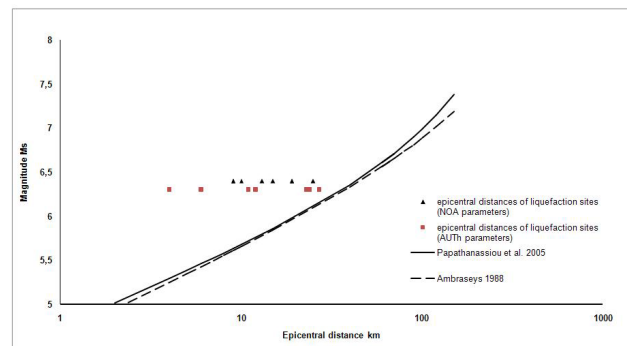
The susceptibility to liquefaction at these sites has been further investigated by correlating the epicentral distance with the earthquake magnitude. The maximum epicentral distances of the liquefied sites, estimated according to the epicentre's coordinates by both National Observatory of Athens (NOA) and Aristotle University of Thessaloniki (AUTH) (Figure 1), were correlated to the magnitude of the event using the regressions proposed by Papathanassiou et al. [2005] and Ambraseys [1988]. It is noteworthy that all sites where liquefaction phenomena have been documented by the present research fall within the maximum epicentral

distance for a 6.4 magnitude event (Figure 10).

Figure 10. Distribution of the liquefied sites based on their epicentral distance and comparison to the upper bound curves proposed by Papathanassiou et al. [2005] and Ambraseys [1988] for the assessment of liquefaction susceptibility.

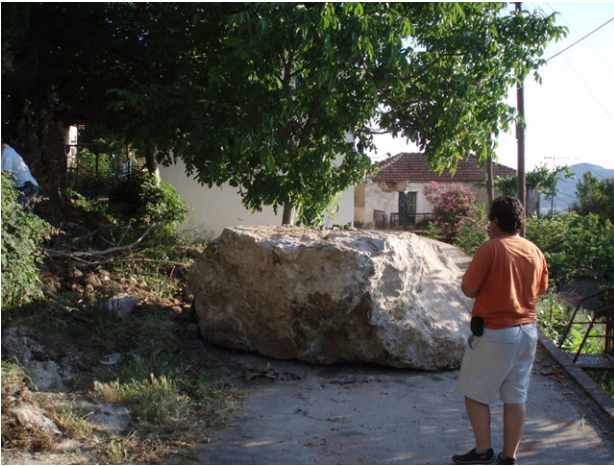
Figure 11. Example of large size rock-fall in the village of Santomeri.

At both western and eastern slopes of Skolis Mountain, rock-toppling phenomena of large dimensions, accompanied by small rock-slides, were observed in steep slopes developed in limestone. The volume of the rock-falls was up to 8 m^3 , causing damages to houses at the village Santomeri (Figure 11) and to the road network. In particular, large size craters up to 2 m in diameter were observed on paved roads as well as north of Santomeri village. Consequently, the local authorities demanded the evacuation of three villages, including Santomeri, for three days following the main shock in order to avoid possible casualties from the possible re-activation of rock-falls during the aftershocks sequence.

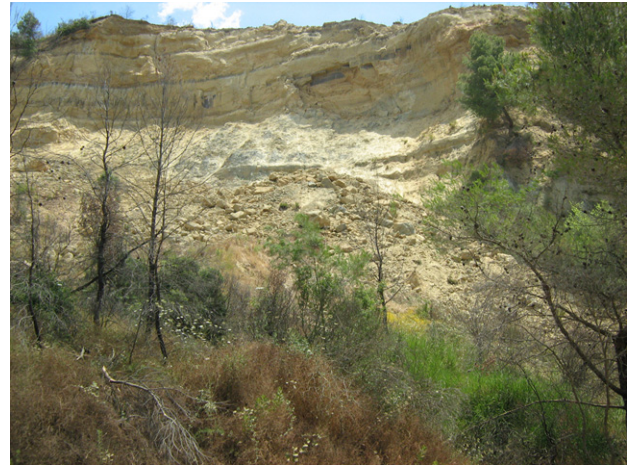
Figure 12. Slope failure close to the village of Valmi.
