Dynamic characteristics of the *Amphitheatrum Flavium* northern wall from traffic-induced vibrations

Giovanni Bongiovanni¹, Giacomo Buffarini¹, Paolo Clemente^{1,*}, Dario Rinaldis¹, Fernando Saitta¹

¹ ENEA Casaccia Research Centre, Rome, Italy

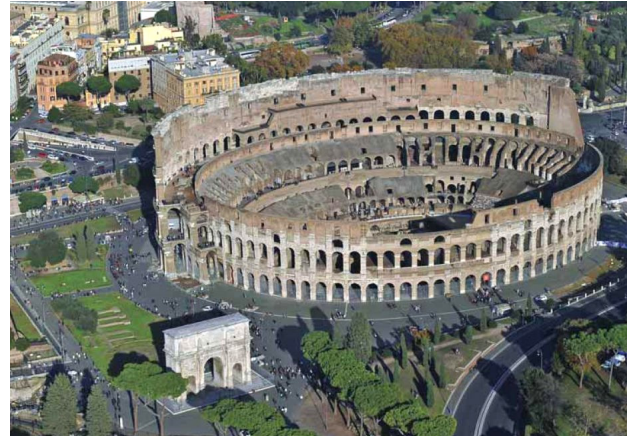
Figure 1. View of the Amphitheatrum Flavium with the northern wall.

The *Amphitheatrum Flavium*, better known in the world as Colosseum, is the largest amphitheater ever built. Its construction began under the emperor Vespasian in 72 A.D., and was completed under emperor Titus in 80 A.D.. It is an entirely free-standing structure, elliptical in plan, 189 m long and 156 m wide (Figure 1).

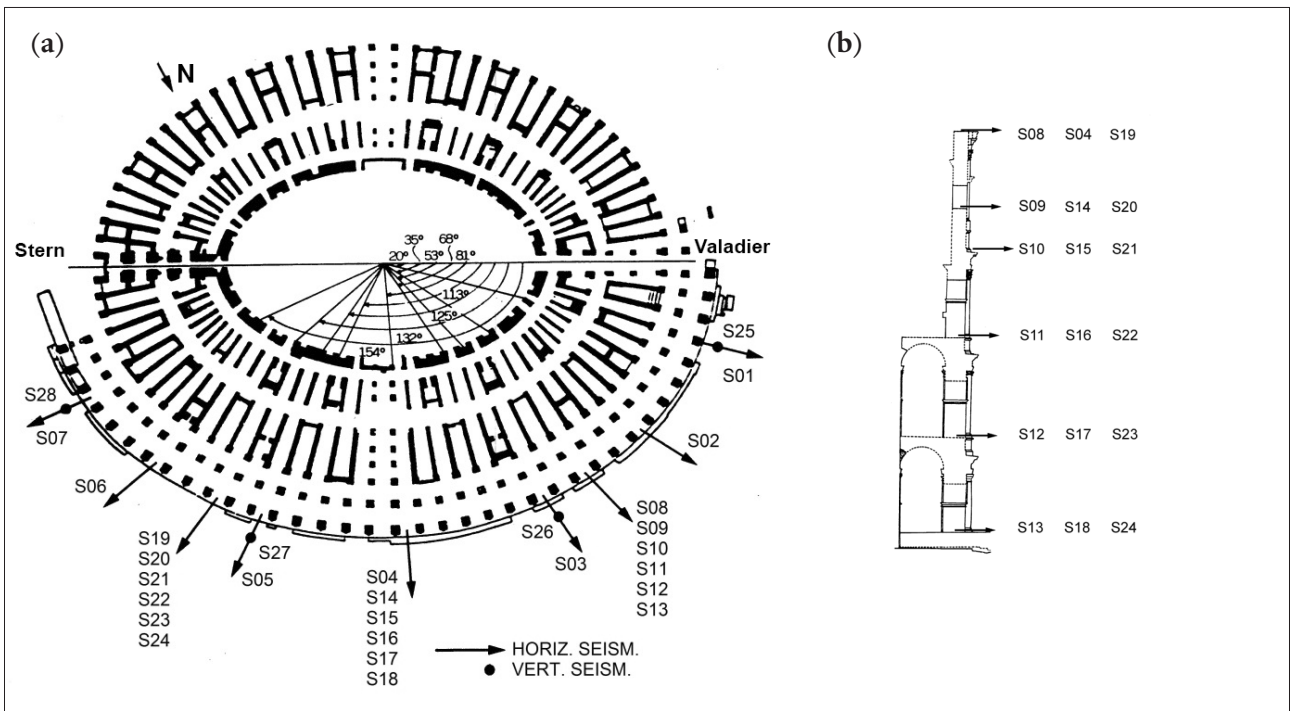
Figure 3. Seismometer locations: (a) plan view and (b) vertical section.

In the first experimental campaign measurements were done by using 13 seismometers Teledyne Geotech S13800 and signals were finally obtained with a sampling rate of 0.005 sec. Sensors were deployed in three different configurations (C1, C2 and C3 in the following). Seven of them were kept in the horizontal radial directions at the top of the wall in the three configurations (locations S01 to S07); the others six were deployed in different locations (Figure 3a). In the first configuration (C1) these six seismometers were deployed along a vertical alignment (locations S08 to S13, Figure 3b), with sensor S08 at the top (Figure 4). In the second configuration (C2) only five seismometers were deployed along a vertical alignment (locations S14 to S18), with sensor S04 at the top. In the third configuration (C3) the six seismometers were deployed along a vertical alignment (locations S19 to S24), with sensor S19 at the top.

on the basement (locations S25 to S28, Figures 3,15). In the recordings obtained at S25, which is very close to the underground line, two passages of the trains are evident (Figure 16, in the intervals 10-30 and 100-120 s). Their effects become negligible going to locations far from the underground as demonstrated by the corresponding RMSs (S26, S27 and S28) plotted in Figure 17. In absence of the train passage, velocity amplitudes were almost similar at all the locations. Furthermore, vertical values were much lower than the horizontal ones obtained on the basement in the other configurations.

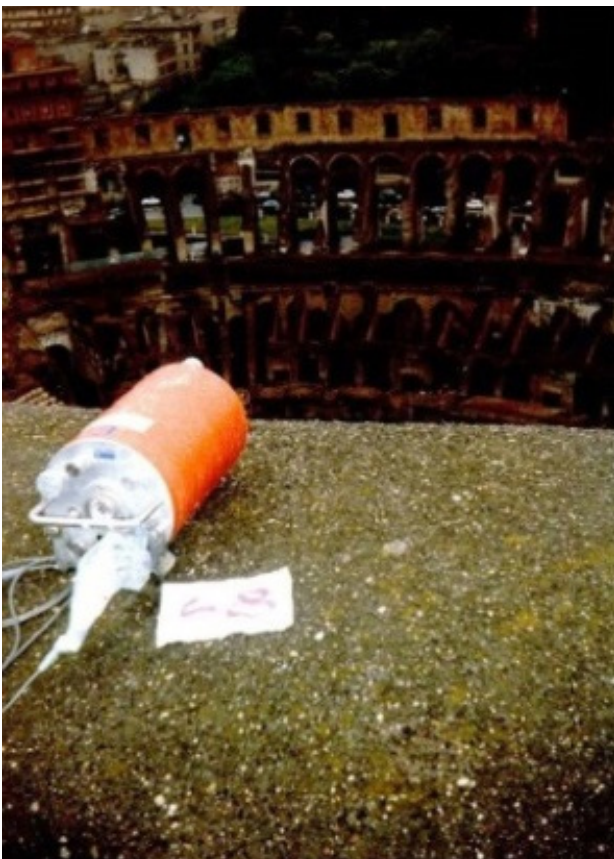
Figure 4. Radial seismometer S08 in configuration C1.

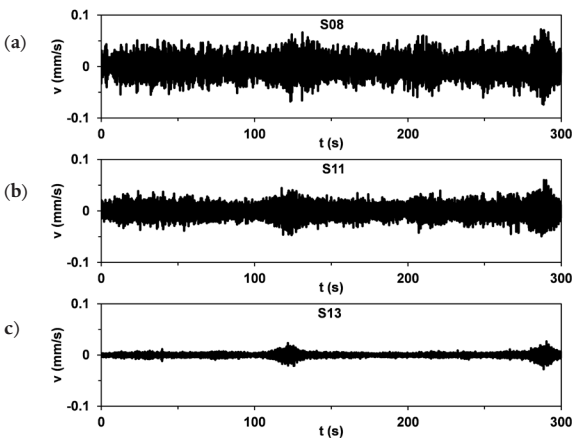
Figure 5. Time histories recorded along the first vertical alignment in configuration C1 at (a) S08, (b) S11 and (c) S13.

In Figure 5 some of the time histories recorded at different height of the first vertical alignment are plotted. The passage of the near underground is very evident on the basement (S13) in two intervals (100÷150 s, 275÷300 s) while becomes less evident at the mid height (S11) and can hardly be seen at the top of the

wall (S08). The amplification of motion from the base-
ment to the top is also apparent.

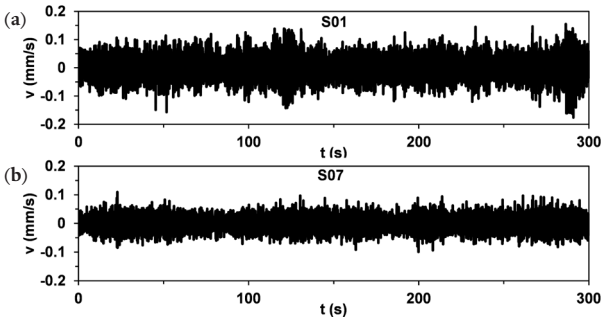
Figure 6. Time histories recorded at locations at the top of the wall in configuration C1 at (a) S01 and (b) S07.

when moving away from S01. Motion amplitudes at
the Stern’s buttress (S07) are much lower than those
at the Valadier’s buttress (S01), also in absence of
train-induced vibrations (Figure 6).

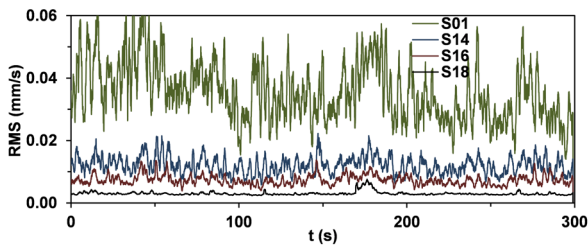
Figure 8. RMSs of recording velocities in configuration C2.

In Figure 8 the RMSs relative to some sensors of
the second vertical alignment in C2 are plotted.

For comparisons with the previous configuration
C1 also the RMS of S01 are shown. It is evident that
the velocity values recorded at the sensor locations of
the second vertical alignment are much lower than the
other ones. This occurrence allows stating that all the
sensor locations of this alignment are close to nodes of
most of the excited modes of the wall.

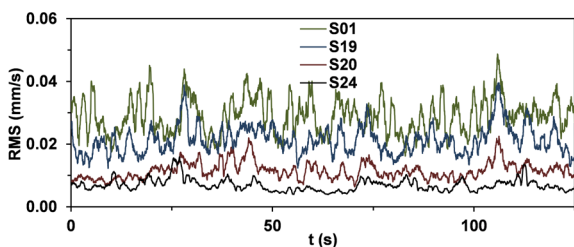
Figure 9. RMSs of recording velocities in configuration C3.

The RMSs relative to the third vertical alignment
in configuration C3 are plotted in Figure 9. A usual
amplification from the basement (S24) to the top (S19)
is apparent but values always lower than at S01.

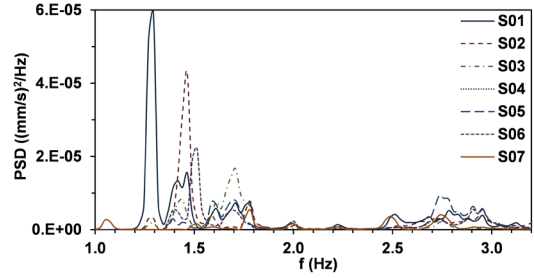
Figure 10. PSDs of S01-S07 in configuration C1.

The PSDs of recordings of sensors S01-S07 were very similar in all the configurations. In Figure 10 those obtained in C1 are plotted. The cross analysis identified the same resonance frequencies; in Tables 2 and 3 the phase factors and the corresponding coherence functions, relative to C1, are shown. These have values not usual for a linear elastic behavior. This occurrence is to be expected due to the materials and the geometri-

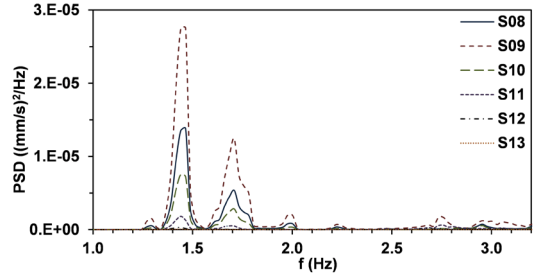
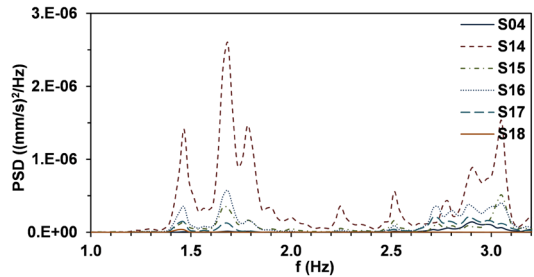
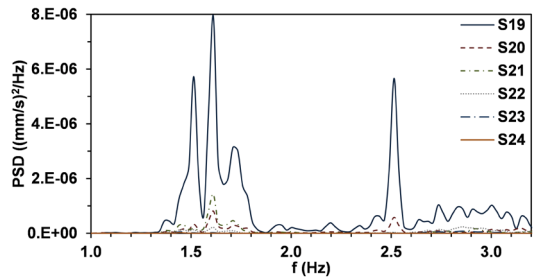
Figure 11. PSDs of S08-S13 in configuration C1.

Figure 12. PSDs of S04-S18 in configuration C2.

Figure 13. PSDs of S19-S24 in configuration C3.

The description refers first to the top of the wall, and then includes also the vertical alignments. Figures 11, 12 and 13 show the PSDs of the recordings obtained along the three vertical alignments. The phase factors and the corresponding coherence functions of the first vertical alignment S08-S13 are shown in Tables 2 and 3, while Tables 4 and 5 and Tables 6 and 7 are relative to C2 and C3 respectively.

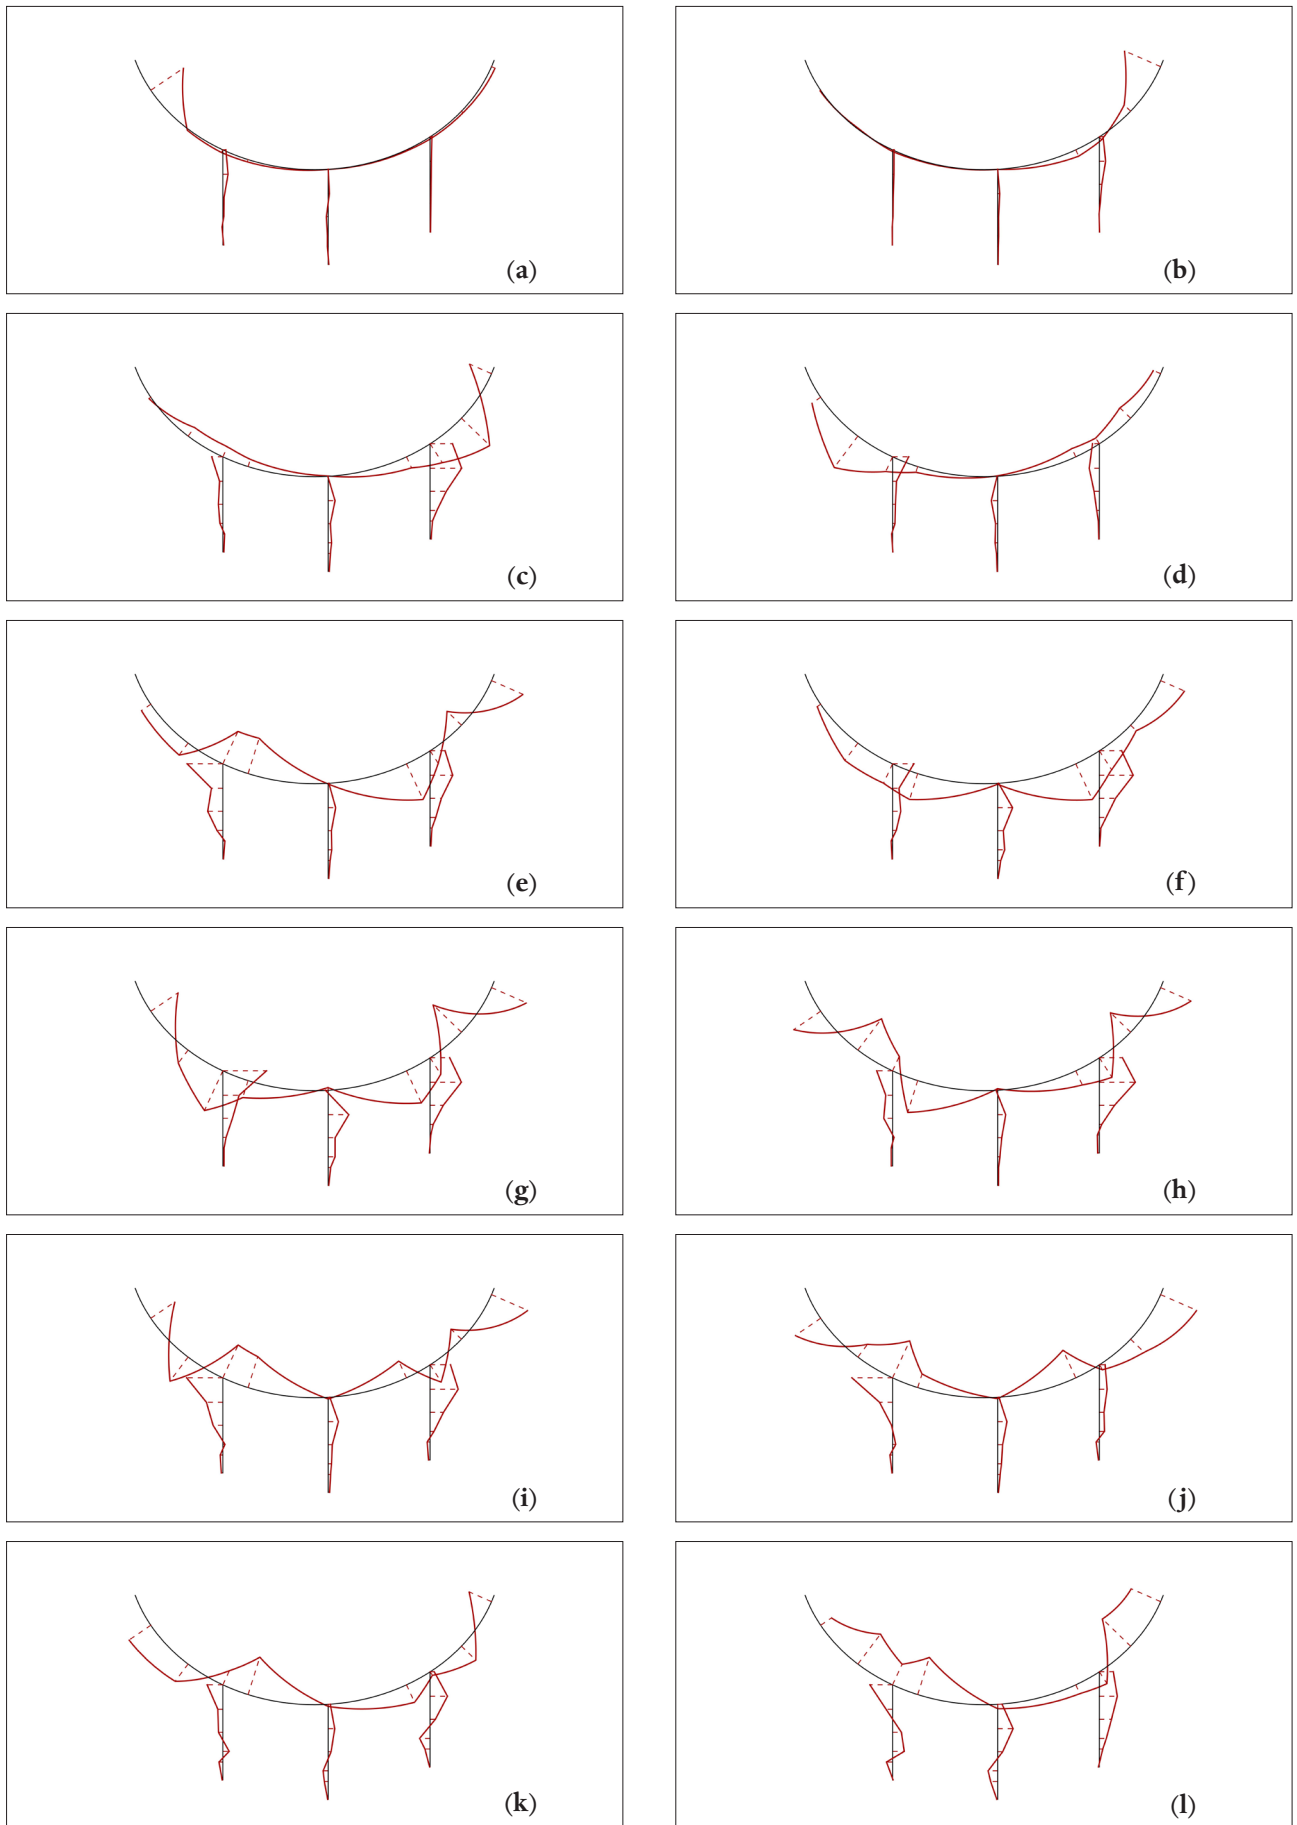
Figure 14. Modal shapes.

1.05 Hz. The modal shape interests mainly the portion of the wall close to the Stern's buttress. Starting from S07, this presents a good coherence with S06 and S05, where peak values in the CSDs are still significant; the coherence with recordings at farther locations is not significant but also the amplitudes are very low. The third vertical alignment is involved in this mode; S19 is coherent with S07 and 180° out of phase (Figure 14a).

1.29 Hz. The associated modal shape is almost symmetric to the previous one with reference to S04 and interests mainly the portion of the walls close to the Valadier's buttress. Starting from S01, the coherence is quite good with S02, S03 and S04, then the coherence becomes poor but also the amplitudes are very low. S02 and S03 are in phase with S01; S04 is 180° out of phase with S01 and the CSD amplitude is much lower than those of the first two. This mode involves the first vertical alignment; S08 has a good coherence and is 180° out of phase with S01; S09, S10 and S11 have very good coherence and are in phase with S08. S12 and S13 have both low coherence and non-significant values of the phase with S08 but are in phase to each other; the maximum amplitude is at S09 (Figure 14b).

1.46 Hz. The modal shape interests a portion of the walls close to the Valadier's buttress but larger than the previous mode. All the sensors have a good coherence with S01; S02, S03 and S07 are 180° out of phase, S04, S05 and S06 are in phase with S01; the maximum amplitude is at S02. The recordings of the first vertical alignment have always good coherence and are in phase with S08 and the maximum amplitude is at S09; the third vertical presents the maximum at the top; radial

components are very low at the second vertical alignment (Figure 14c).

1.51 Hz. The modal shape associated to this frequency is qualitatively symmetric to the previous one with reference to S04, which is a modal node; it is to point out that S05 is assumed to be in phase with S07, even though the coherence is quite poor (Figure 14d).

1.61 Hz. The modal shape associated to this frequency involves the entire wall with two waves; so it is almost antisymmetric with reference to the middle of the wall (S04); the phase factor assumes always quite significant values and also the coherence function is acceptable. The first and the second vertical alignments present the maximum displacements not at the top (Figure 14e).

1.71 Hz. This frequency is not apparent in all the recordings, and often where it is present, the following (1.78 Hz) is often not present. The associated modal shape involves the entire wall with displacements all at the same side; S04 is a node for the mode; signals are almost in phase and the coherence function is quite good; the displacement at the vertical alignment are very similar to those of the next modal shape (Figure 14f).

1.78 Hz. The mode involves the entire wall with displacement quite symmetric with respect to S04 where it is negligible; there are two sign inversions at the Valadier's side, only one at the Stern's side; phase factors and coherence function assume quite significant values. The second and third vertical alignments present displacements not always increasing to the top (Figure 14g).

2.00 Hz. The modal shape is symmetric with two changes of sign at both the sides; phase factor and coherence functions are quite significant. The first and third vertical alignments present changes in the displacement sign along the height; the second one presents an inversion at the lower part (Figure 14h).

side, only one at the Valadier's side; phase factor and coherence functions are very significant. The first and third vertical alignments present changes in the displacement sign along the height; the second one presents an inversion at the lower part (Figure 14i).

2.51 Hz. The modal shape is symmetric with respect to S04, with one change of sign at both the sides; phase factor and coherence functions are always quite significant. The first and third vertical alignments present changes in the displacement sign along the height; the second one presents an inversion at the lower part (similar to the previous mode at 2.22 Hz) (Figure 14j).

2.76 Hz. The modal shape is almost antisymmetric with respect to S04 and presents displacements of different sign at the two sides, with one inversion at both the Valadier's and the Stern's sides. The first and second vertical

alignments present one change in the displacement sign along the height; the third one presents two inversions (Figure 14k).

2.95 Hz. The modal shape presents very low and consistent displacements at S04 and S05 and larger displacements with opposite sign at the other locations; phase factor and coherence function are always significant. The first vertical alignments present one change in the displacement at low height; the second one has one change of sign; the third one presents two inversions (Figure 14l).

In Figure 14 the individualized twelve possible modal shapes of the top of the wall and at the three vertical alignments are plotted.

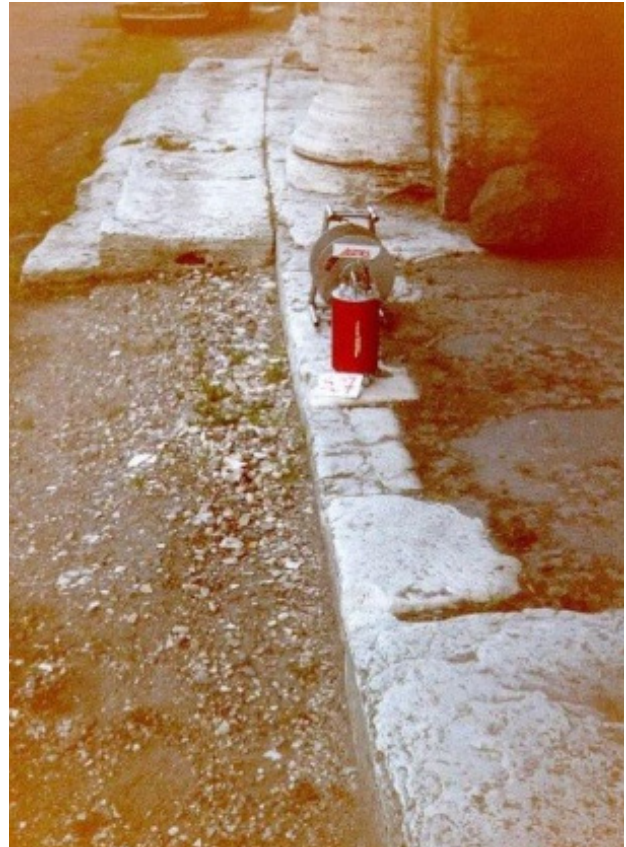
Figure 15. Vertical seismometer S27 in configuration C4.

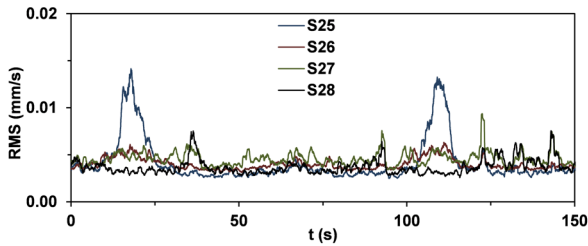
Figure 17. RMS of vertical recordings V25 to V28 in configuration C4.

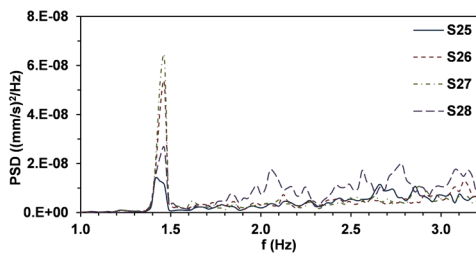
Figure 18. PSDs of S25-S28 in configuration C4.

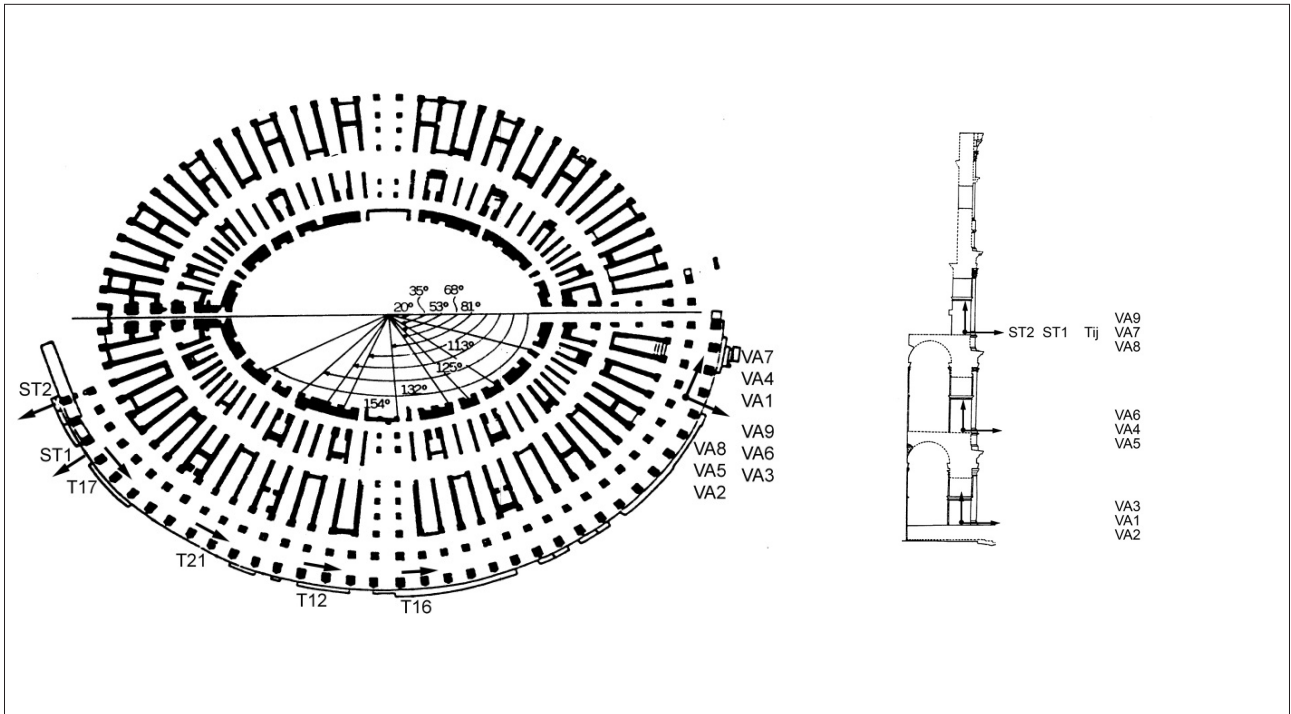
Figure 19. Plan view of the seismometer locations in the second campaign.

In the second experimental campaign also 24 seismometer Kinematics SS-1, connected to a Kinematics Granite multi-channel recorder, were deployed in tangential directions along the wall (Figure 19).

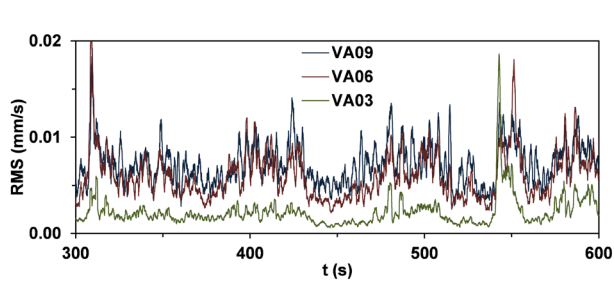
Figure 20. RMSs at Valadier's buttress in radial direction.

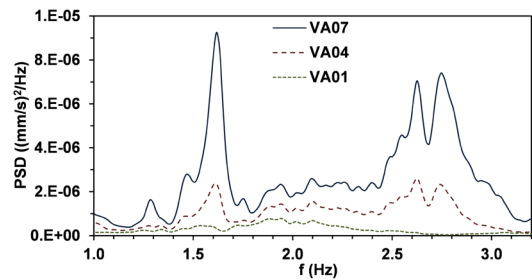
Figure 23. PSDs at Valadier's buttress in tangential direction.

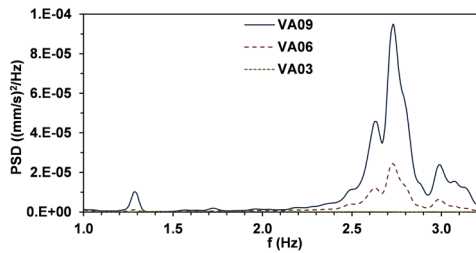
Figure 21. PSDs at Valadier's buttress in radial direction.

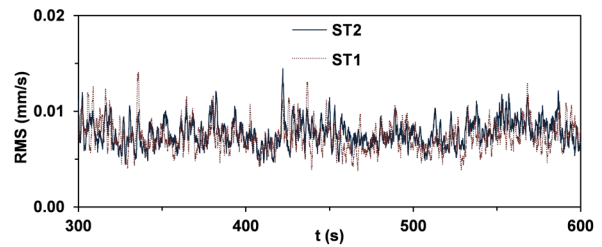
Figure 24. RMSs at Stern's buttress in radial direction.

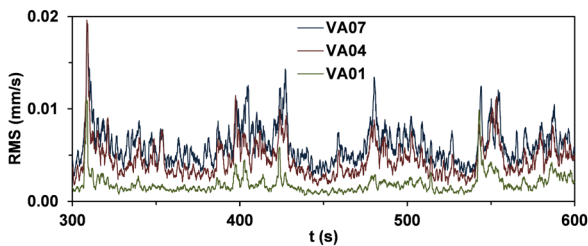
Figure 22. RMSs at Valadier's buttress in tangential direction.

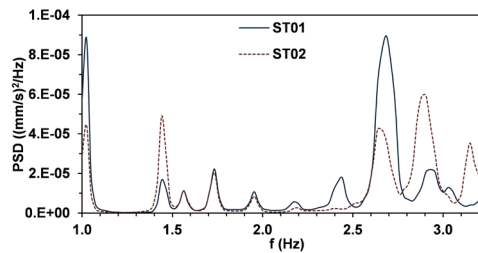
Figure 25. PSDs at Stern's buttress in radial direction.

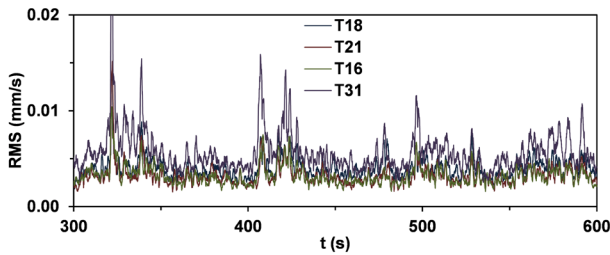
Figure 26. RMSs in tangential directions at T18, T2, T16 and T31.

The RMSs obtained at locations T18, T21, T16 and T31 are plotted in Figure 26. It is apparent that

tangential motion was much higher at the Valadier's buttress (T31) than at the Stern's buttress. This occurrence confirms the lower stiffness of the Valadier's

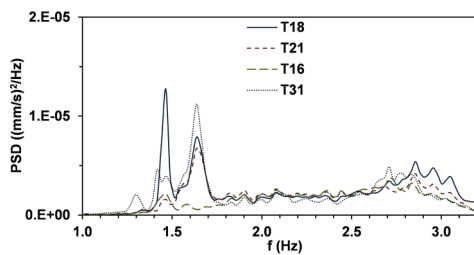
Figure 27. PSDs in tangential directions at T18, T2, T16 and T31.

The main resonance frequency at the Stern's buttress is at 1.46 Hz, while at the Valadier's buttress the

higher peak is at 1.61 Hz but also the already pointed out peaks are present (Figure 27).
