## SOLID BURNT BRICKS' TENSILE STRENGTH

**ABSTRACT.** This paper deals with experimental testing of solid burnt bricks and mortar in pure (axial) tension. The obtained working diagrams will be further use for a detailed numerical analysis of whole brick masonry column under concentric compressive load. Failure mechanism of compressed brick masonry column is characterized by the appearance and development of vertical tensile cracks in masonry units (bricks) passing in the direction of principal stresses and is accompanied by progressive growth of horizontal deformations. These cracks are caused by contraction and interaction between two materials with different mechanical characteristics (brick and mortar). The aim of this paper is more precisely describe the response of quasi-brittle materials to uniaxial loading in tension (for now only the results from three point bending test are available). For these reasons, bricks and mortar tensile behavior is experimentally tested and the obtained results are discussed.

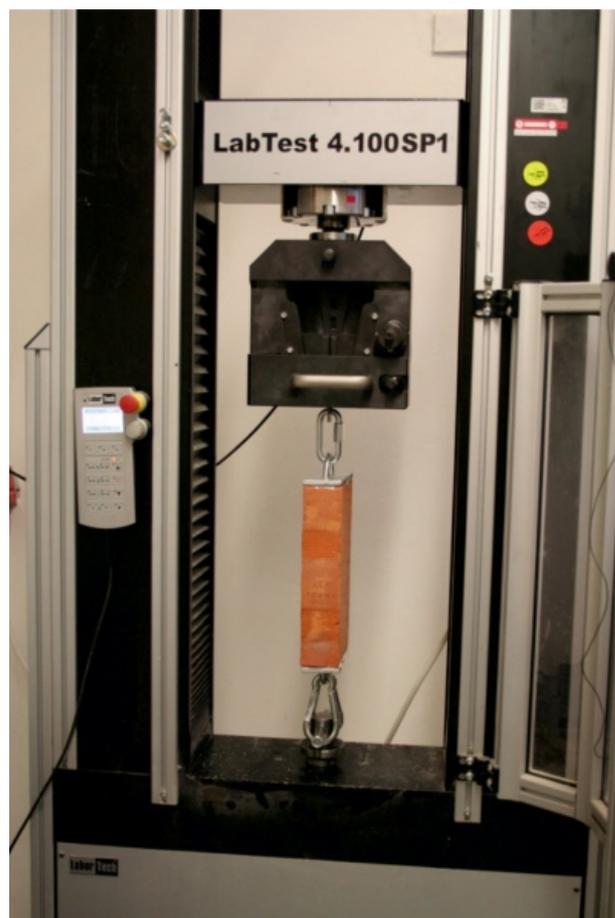
Six P20 solid burnt bricks with dimensions of 290×140×65 mm (the declared compressive strength is 20 MPa) were experimentally tested in pure tension test. All specimens were measured and the specific dimension were used for each specimen. Steel plates were glued on brick's face in longitudinal directions by means two components epoxy glue Akepox 2040 according to technological procedure in laboratory conditions. Akepox 2040 reaches the maximal strength in seven days, after that the specimen were tested. Brick with steel plates were placed into testing equipment LabTest 4.100SP1 by means two snap hooks (Fig. 1). This equipment adds load in form of deformation in regular steps.

FIGURE 1. Experimental setup.

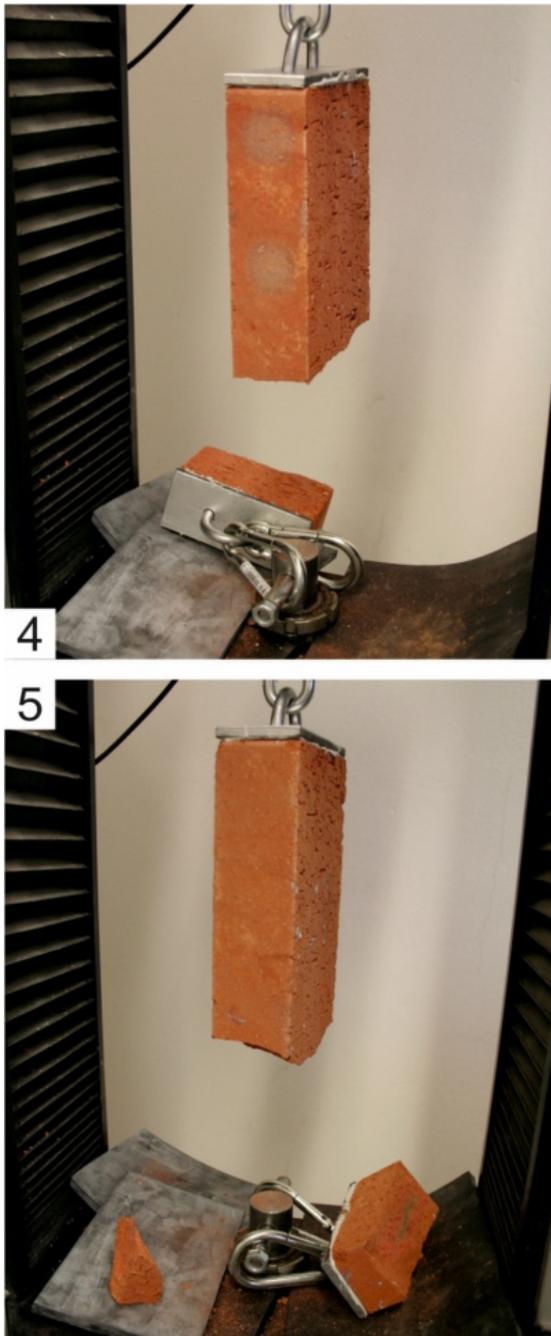
FIGURE 2. Failure of specimens no. 4 and 5.

Failure occurred at the interface between steel plate and brick with the exception of two samples. These two samples had initial damage from manufacturing. During experimental testing was observable a slowly opening of the crack following by brittle failure. Failure mode of both specimen (no. 4 and 5) is showed in Fig. 2.

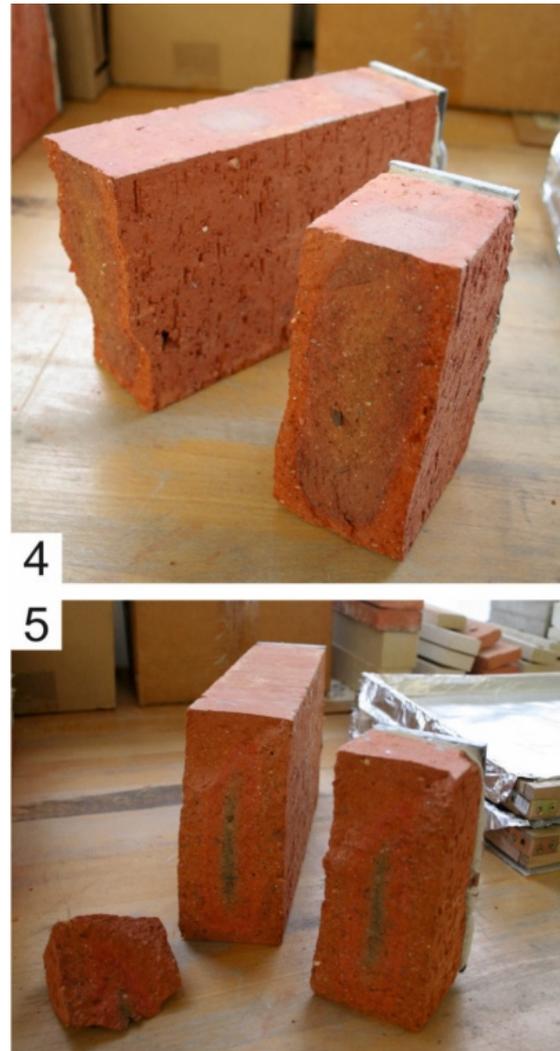
After failure, different level of burning is evident on the cross-section of specimens. Grey core in specimen 5 indicates incomplete burning process. Specimen 5 showed lower tensile strength, however it is

FIGURE 3. Cross-sections of specimens no. 4 and 5.

necessary take into account the size of initial crack from manufacturing.

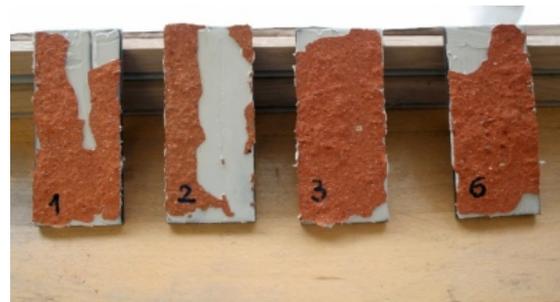
FIGURE 4. Failure of specimens no. 1, 2, 3 and 6.

Other specimen showed failure between brick and one of steel plates. Reason of this type of failure is given by low interface adhesion. Usage of insufficient amount of epoxy resin is probably the explanation. Another stone specimens were also tested in pure tension test and the expected failure was reached – all specimens failed in stone (interface strength was higher than specimen tensile strength). Fig. 4 shows failure of specimens 1, 2, 3 and 6.

Figure 5 shows working diagrams of each specimen. The highest value of force was reached for specimen 6. Specimen 6 (together with specimen 3) was quite enough glued (see Fig. 4) and the failure occurred predominantly in very first layer of masonry unit [3]. This layer has improved properties thanks to glue penetration into porous system. For this reason, there is no failure direct at the interface, but a small layer of brick was thrown away.

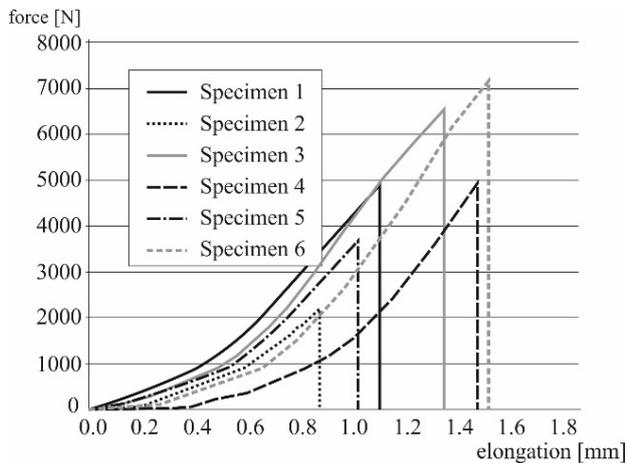
FIGURE 5. Working diagram force-elongation of bricks.

Specimen 1 and 2 show poor gluing of steel plate, especially specimen 2 has the lowest value of reached force. Specimens 4 and 5 had an initial manufacturing crack and have failed in brick. The maximal value of reached force is different, it could be caused by distinct depth of initial crack. It was not possible to measure the size of initial cracks, because there were only hair cracks observed. The possible solution is using specimen with notches whose accurate size would enable a conversion force to area.

The initial slip of the specimens is not displayed in working diagrams (Fig. 5). The diagrams show brittle rupture in all cases.

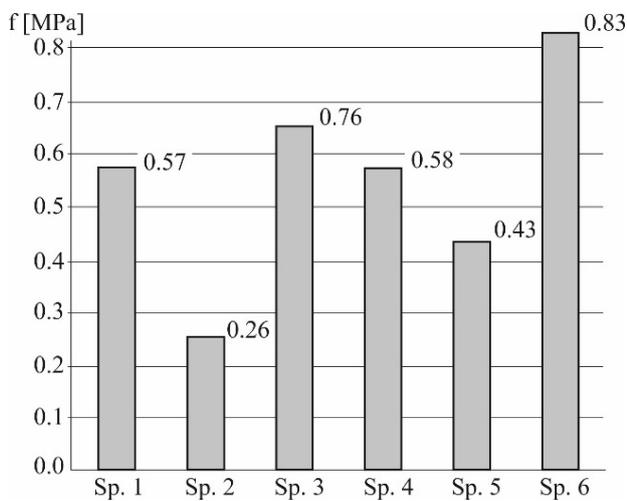
FIGURE 6. Tensile strength of bricks.

Average tensile strength was determined to

0.64 MPa with standard deviation 0.15 MPa. Specimen no. 2 was not taken into account.

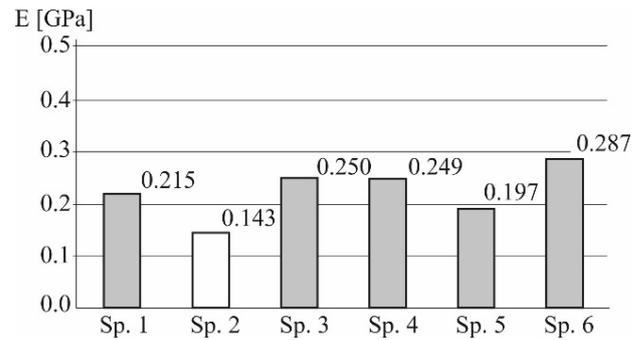
FIGURE 7. Young's modulus of bricks.

Young modulus was obtained as secant modulus between two loads: 90 %  $N_{um}$ , 40 %  $N_{um}$ , where  $N_{um}$  is maximal load. Average modulus of elasticity was determined to 0.24 GPa with standard deviation of 0.03 GPa. Specimen no. 2 was not taken into account.

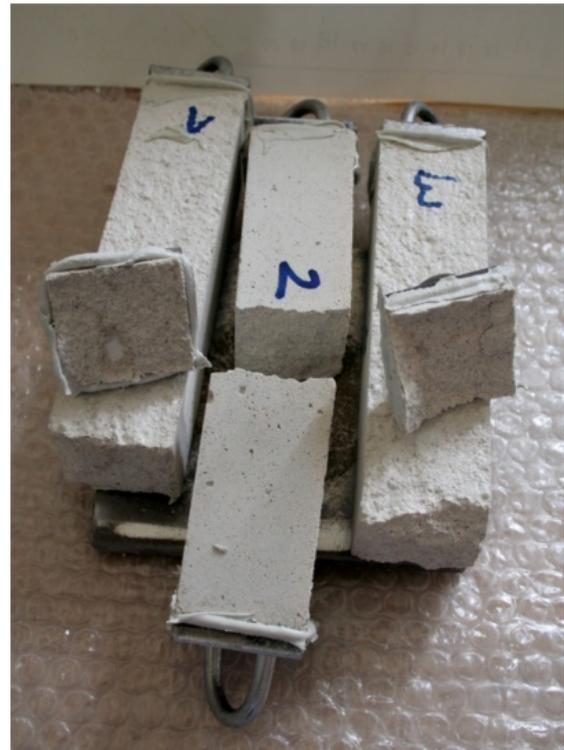
FIGURE 8. Failure of mortar specimens.

Two mortar specimens show failure close to THE glued steel plates. After failure of specimen no. M1 small place of incomplete gluing is evident. Specimen no. M2 failed approx. in a half of its length. Calculated values of tensile strength and Young modulus are reported in bar charts (Fig. 11 and 12).

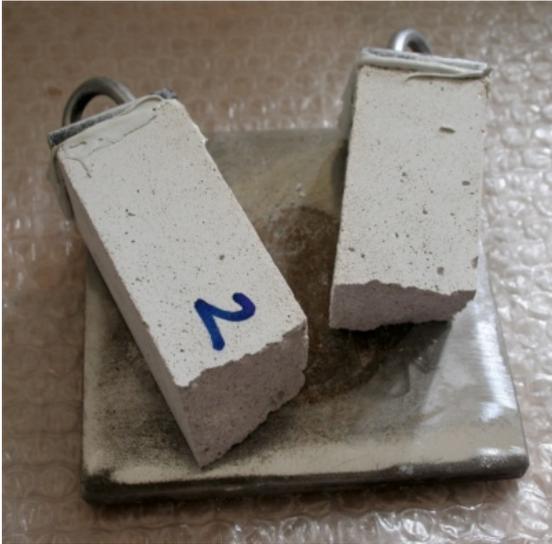
FIGURE 9. Failure of specimen M2.

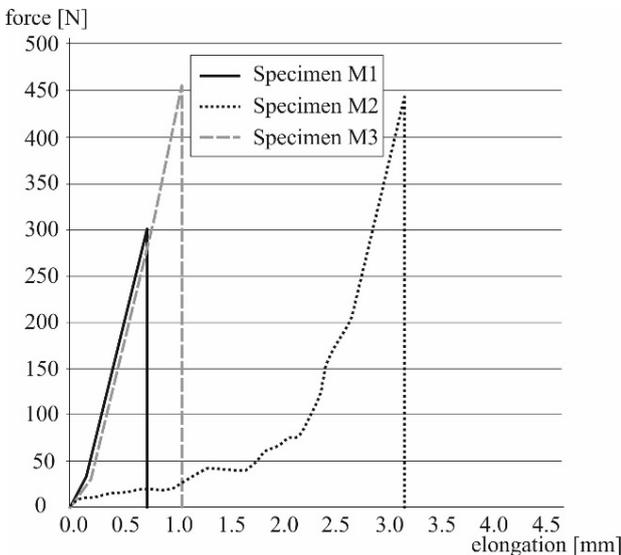
FIGURE 10. Working diagram force-elongation of mortar.

The initial slip of the specimens is not displayed in working diagrams (Fig. 10). The diagrams show brittle rupture in all cases. Average tensile strength was determined to 0.25 MPa with standard deviation 0.04 MPa.

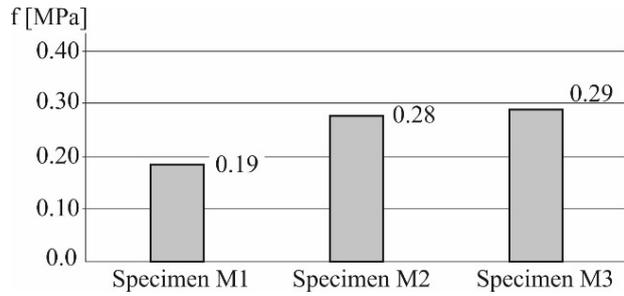
FIGURE 11. Tensile strength of mortar.

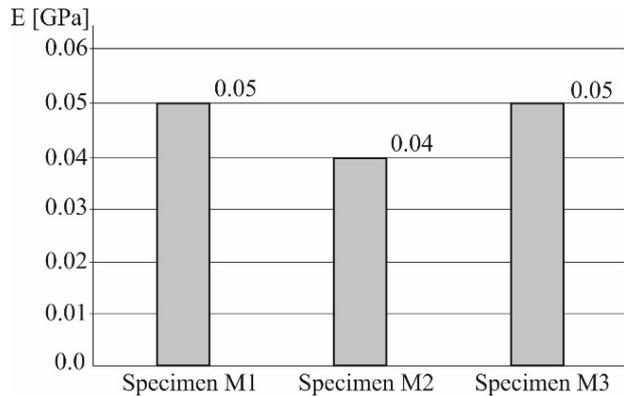
Young modulus was obtained as secant modulus between two loads: 90%  $N_{um}$ , 40%  $N_{um}$ , where  $N_{um}$  is maximal load. Average modulus of elasticity was determined to 0.047 GPa with standard deviation of 0.005 GPa.

FIGURE 12. Young's modulus of mortar.
