THE FATIGUE BEHAVIOUR OF GFRP BARS - EXPERIMENTAL STUDY

ABSTRACT. The paper describes an experimental program for studying the fatigue performance of GFRP bars, which has been initiated by the authors. Two different test configurations were used to assess the fatigue behaviour. The bare specimens were tested within the first series. A modified gripping system was used to reduce eccentricity when the bar was not directly fixed. However, the boundary conditions seem to affect the results. The second series consisted of a set of specimens of bars embedded in concrete. This configuration seems appropriate for determination of fatigue life of GFRP bars. Two S-N curves for bare bars and bars embedded in concrete were created and compared. Significant reduction of interlaminar shear strength at the beginning of fatigue loading proved matrix or fibre/matrix interface damage.

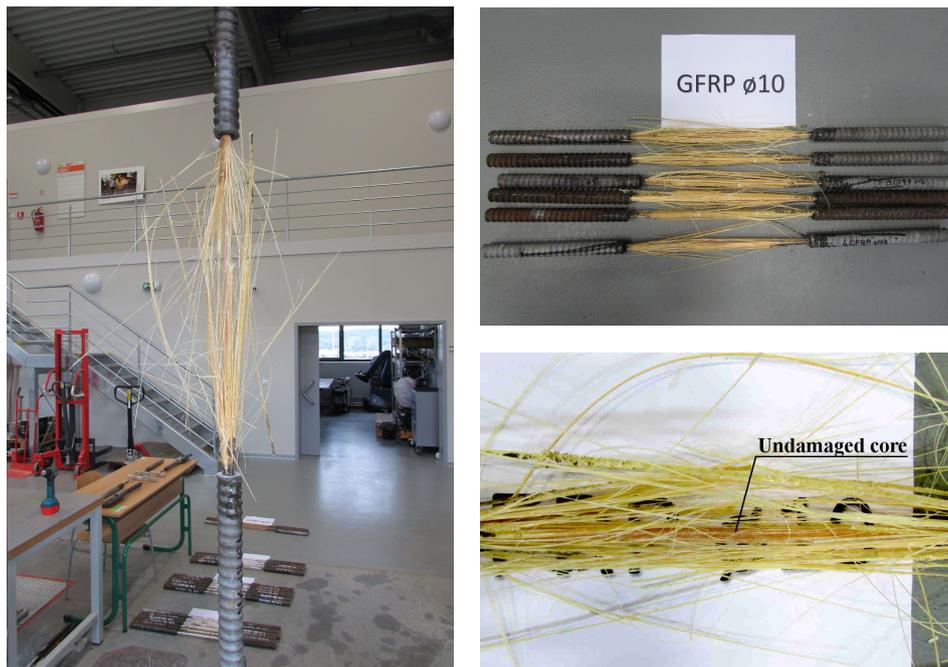
FIGURE 1. Failure of samples during monotonic test.

The tensile testing of FRP bars, including the subsequent evaluation, was performed according to ISO 10406-1 [9]. Six test specimens, 1.0 m in length, were fitted with steel anchors for mounting on a test device. The anchors eliminate the risk of crushing the composite bar by the transverse pressure exerted by the jaws of the device. The middle (free) part of the sample was then fitted with LVDTs. Simultaneously with the strain of the sample, the applied tensile force was read. The load was applied at a deformation rate of 3 mm/min until the sample was completely broken. The configuration of the test and the typical way of failure is shown in Fig. 1. The obtained results are shown in Table 1, the stress-strain diagram is shown in Fig. 2. All samples were broken in an expected manner. There was a significant delamination of the individual layers of the cross-section (broomlike failure mode). However, all samples were found to have an intact core diameter of approximately 6 mm. The creation of this core indicates a different cure of the matrix at the centre of the cross-section.

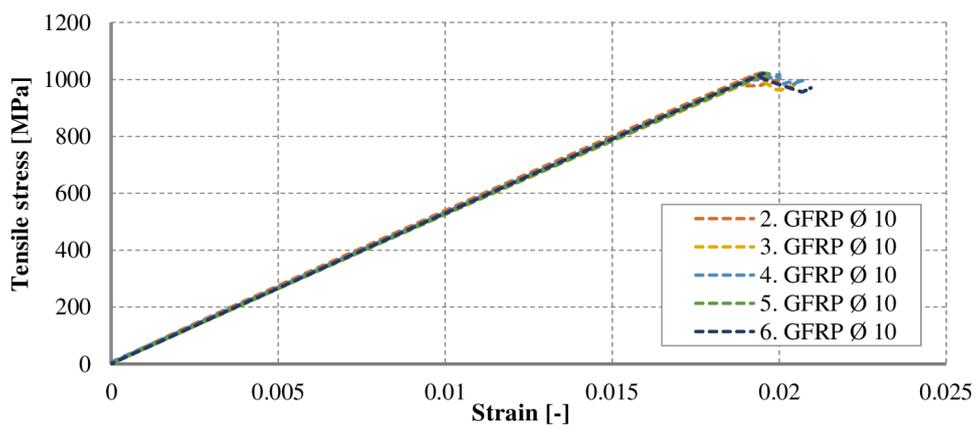
FIGURE 2. Stress-strain diagram during monotonic tensile test.

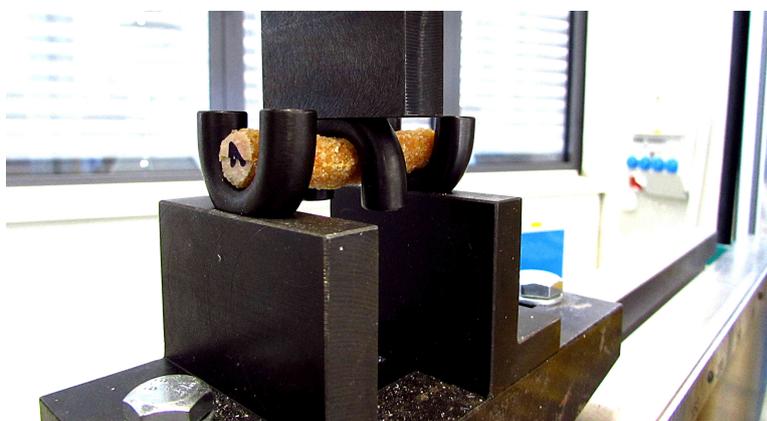
FIGURE 3. Configuration of interlaminar (longitudinal) shear test.

The purpose of interlaminar shear test was to determine the strength of matrix and/or interface between fibre/matrix. The tests were performed according to ASTM D 4475 [10]. The distance between the supports was chosen with respect to the desired mode of failure, i.e. a crack parallel to the direction of the fibres (perpendicular to the load direction). A set of samples of 60 mm length (i.e. the distance of the theoretical supports corresponded to 5 sample diameters) was tested. The average strength in the longitudinal (interlaminar) shear is shown in Table 1.

Samples were then cut into 6 pieces of 60 mm for the interlaminar (longitudinal) shear test. The test was carried out in the same configuration as the reference samples (see Fig. 3). At all tested levels after 100 cycles a significant reduction of the matrix or fibre/matrix interface strength was observed (see Table 2 results).

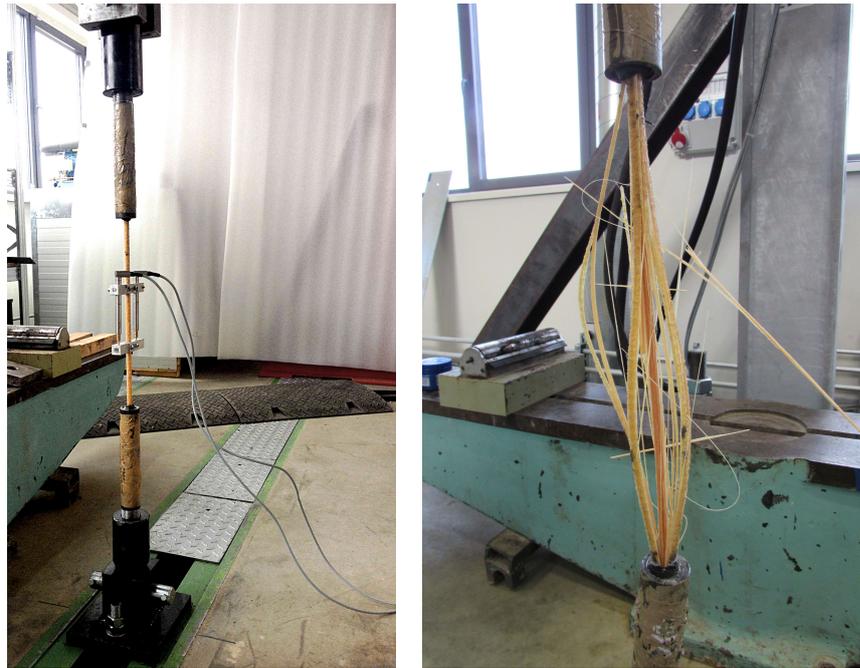
FIGURE 4. Cyclic test configuration with LVDTs (left), broom-like failure mode with an undamaged core (right).

The first set of samples subjected to cyclic loading was tested with a similar solution to the anchors used in the monotonic tensile test. To ensure a better connection of the steel anchor with the grouting, the steel anchor body was perforated by openings (Fig. 5). However, during cyclic loading, these anchors did not work sufficiently. All samples were prematurely broken. The sample behaviour analysis had shown that the failure was accelerated by the eccentricity arising from the imperfect/inaccurate bar mounting in the anchor. This imperfection can be limited to a certain extent by inserting joints that are mutually rotated by 90° (Fig. 4). The adjusted test configuration has been verified on six samples at load level $f_{max} = 60\%f_{ult}$. With this configuration, a failure in the anchor occurred only in one case.

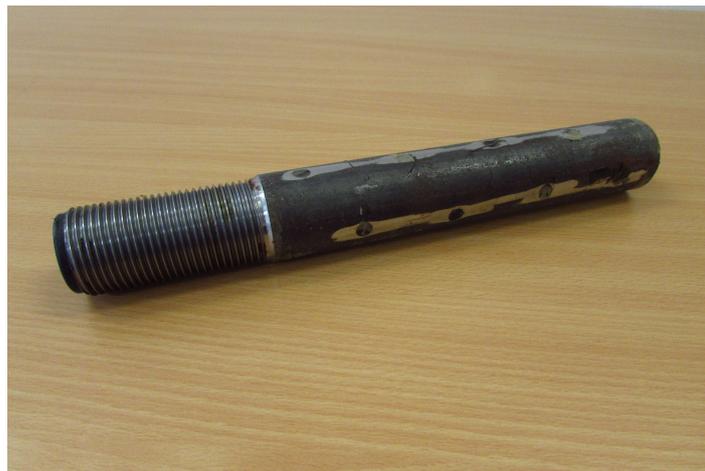
FIGURE 5. Anchor for a cyclic test of bare bars.

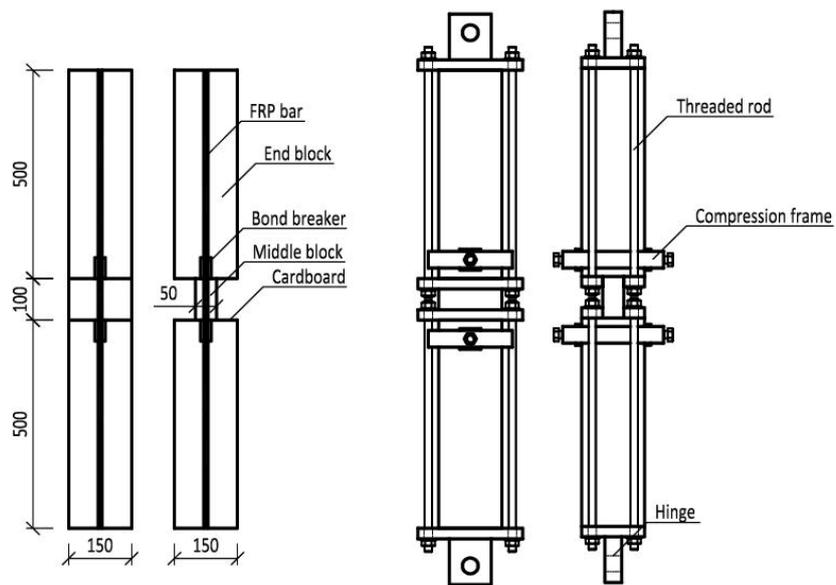
FIGURE 6. Bars encased in concrete - specimen geometry.

The configuration of fatigue tests of reinforcement embedded in concrete was set according to Rahman et al. [4]. The length of the end (anchorage) blocks of 500 mm was considered with regard to securing a sufficient bond length for the tested bars. A 100 mm long central block was separated from the anchor blocks using cardboard. The total length of the whole sample was 1100 mm (Fig. 6). To prevent splitting of concrete, the anchor blocks were compressed by steel frames. To eliminate possible eccentricities caused by the production, the sample was provided with hinges. The average compressive strength of the concrete was 63 MPa.

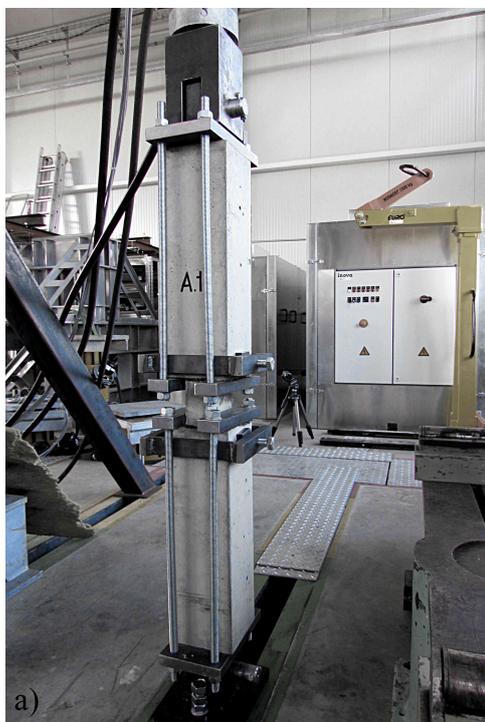
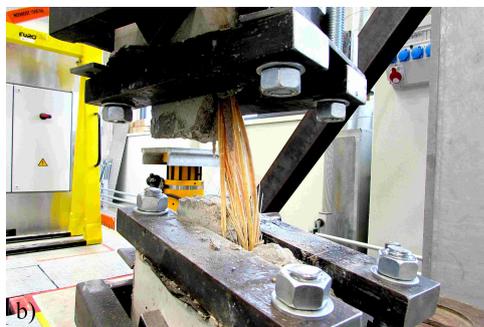
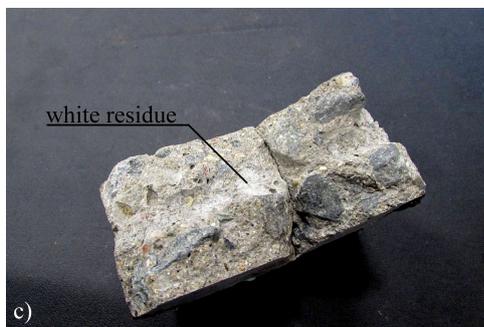
FIGURE 7. a) Cyclic test configuration, b) Broom-like failure mode, c) Concrete surface with a white residue.

After the test, the area of the reinforcement in contact with the concrete in the middle block was examined in more detail. The surface of the concrete or reinforcement in most cases did not show signs of macroscopic failure. However, a white residue on the surface of the concrete was evident locally (most often near the transverse crack), apparently created by the

crushing of the silica sand-coating of the tested bar (Fig. 7c). The observed phenomenon occurred only in samples that were exposed to the lowest tested level of loading ($40\% f_{ult}$) and, therefore, the highest number of cycles. From the observation, one can conclude that a higher number of cycles can damage the contact between the tested reinforcement and the surrounding concrete. For that reason, the next series of samples will be subjected to a deeper exploration of the surface.

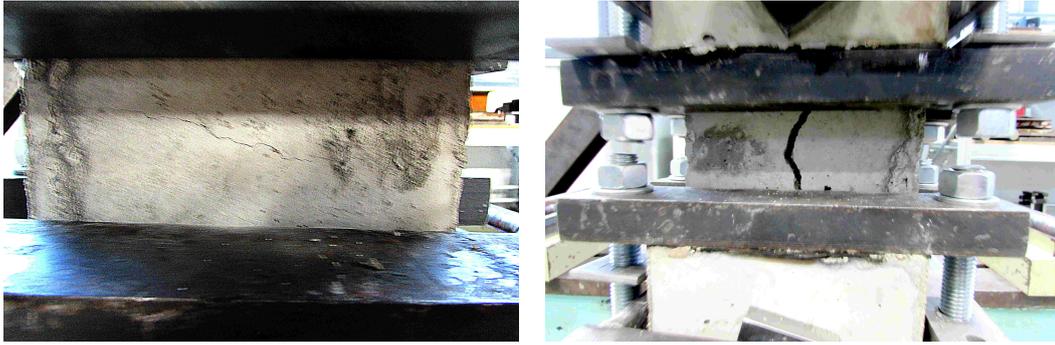
FIGURE 8. Transverse (left) and longitudinal (right) crack during cyclic loading.

the samples. In the first phase of loading, a transverse crack in the concrete was formed at approximately half the height of the middle block due to the tensile force applied (Fig. 8). The further development of cracks in the middle block of the specimen was observed just before the reinforcement failure. A longitudinal crack was created, which in many cases led to the splitting of the middle block. This longitudinal crack was caused by the transverse pressure of the breaking bar on the concrete, where most of the samples tested broke in a broom-like failure mode.

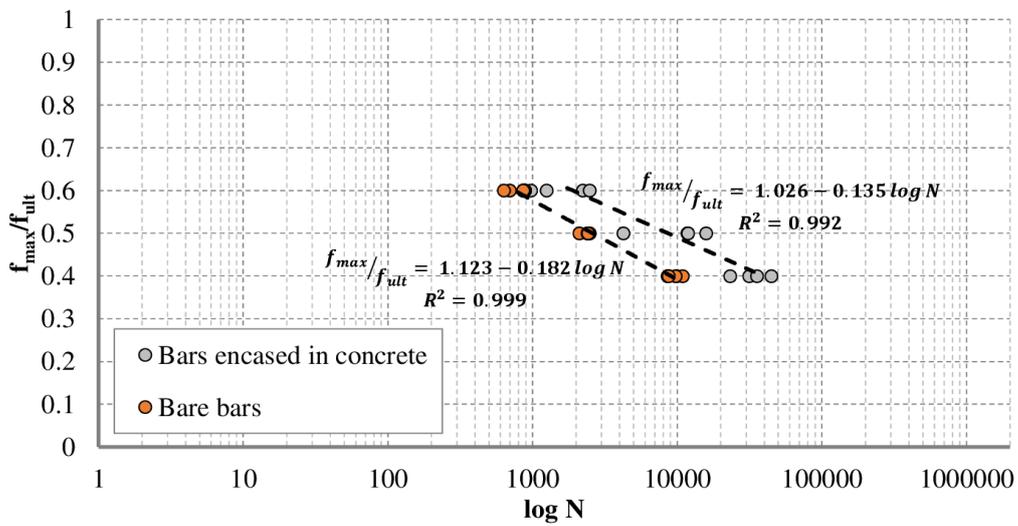
FIGURE 9. S-N diagram for tested bare GFRP bars and bars encased in concrete.

The fatigue life of samples tested so far is shown in Tables 3 and 4. Only samples that have been broken in a satisfactory manner (i.e. failure of the free part of the bare bars or failure of the bar in the central block area of the encased bars) are used to construct the S-N curve (Fig. 9).

The fatigue life of the samples increases exponentially with decreasing stress level. Equation (1) for bare bars and equation (2) for bars embedded in concrete is expressing the S-N dependence.

It can be seen from Fig. 9 and the equation (1) and (2) that the fatigue life of the samples embedded in concrete is higher. In the macroscopic scale, in most cases, the embedded samples did not show indications of failure of the surface treatment of the bar caused by friction between bars and concrete. In addition, the surrounding concrete prevented the broomlike failure mode of the bars. On the other hand, the fatigue life of bare bars is significantly reduced by the steel anchors. This is especially noticeable at 40% f_{ult} , load level. At this level, at most samples occurred undesirable failure near the anchors. However, fatigue life is likely to be affected at all tested levels.

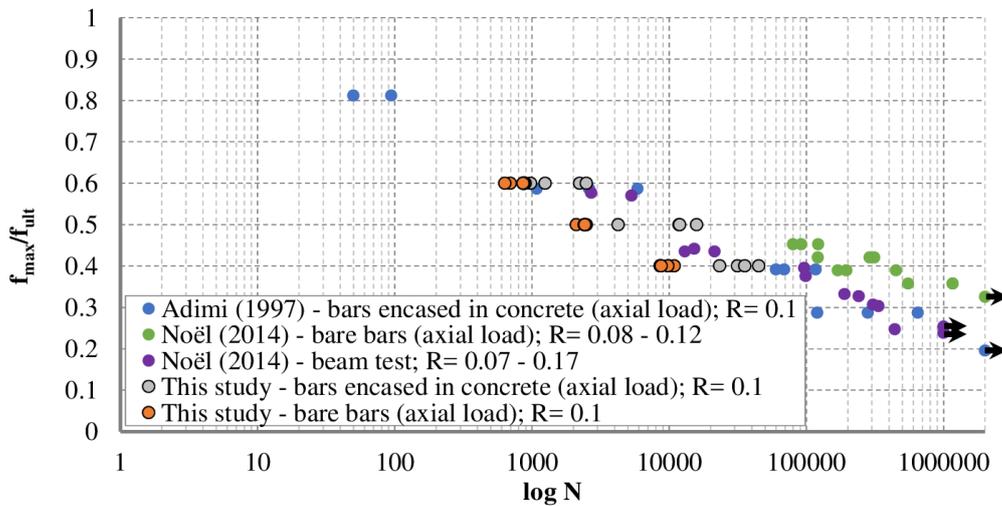
FIGURE 10. S-N diagram for GFRP bars.

Fig. 10 shows the results of the bare bars and bars embedded in concrete tests performed in this study presented along with other experiments with the same configuration and GFRP reinforcement [2, 3]. Demers [12] stated that the shape of the sample influences the resulting fatigue life of the composite materials. Therefore, only the results obtained from the experiments on the samples of the GFRP bars are included here. The tests published in [2] are performed with a variable stress ratio, which affects the fatigue life, see [12]. The lower fatigue life of the bare bars tested in this study indicates the negative impact of anchoring (especially at the lowest tested level). The results obtained from the tests of bars encased in concrete are comparable with other presented results (see Fig. 10).
