EXPERIMENTAL STUDY OF DAMAGED CR-COATED FUEL CLADDING IN POST-ACCIDENT CONDITIONS

PETR ČERVENKA^{a,b,*}, JAKUB KREJČÍ^b, LADISLAV CVRČEK^a,
VOJTĚCH ROZKOŠNÝ^b, FRANTIŠEK MANOCH^b, DAVID RADA^b,
JITKA KABÁTOVÁ^b

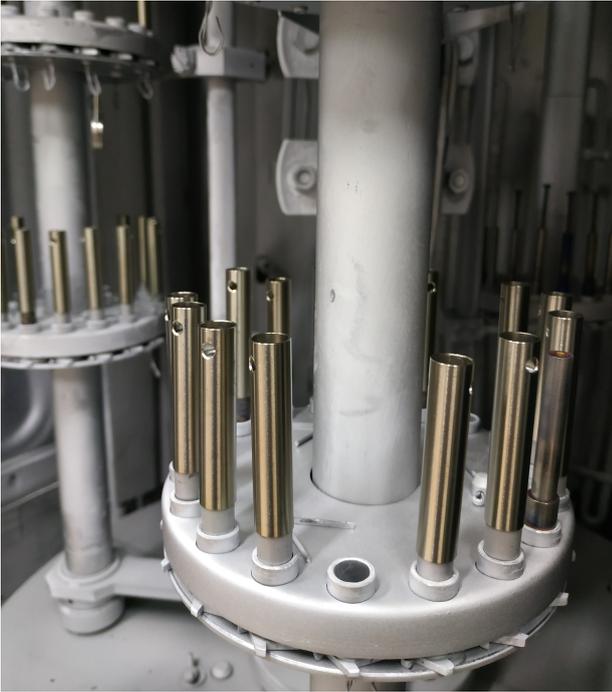
FIGURE 1. The chamber of Hauzer Flexicoat 850 system.

surface of the specimen using the magnetron sputtering process with 99.6 % Cr sputtering targets in the protective argon atmosphere of the Hauzer Flexicoat 850 device (Figure 1). The process lasted 16 hours at the temperature of 250 °C, which is even lower than the normal operation cladding temperature in the core, thus the cladding was not thermally affected. Finally, the coating thickness of 18.6 μm was determined using the calotest method (Figure 3). To simulate the coating defects (cracks) occurring during the ballooning process, several scratches through the chromium layer were made using the scratch test device CSM Instruments Revetest Xpress (Figure 2). The constant force of 50 N was required to make the scratch go through the whole chromium layer without affecting the Zr substrate more than necessary by adding additional local plastic deformation. The resulting U-shaped scratches (Figures 6, 7) had a width of 200 μm and the length of 40 mm.

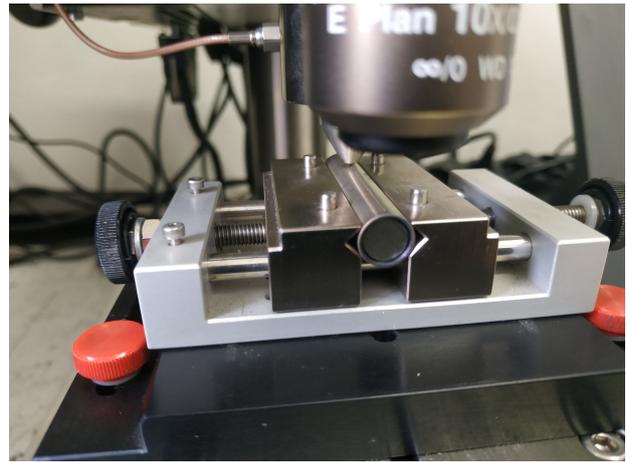
FIGURE 2. Process of creating scratches.

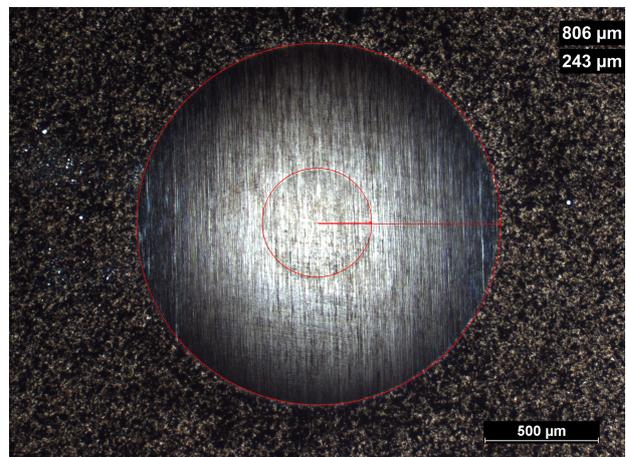
FIGURE 3. Calotest.

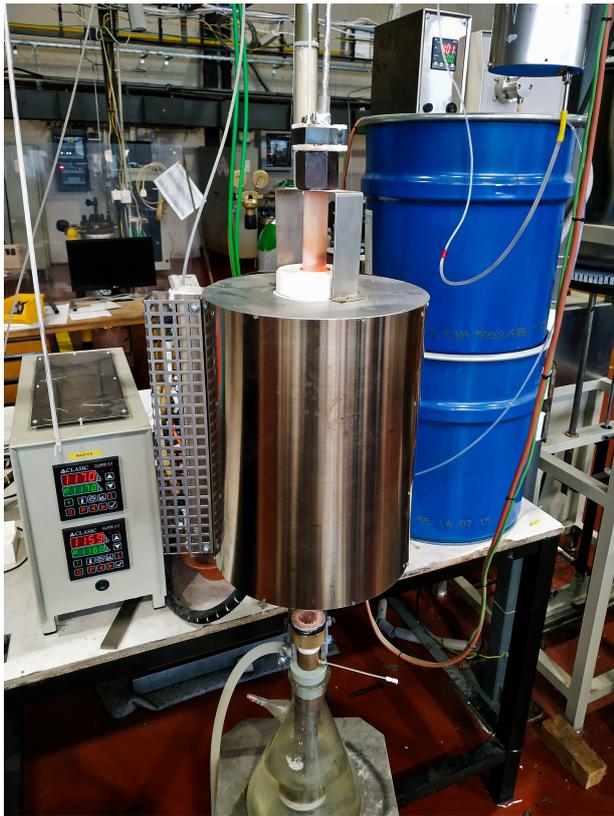
FIGURE 4. The apparatus for high-temperature oxidation.

The experiment of high-temperature oxidation was performed in an electric resistance furnace (Figure 4)

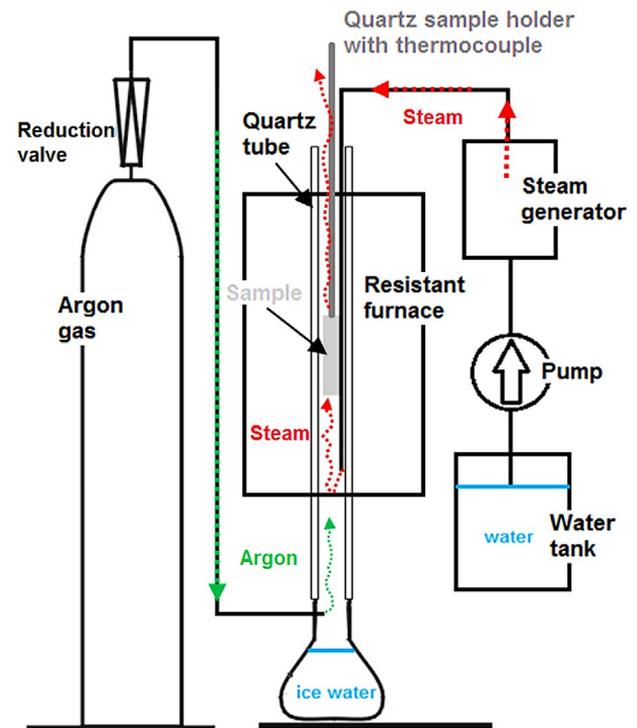
FIGURE 5. The scheme of high-temperature oxidation experiment.

in an argon-steam mixture according to the scheme shown in Figure 5. The temperature of the experiment was set up to $1200 \pm 3^\circ\text{C}$ since it is generally accepted as the highest possible temperature within the acceptance criteria for DBAs [2]. A thermocouple was located inside the cladding tube and it was recording the temperature every 2 seconds. Specimens were oxidized for 1.5; 3; 4.5 and 9 minutes. At the end of the experiment, the specimens were directly quenched in cold water (water + ice) and dried out at the temperature of 90 °C.

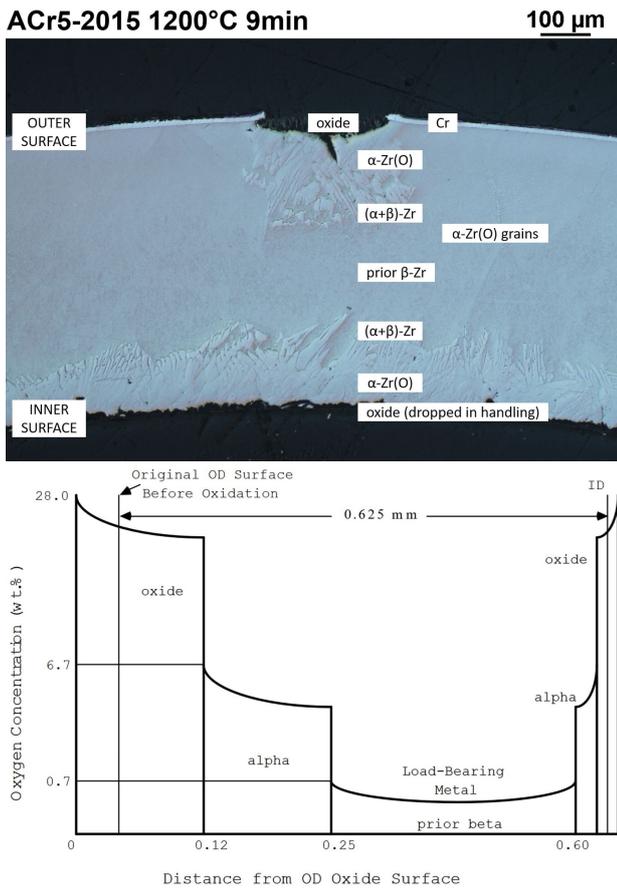
FIGURE 6. Typical microstructure of high-temperature oxidized Zr-based cladding: with Nb (top) and without Nb (bottom).

Metallographic specimens were analyzed using an optical microscope Nikon Eclipse MA200. The images were captured and enhanced using NIS-Elements software. In the Figure 6 a typical microstructure of high temperature oxidized specimen can be seen. The oxygen-stabilized $\alpha\text{-Zr(O)}$ phase grows from the unprotected surface at the expense of load-bearing prior $\beta\text{-Zr}$ phase. In addition to that, the process of oxygen absorption through the coating defects (scratches) locally leading to the growth of the $\alpha\text{-Zr(O)}$ phase can be seen, whereas there is no oxidation through the undamaged coating (Figure 6). Since the E110 tested cladding contains Nb, there is a layer of both $\alpha\text{-Zr(O)}$ and $\beta\text{-Zr}$ grains. The structure of Zr cladding without Nb (such as Zry-4) is shown in Figure 6, the difference in the presence of the layer containing both $\alpha\text{-Zr(O)}$ and $\beta\text{-Zr}$ grains is evident. The local microstructure close to the scratch is very similar to the microstructure in the area of the inner surface.

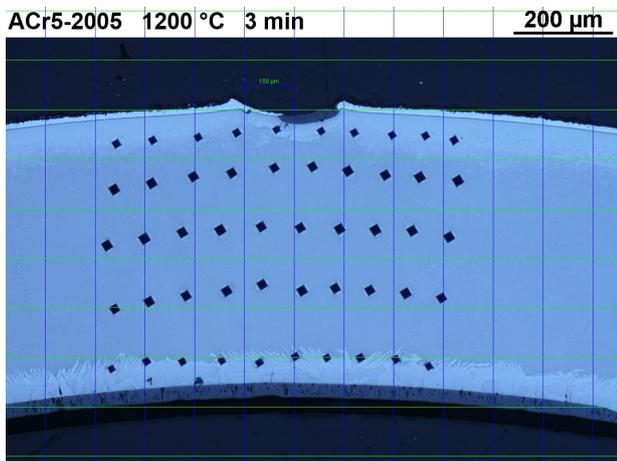
FIGURE 7. Microhardness indents in 5 vertical lines.

The hardness across the cladding wall was analyzed on Buehler Micromet 5114 device by using the Vickers microhardness test. The pyramidal Vickers-type indenter was used and the test load was 0,1 kg. On each specimen, 10 square indents were produced in 5 lines across the cladding wall as shown in Figure 7. Afterward, every indent was precisely located using GetData Graph Digitizer software to get the information about the position and appropriate hardness. As a result, the hardness profiles across the wall in

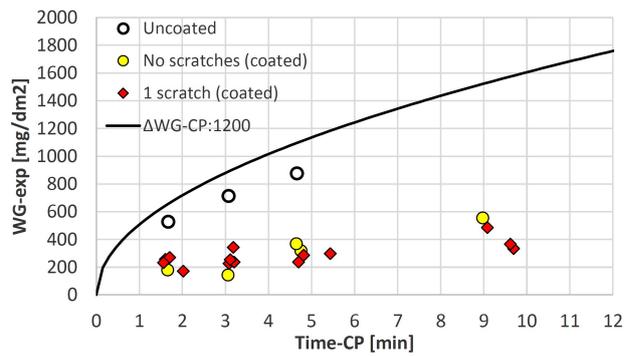
FIGURE 8. Results of weight-gain.

As it can be seen in Figure 8, the coating effectively protects the cladding from oxidation. Even in the case of a 9-minute exposition, the weight gain is relatively small. On the contrary, the reference cladding oxi-

dized from both sides features a significantly higher weight gain, which is rather similar to the expected rate calculated according to the Cathcart-Pawel correlation [11]. Furthermore, Figure 8 shows the weight gain comparison of the coated cladding with and without a scratch (red and yellow dots). The presence of scratch did not have a measurable impact on the overall weight gain.

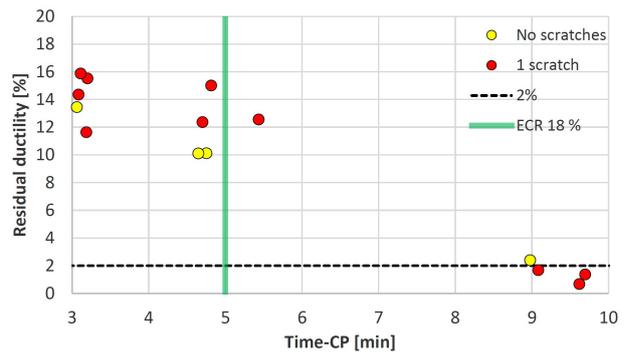
FIGURE 9. Results of RCT with theoretically obtained value (green) for double-sided oxidation (= uncoated).

The residual ductility of 2 % is generally considered as the ductile-brittle transition. All specimens seem to undergo the transition at the time of high-temperature oxidation lasting around 9 minutes. The presence of the scratch does not seem to affect the ductile-brittle transition as shown in the Figure 9. According to the Cathcart-Pawel correlation (Equivalent Cladding Reacted - ECR-CP 18 %), the limit time value of high-temperature oxidation at 1200 °C for double-sided oxidation is 5 minutes. Therefore, regardless of the scratch being present or not, the coated specimens feature a significantly longer time to undergo the ductile-brittle transition, thus the positive impact of Cr coating is apparent.

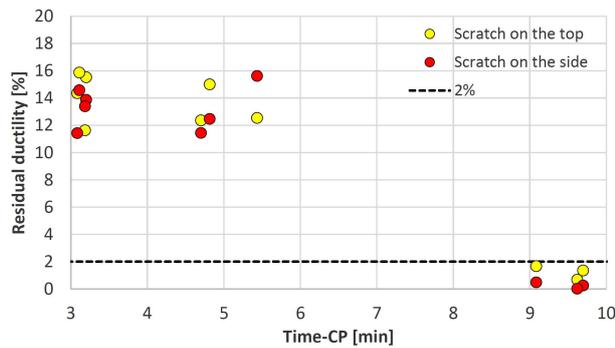
FIGURE 10. Comparison of differently rotated scratches.

As all specimens had inclined to crack on the side, specimens with scratches were tested twice to determine the impact of the crack rotation. First, the cladding ring was rotated featuring a scratch on the top, second, the scratch was on the side. The results are summarized in Figure 10.

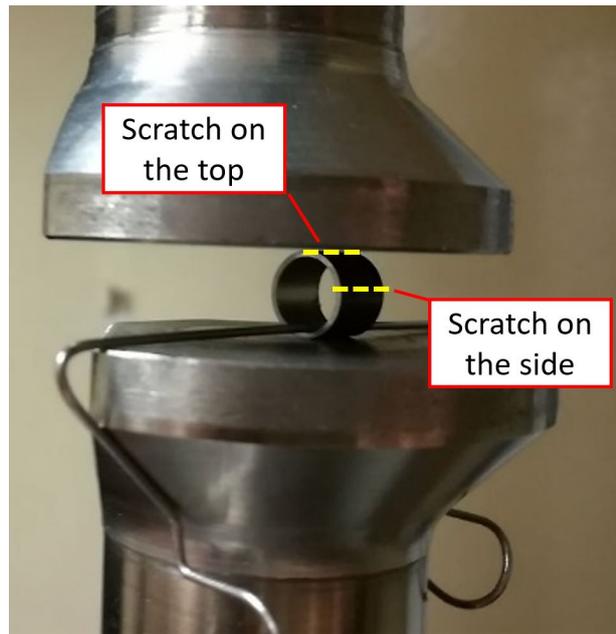
FIGURE 11. Ring Compression Test with the position of the scratch.

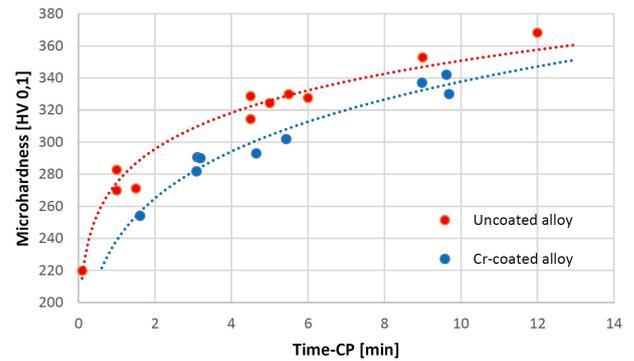
FIGURE 12. Comparison of single- and double-sided oxidation.

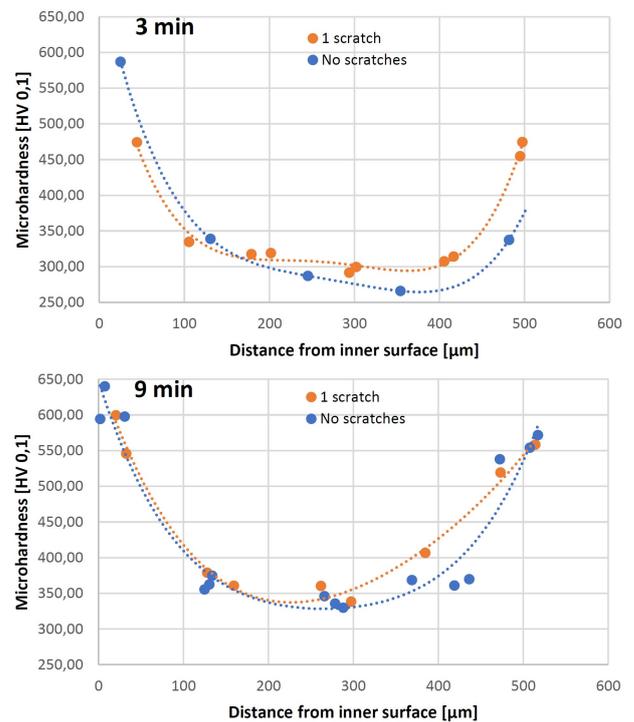
FIGURE 13. Transversely measured microhardness: 3 min exposition (top) and 9 min exposition (bottom).

The increase in the hardness values at the area near the uncoated surface is the result of oxygen absorption. Against the odds, the hardness values increase also close to the coated surface as shown in Figure 13. The diffusion of Cr coating into the Zr substrate is clearly present. The longer is the time of the high-temperature oxidation, the larger is the affected area with increased values of hardness. The results in the form of surface plots are presented in Figure 14.

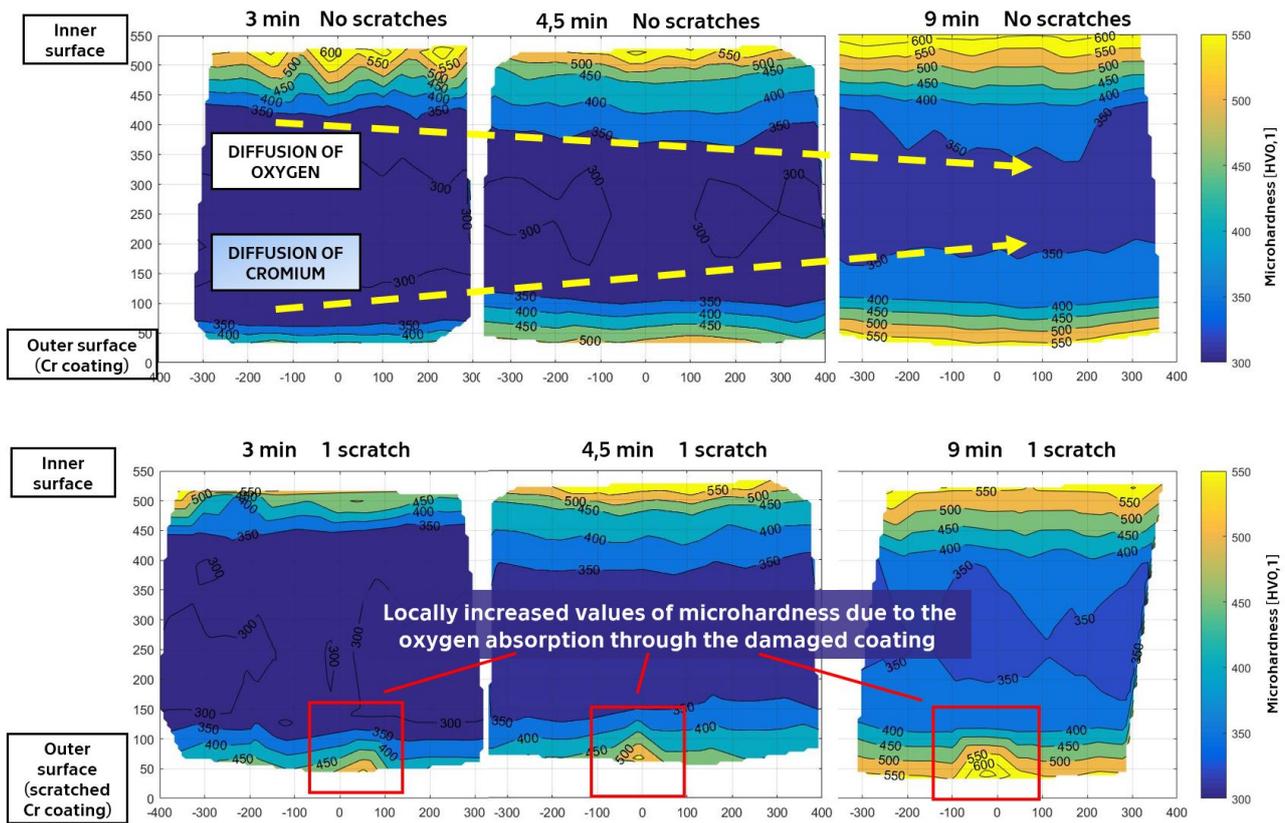
FIGURE 14. Surface plots of microhardness.

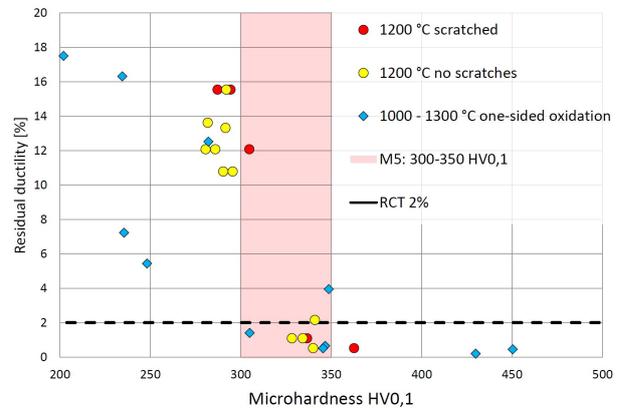
FIGURE 15. Comparison of obtained results with the ones presented in other studies

In the Figure 15, the residual ductility in relation with the microhardness values measured in the middle of the cladding wall can be seen. The critical microhardness value for uncoated Zr-1%Nb (M5) cladding for ductile-brittle transition (DBT) is 300 - 350 HV0,1 [13]. Presented results (red and yellow dots) are in accordance with the existing results. Moreover, according to the following studies [1, 14], the Cr-coated specimens performing double-sided oxidation at various temperatures (blue dots) feature similar values for DBT, thus the obtained results seem to be relevant.
