A Critical Review of Stability Analysis and Design of Pit Slopes in Indian Opencast Coal Mines

Inumula Satyanarayana^{a*}, Ashim Kumar Sinha^b

^a Deputy Director of Mines Safety (Mines), DGMS, Dhanbad, 826001, India

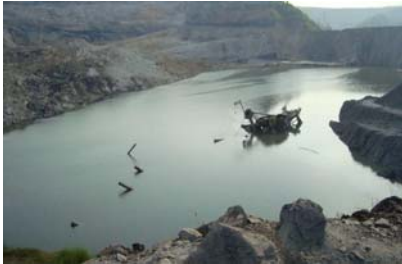
(2) Gross stability problem: It refers to large volumes of materials which come down the slopes due to large rotational type of shear failure and it involves deeply weathered rock and soil (Fig.1). In India, regional failure of coal benches occurred at Jayanth Open cast Project, M/s NCL and Umrer Opencast Project, M/s WCL.

Figure 1: Regional Failure of benches at Umrer OCP, M/s WCL

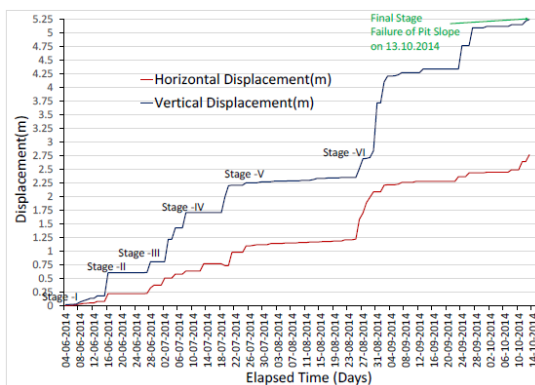
On 17.06.2014, there was again a heavy rain fall recorded i.e. 68 mm at this mine (Stage-II) (Fig.5 & Fig. 7). The maximum portion of strata from surface (960 RL) to 50m depth (910 RL) consist of soil and clay (Fig.8). The vertical and horizontal displacements recorded by total station were 0.609m and 0.225m respectively due to erosion of weak strata by rain water (Stage-II) (Fig.9 & Fig.10). The measured length of the tension crack was about 400m. During the month of June 2014, the rainfall recorded at this mine was about 249mm which severely caused the weathering of weak strata in slope. Due to the flow of rain water into the crack, it got widened and deepened by eroding soil and clay. The vertical and horizontal displacements recorded were 0.812m and 0.382m respectively on 28.06.2014 due to erosion caused by rain fall of 36mm (Stage-III) (Fig. 5, Fig. 6 & Fig. 7). The effects of rainfall and progressive widening and deepening of crack in the remaining stages (stage IV to stage VI and final stage) are represented in Fig. 5, Fig. 6 & Fig. 7. The average rainfall recorded from the month of May 2014 to October 2014 was about 1160 mm which was very high. As the area is hilly and there was no drainage system or seepage holes to drain rain water away from the mine, the water table got charged near to surface. Due to increase in groundwater pressure and flow of rain water over the benches, the soil and clay in the slope were eroded with the passage of time. Subsequently, the crack was progressively got deepened and widened. The variation of vertical and horizontal displacements of tension crack with time is shown in Fig.9. The visual representation of different stages of deepening and widening of tension crack is shown in Fig.10. Due to the rainfall (41mm) on 13.10.2014, the crack was got displaced by 2.765m horizontally and 5.24m vertically. As a result, all the seven benches consisting of soil and clay from surface to 50m deep were collapsed and the bottom benches from 910 RL to pit bottom (840RL) were merged with the loose material of soil and clay (Fig.6). After collapse, the monitoring stations got disturbed. The rainwater flow channels are also observed near the failed zone. The rainwater of the adjacent catchments was infiltrating down below, which must have caused increase in hydrostatic pressure behind the weak slope mass. Fig. 7 shows the daily and total recorded precipitation as a function of the time elapsed during the monitoring period. In particular, daily average rainfall amounts of 25mm were recorded on ten days before the onset of tension crack on 04.06.2014 and the maximum daily rainfall was 114 mm on 06.09.2014 due to which the crack was widened and deepened extensively.

Figure 5: Variation of vertical and horizontal displacements of tension crack with time monitored by total station

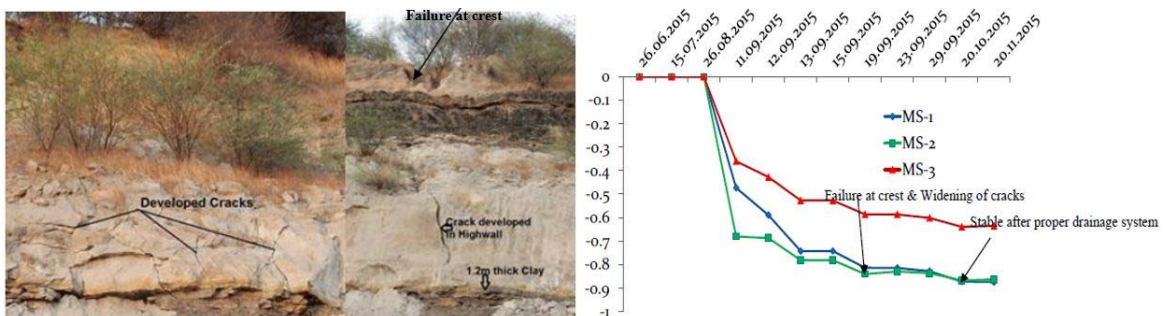
Similar failure was occurred in 170m pit slope of Medapalli opencast project of M/s SCCL on 19.09.2015 (Fig.8) and 150m pit slope of Goutham Khani Opencast Project of M/s SCCL on 31.07.2012 (Fig. 9) in India.

Figure 8: Photograph depicting failure and displacement in Medapalli opencast project

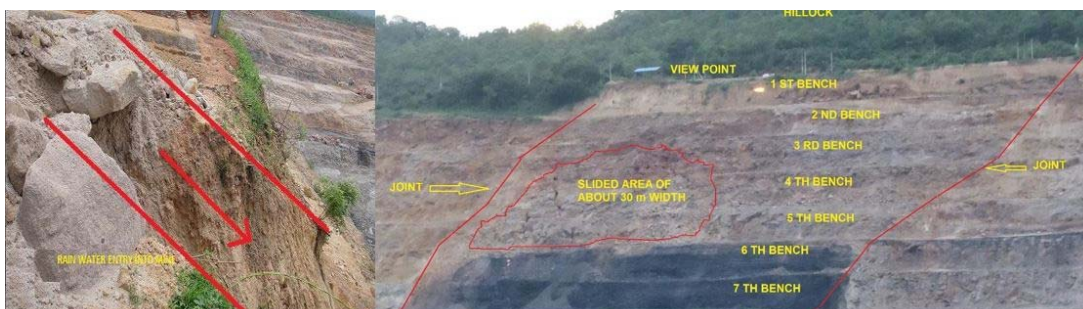
Figure 9: Photograph depicting failure and displacement in Goutham Khani Opencast Project
