Classification of cut slopes in weathered meta-sedimentary bedrocks

Johnbosco Ikenna Nkpadobi, John Kuna Raj and Tham Fatt Ng

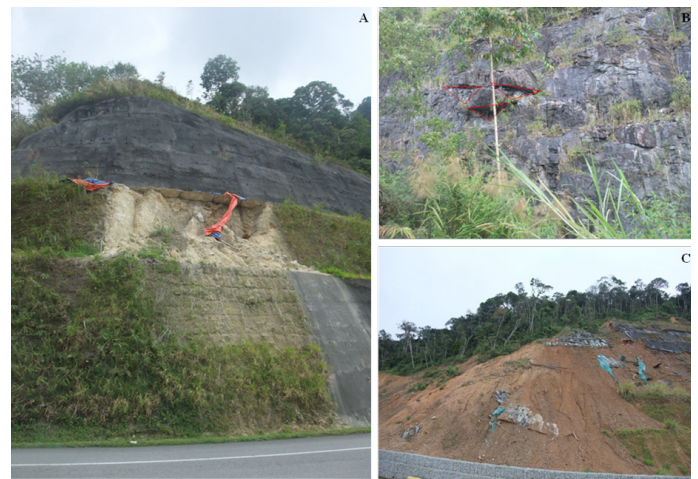
Figure 2.
(a) Planar failure. (b) Wedge failure. (c) Complex failure.

The major identified failure types in the area include planar sliding, wedge failure, and complex failures characterized by slump and earth flow which occurred along the Gunung Pass axis. The geometrical properties of failed slopes are shown in Table 1. However, the plausible triggering factors for these different types of failures varied. Figs. 2(a) - (c) represent these planar, wedge and complex failures in the area respectively.

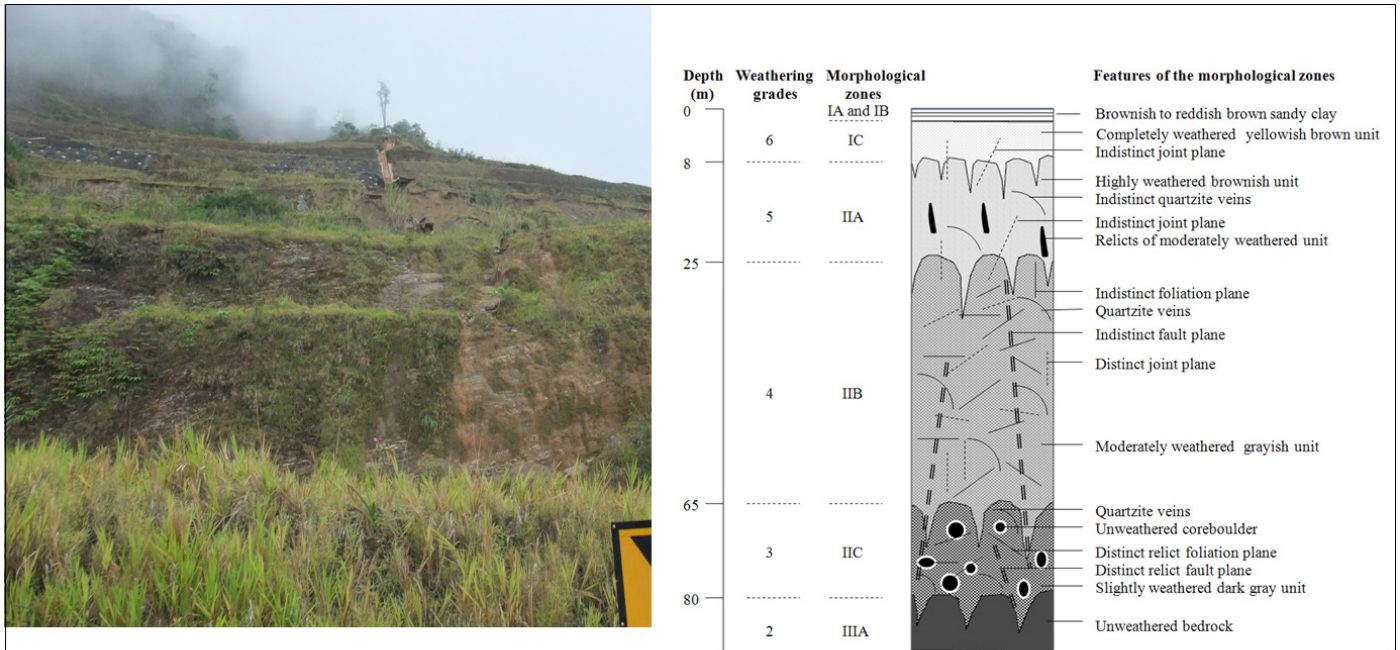
Figure 3. Field photograph and schematic diagram of weathering profile over quartz mica schist at location 010.

Since the failures in quartz mica schist occurred in the weathered zones, the characteristics of these weathered earth materials were studied in order to interpret the features of the morphological zones. The photograph and schematic diagram of weathering profile of location 010 shown in Fig. 3 is typical of quartz mica schist units. Employing BSI (1981) code of practice for site investigations, the weathering profile was graded. By identifying the lateral changes in colour, texture, hardness, and consistency of material extension, the weathering profiles over the quartz mica schist are broadly differentiated into three zones; pedological soil zone, intermediate zone and bedrock zone corresponding to zones I, II and III respectively. Based on differences particularly in textures and structures of original bedrock as well as degree of preservation of the constituent minerals, these three broad zones are further differentiated into thinner characteristic horizons.

Zone I with vertical thickness of less than 8m which corresponds to grade 6 is further sub-divided into IA, IB, and IC. Horizons IA and IB are brownish to reddish brown pedological soil profile, whereby IA which is less than 1m is friable sandy clay, whereas IB which is less than 2m is firm sandy clay. Horizon IC is completely weathered, stiff yellowish brown sandy clay devoid of any distinct discontinuity plane. Greater attention is focused on zone II because of its extensive thickness, complexity, and easy accessibility. With vertical thickness measuring up to 72m, this zone II comprises about 24% vertical thickness of higher horizon IIA (corresponding to grade 5) of highly weathered brownish unit devoid of distinct discontinuity plane, but with intercalations of relicts of moderately weathered units. The lower horizon IIB is about 55% vertical thickness of the entire zone II, comprising moderately weathered grayish coloured quartz mica schist. It corresponds to grade 4, exhibits conspicuous quartzite veins, and distinct joint and foliation planes, but indistinct fault plane. Horizon IIC is the lowest horizon of zone II, and it corresponds to grade 3. With vertical thickness of about 21% of the entire zone II, this slightly weathered dark gray unit comprises distinct relict discontinuity planes and unweathered core-boulders which are very prominent. Zone III which is schematically represented only by morphological zone IIIA is unweathered bedrock which experiences the effect of weathering only along and between structural discontinuity planes.

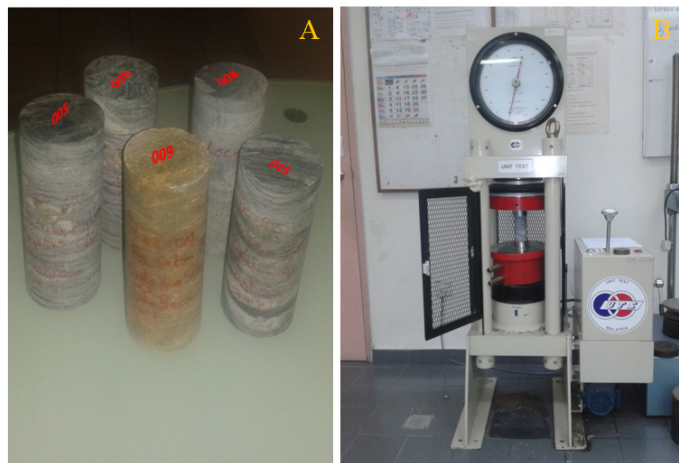
Figure 4.

(a) Some of the rock core samples. (b) Set up of uniaxial compressive strength test.

Very large rock blocks were collected in the field with use of sledge hammer and chisel for this very test, and the laboratory determination of the strength of the rock samples was carried out using ISRM (1981a) standard. As shown in Fig. 4(a), the rock samples were prepared into right circular cylinders ranging from 12.5 to 15cm in height and 5cm in diameter using diamond embedded rock core drilling machine while Fig. 4(b) shows the set up of this test. The uniaxial compressive strength of the samples was then determined under dry condition which is their ultimate strength.
