Surveying Heritage with Affordable Yet Accurate Methods. A Study Case from Arequipa, Peru

Abstract

The case study selected for this research is a mansion called "Casa del Corregidor Abril y Maldonado", whose origins date back to the 16th century. Its architectural typology stands out for the use of “sillar” as a constructive material in almost the entire building elements such as walls, pretables, stairs, roofs, floors, niches, arcades, etc. This two-story house is arranged around two patios as it was a common way to spatially distribute and provide light for ventilation to the surrounding rooms. These patios also represented different types of privacy, as the most external one has a social role (and therefore it includes the stairways) whereas the inner yard ad a more intimate function. Nevertheless, the latter is framed by a beautiful arcade. Both patios are connected by an alley and many of the surrounding rooms are covered by vaults. Currently, the Casa del Corregidor Abril y Maldonado, is restored, having a high percentage (65% approx.) of conservation from its original status. (Fig. 1).

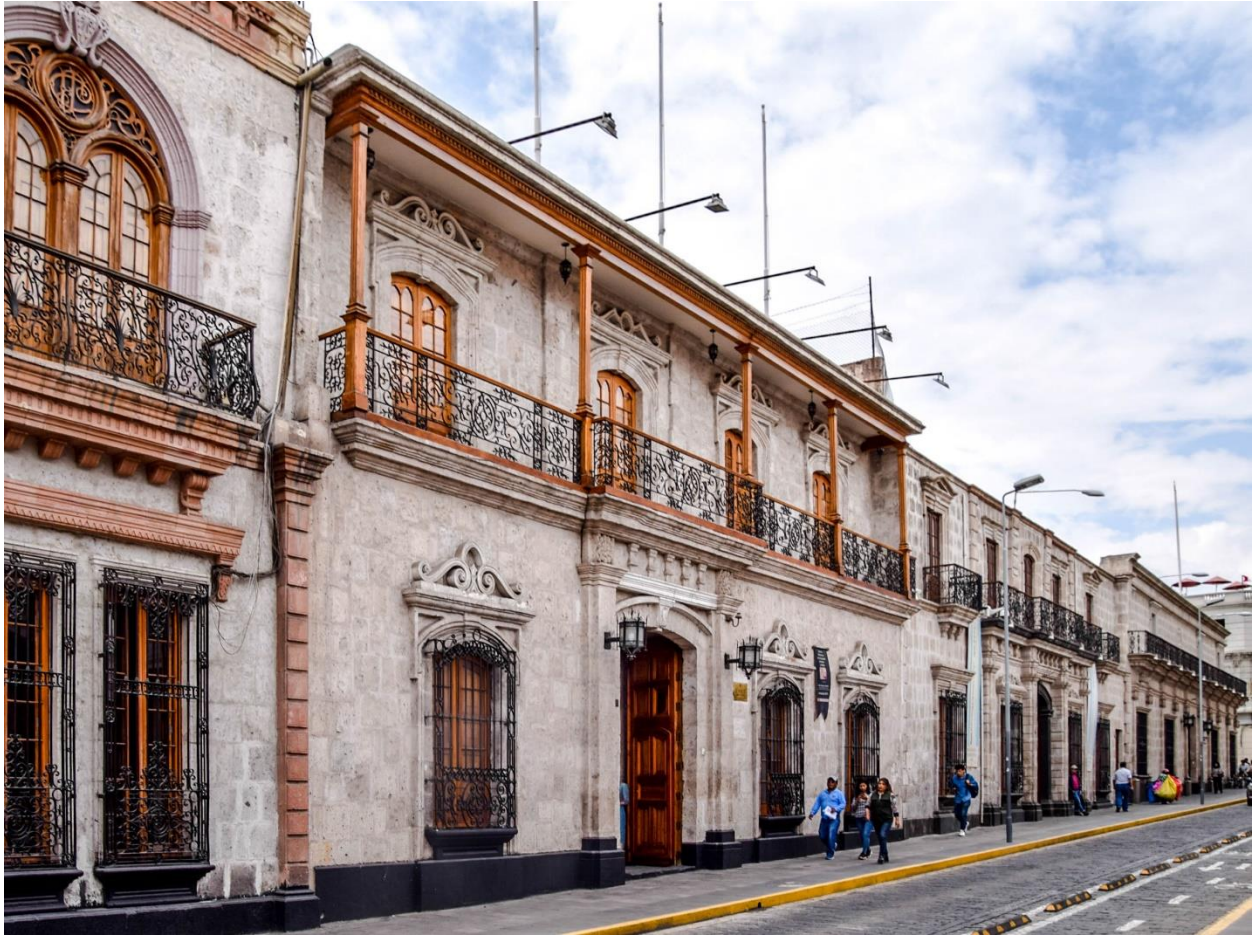
Figure 2. Façade of the building (Zeballos, 2019)

The main façade of the building which is composed of two stories, made in the so-called a Republican-style, which has fewer ornaments than the Baroque style, yet it includes a wooden balcony and windows with neoclassical ornaments (Fig. 2).

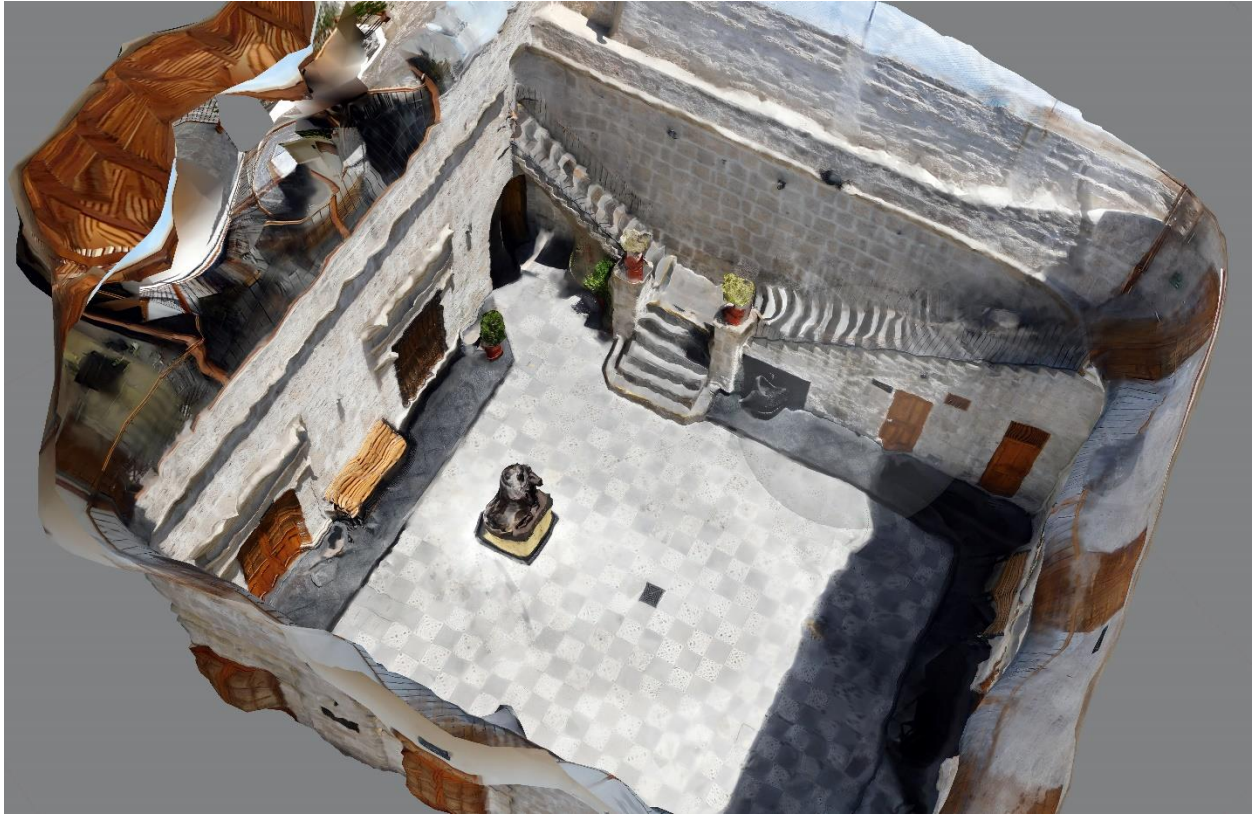
Figure 3. Image processing in Agisoft.

The second stage was to process the images. The specialized software for processing photographic data requires that the images should not be manipulated in any way, that is, rotating them, trimming them, adjusting contrast values, color, brightness or any alteration; since it produces loss of valuable information and in many cases, the software simply does not recognize the image file. Images that are discarded usually mostly due to problems such as overexposure, dark surfaces or high contrasts (Fig. 3)

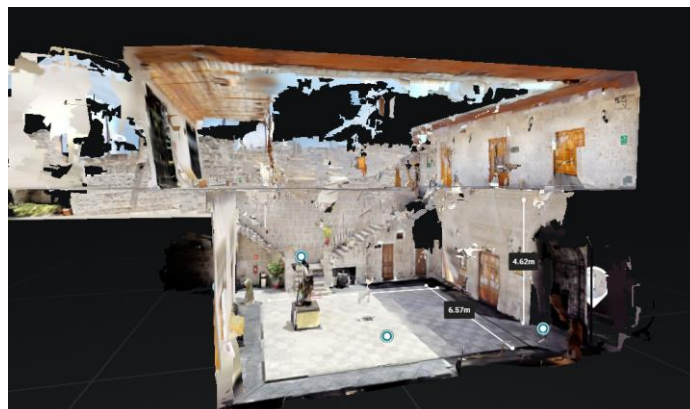
Figure 4. Image processing in Matterport.

The model is built using the captured imagery and is stored on the mobile device using the Matterport app. For the construction of the 3D model, a sequential workflow must be carried out that is progressively checked on a plan layout (Fig. 4).

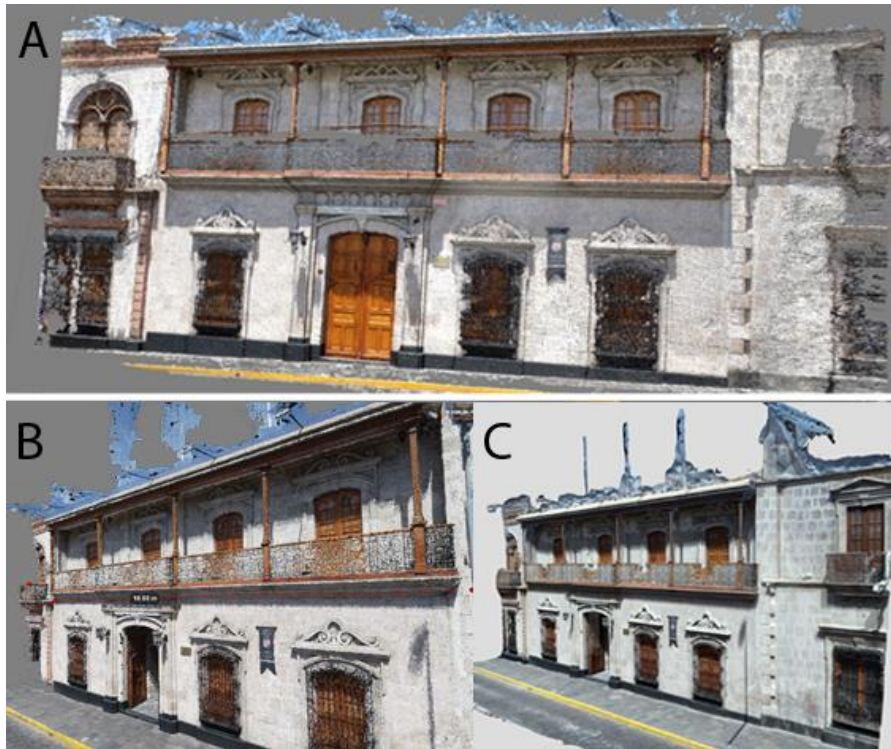
Figure 6. Results of point cloud format in photogrammetry (a) and aerophotogrammetry (b and c).

The methods used had different performances and qualities of the results. As for the façade, there were results were obtained by a combination of UAV imagery and Pix 4D software, as it was possible to obtain a point cloud of acceptable accuracy and consistency of materials, which can be clearly distinguished (Fig. 6b and 6c). Less accurate results were obtained in the photogrammetry method, which succeeded in showing the volumetry and general ornaments in the façade (Fig. 6a). However, none of these methods was accurate enough to collect fine detail form details, such as metal latticework and other ornaments, as well as cracks in the frontage. To get enough quality of these elements the use of a LIDAR scanner is advisable.
