Long-term Deformation Measurements of Atypical Roof Timber Structures

Jiří Bureš, Otakar Švábenský, Marek Kalina

Brno University of Technology, Faculty of Civil Engineering, Veveří 331/95, 602 00 Brno, Czech Republic, E-mail: bures.j@fce.vutbr.cz, svabensky.o@fce.vutbr.cz, kalina.m@fce.vutbr.cz

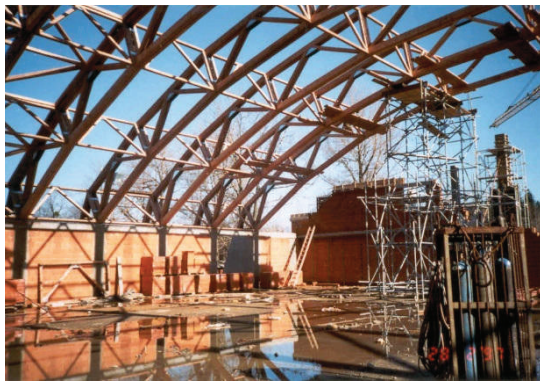
Figure 1: Tennis hall in Frýdlant nad Ostravicí, 1997, span 40,4 m

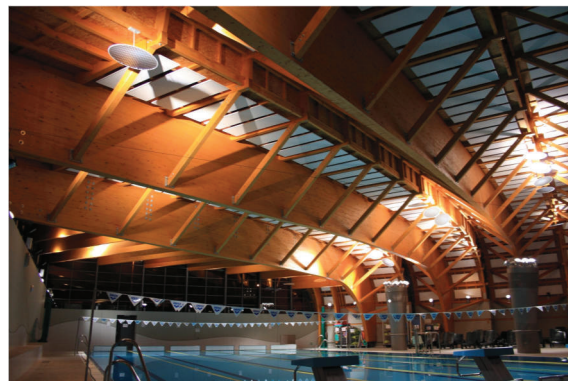
Figure 2: Swimming pool in Brno, 2010, span 35 m

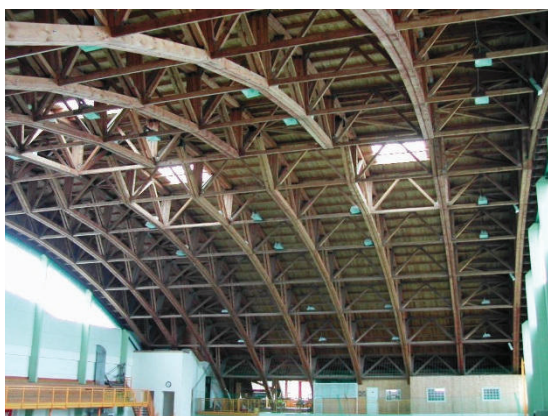
Figure 3: Roof after its completion

Sporty multi-purpose hall in Bílovec was implemented in 2001. Figure 3 gives a view of the completed structure inside the hall. Hall ground is rectangular measuring 60 x 30 m. The main structure supporting the roof system is made up from three-hinged arches with a span of 59 m (Figure 4).

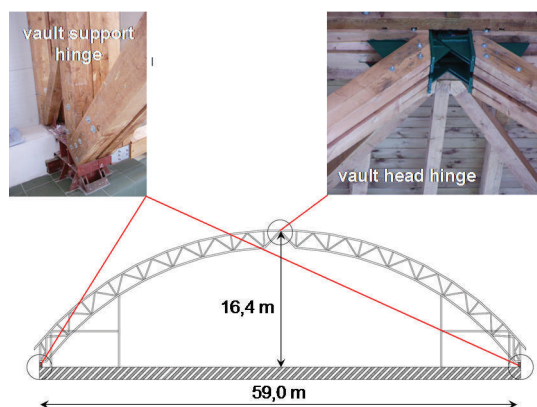
Figure 4: Three-hinged arch

The arches are in the transverse direction stiffened by longitudinal and lateral bracing, and the entire framework creates the spatial carrying system [4]. Bar connections in the joints are designed using thin steel plates inserted in the slots and steel nails [5]. The roof structure supporting is attached to the concrete foundation footings by hinge bearings. Installation of the roof structure was realized with high accuracy (actual radial deviation of the roundness of the structure did not exceed 16 mm) [4].

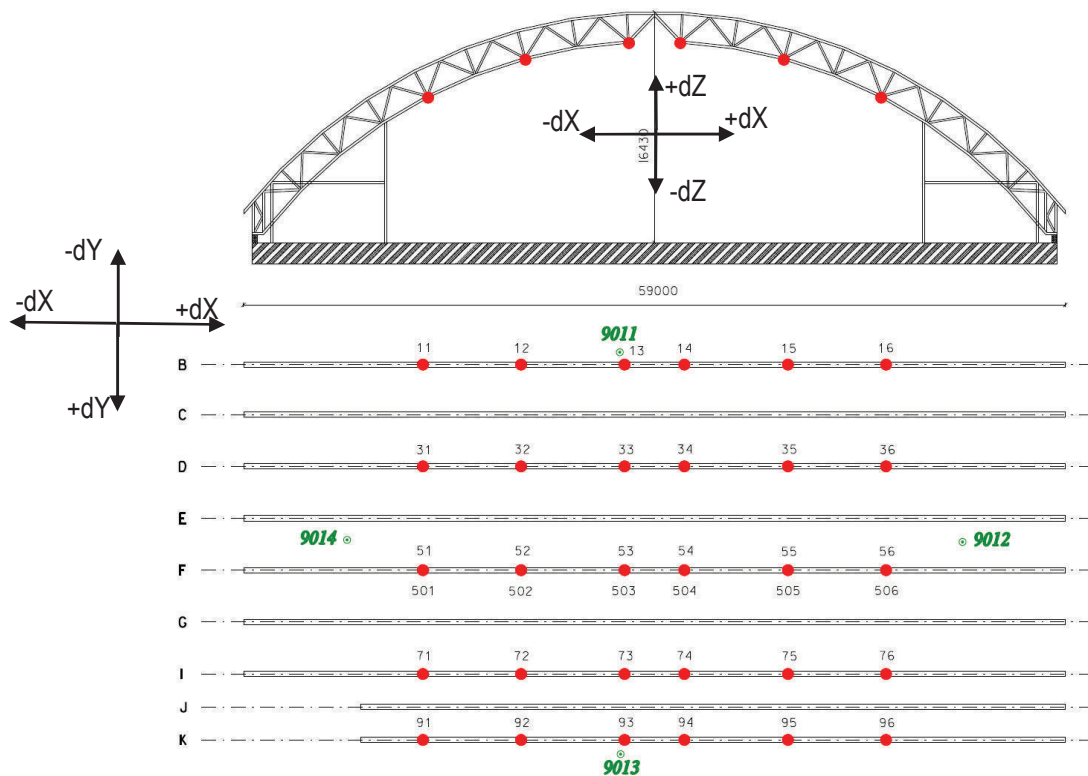
Figure 5: Layout of the construction surveying markers

The behavior of the observed roof structure is evaluated on base of measurement results of surveying markers system mounted on the lower bands of arch construction. The entire structure is composed of nine arches, measuring markers are mounted on five of them. Site network consists

of 36 surveying markers, their positioning in the section and plan is shown in Figure 5. The control system consists of 4 surveying marks 9011-9014 set up on the supporting pillars of the structure side walls. Surveying marks are in the shape of 30 mm targets with concentric circles.

From the data in each stage the spatial coordinates are calculated using least squares adjustment (LSA). Cartesian coordinate system X, Y, Z is oriented in the direction of main axes of the construction (Figure 5). From the differences of the coordinates in various epochs the deformations can be evaluated in the longitudinal, transverse and vertical direction. Characteristics of the accuracy of coordinates derived from the LSA can be directly used to calculate the uncertainties in deformations and their interpretation. An analysis of the accuracy of the single measurement epochs, the mean expanded uncertainty for an epoch deformation is $\Delta\delta = 1.4$ mm (for $K = 2$, $P = 0.95$, $\alpha = 5\%$).

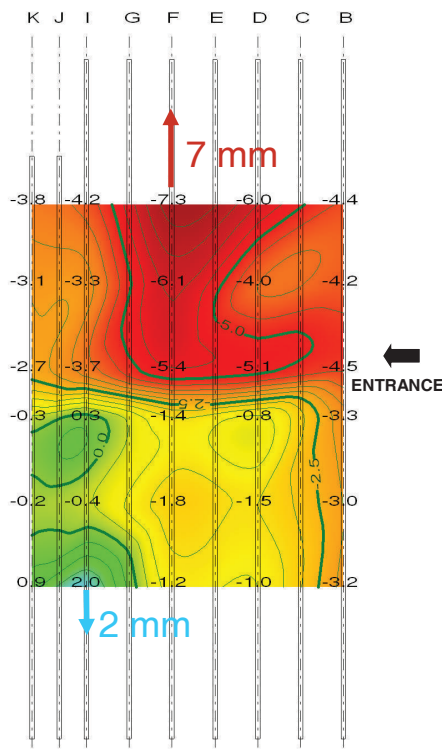
Figure 6: Longitudinal deformation

In Figure 6 is shown in plan in form of isolines and color hypsometry the state of longitudinal deformation, in Figure 7 the state of transverse imperfections. In terms of distribution of the longitudinal strain it is evident that half the roof structure is deformed more strongly than the other, due to the structural arrangement of trusses which is different in both halves of the structure.

Maximum longitudinal deformations are as high as 7 mm, and maximum values of transverse imperfections are up to 8 mm, while the isolines with support of color hypsometry can help to identify the most-stressed particular structural components joints.

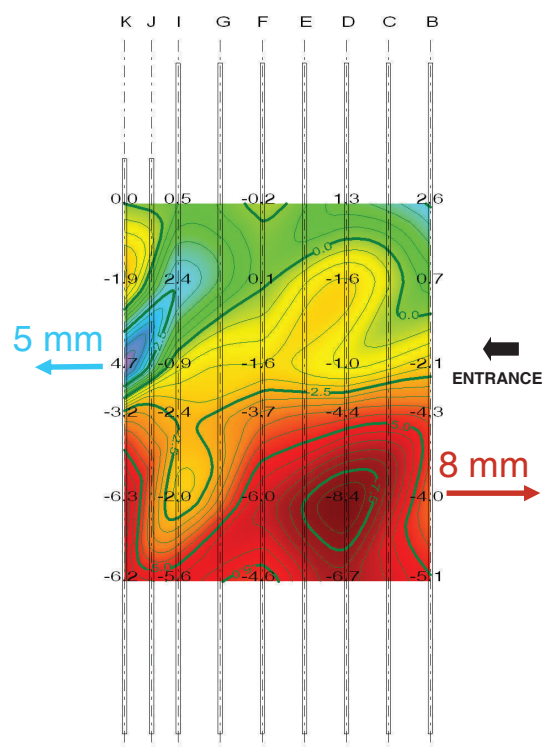
Figure 7: Transverse imperfections

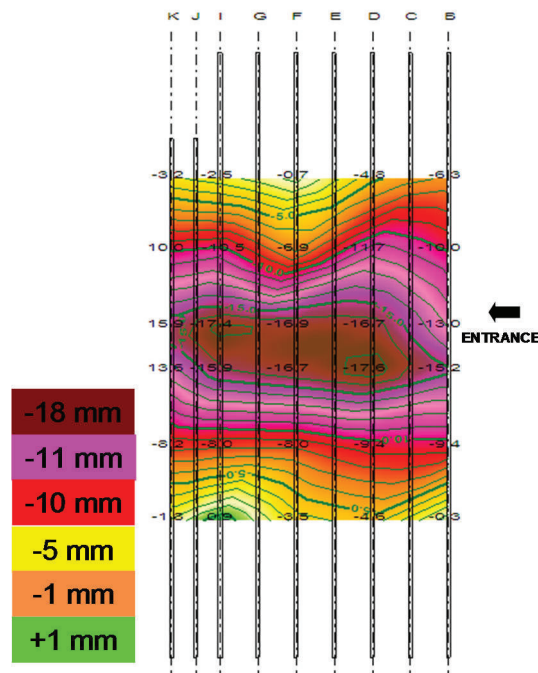
Figure 8: Isolines and hypsometry of vertical deformations

In Figure 8 the state of vertical deformations of the roof structure after 12 years of its commissioning. In vertical direction of the monitored roof construction the greatest distortions were in the tops of arches, considerably smaller vertical deformations were in arch quarters. Over the years, the hall vertical deformations gradually slightly increased. The values of deformation are strongly influenced by exposure to ambient temperature. In winter there is a vertical downward movement - the deflection of the roof, and in the summer months there is a vertical shift upwards [6], [7]. The vertical deformations are manifested mostly by decrease amounting to 18 mm at the top of the arch, and shrinking toward the arch $\frac{1}{4}$., where are smaller than 5 mm. Deformations are partially compensated by movements in the underlying spherical bearings and in the top hinge. Mechanics of motion of the arch construction is in a section shown in Figure 9. Figure 10 shows the evolution of the vertical deformation at the top of the arc in time given in calendar months from the beginning of the surveying, and the temperature in intermediate epochs of measurement. At higher temperatures in summer there is an uplift in the top of the arc, and vice versa at low temperatures in winter is the top to decrease. In particular, the vertical deformation are strongly influenced by ambient temperature. The effect of temperature shows in the vertical change of about 4 mm over 10°C temperature changes.

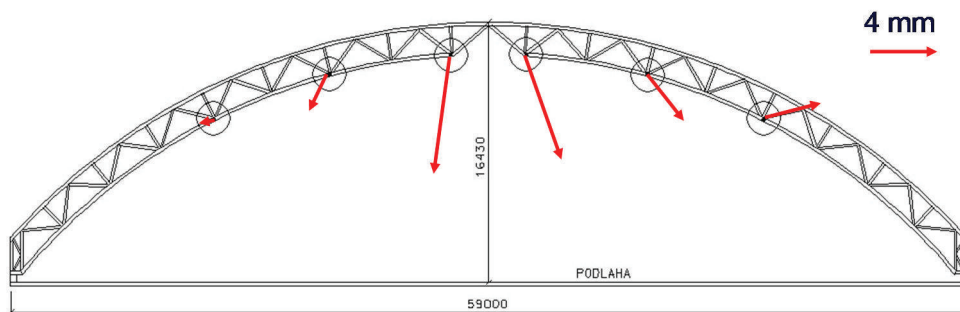
Figure 9: Mechanics of arc movements

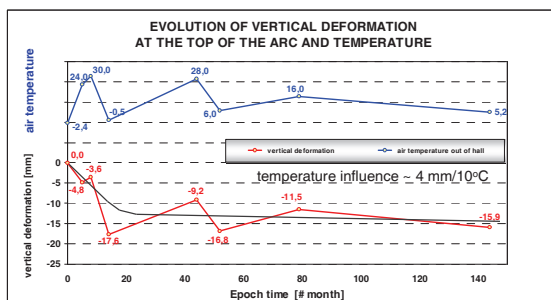
Figure 10: Vertical deformations and temperature

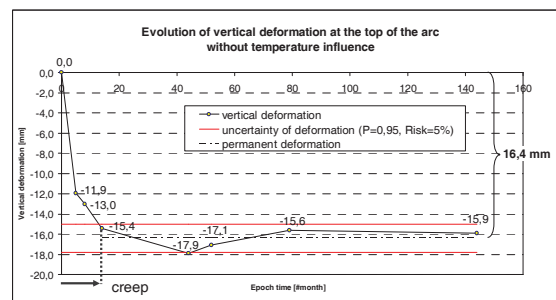
Figure 11: Vertical deformations without temperature influence

Figure 11 shows the evolution of the vertical deformation at the top of the arc in time given in calendar months from the beginning of the surveying with correcting temperature influence in intermediate epochs of measurement. It is evident from the development of vertical deformation that during approximately the first 15 months after the commissioning proceeded the gradual fitting together with the creeping yield of the construction joints.

After one or two years the construction has settled, what was demonstrated by permanent vertical deformation at arc top 16,4 mm, and after 10 years of commissioning the vertical deformations have not changed within accuracy limits and therefore the construction is stable.
