Case Report

Aesthetic treatment on anterior teeth crown fracture caused by dental trauma

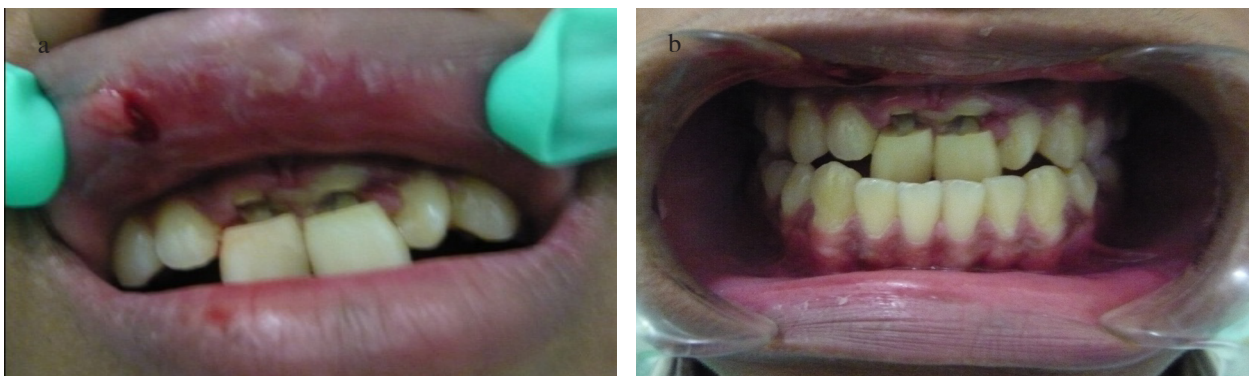
Figure 1. a) The condition of upper lip with torn ragged wound; b) The initial condition of complicated crown fracture on teeth #11, #21 and #22.

was found around the vestibule areas of the teeth #11, #21, #22 and the upper lip (Figure 1a). The patient wanted to have his anterior teeth aesthetically improved to normalized its form and function.

Intra oral examination was conducted on the teeth #11, #21 and #22 suffering from complicated crown fracture causing an fully opened pulp around tooth cervical areas (Figure 1b). Panoramic and local x-rays were conducted (Figure 2). Based on the results, there was radiolucency appeared on the periodontal ligament of the teeth #11, #21 and #22. The teeth #11, #21 and #22 were then diagnosed as pulpitis irreversible.

At the first visit, to dental hospital emergency treatment that consisted of soft tissue cleansing around the mouth and lips with saline and hydrogen peroxide and giving antibiotics, analgesics, and anti-inflammatory were conducted. The patient was also suggested to maintain his oral hygiene by using chlorhexidine mouthwash and having soft food diet. The emergency care should immediately be taken to prevent the patient from soft tissue.²

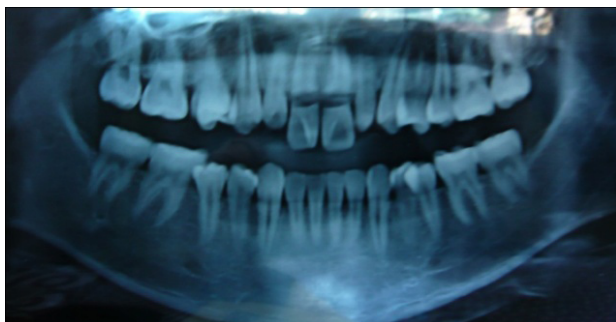
Figure 2. Panoramic x-ray image.

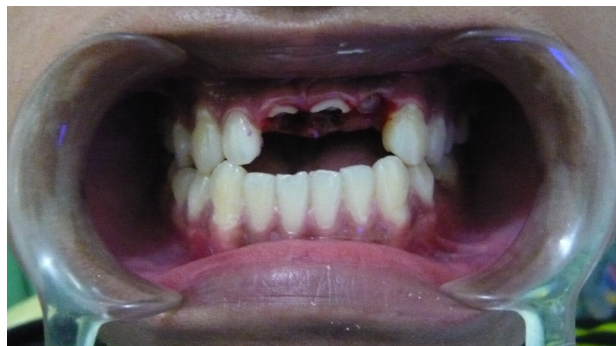
Figure 3. The Condition of teeth after the releasing the crowns of #11, #21, #22 prior to the treatment.

The crowns of fractured teeth #11, #21 and #22 were extracted until the cervical areas and gingivectomy was done in the palatal rugae frenulum areas to improve the shape of excessive gingival contour lines that corresponded to palatal and labial cervical portion of the anterior teeth (Figure 3). After wound healed, an impression were taken on maxillary and mandibula for model study. Dental records

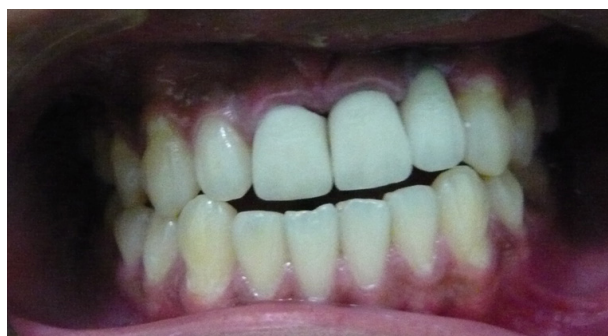
Figure 4. Temporary tooth crown on teeth #11, #21 and #22.

were then also conducted in order to record occlusion and relationship, and to be used as temporary jacket crowns on teeth #11, #21 and #22 to prevent bad appearance during the dental treatment.

Moreover, pulpectomy treatment was conducted for one visit on the teeth #11, #21 and #22 with crown down pressureless technique by using file Pro Taper preparation tools and single cone filling technique by using ultracal pasta sealer material. In the next stage, the preparation of post channel was conducted by taking gutapercha using gates gliden drill, and then followed with conducting peeso reamer leaving the gutta-percha about 4-5 mm from the apex of the root canal. Afterwards, the root canal was printed by using elastomer print materials to make post and core. The temporary crown was then inserted for maintaining the aesthetics of the teeth during manufacturing process of casting post and core in dental laborioium (Figure 4).

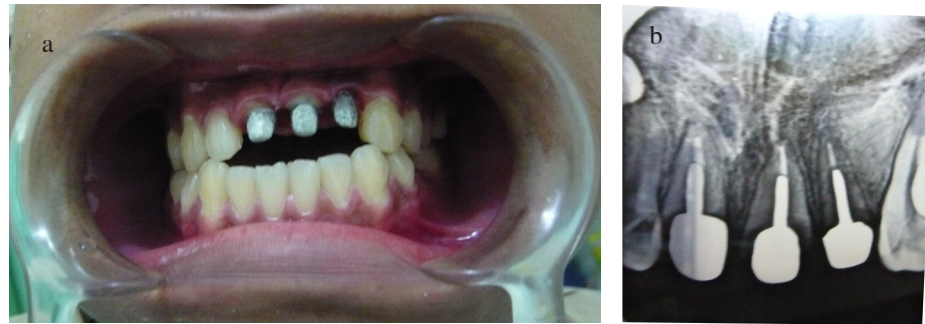
Figure 5. a) The inserted of casting post and core on teeth #11, #21 and #22; b) Casting post and core insertion in the root canal.

Few days later cast posts and cores were inserted into the root canal of teeth #11, #21 and #22 by using glass ionomer cement type I luting cement (Figure 5a). Local x-ray were conducted (Figure 5b). Impression was done on teeth #11, #21 and #22 by double impression technique. In the next stage, temporary crown was inserted and the print result was sent to the dental lab for making porcelain fused to metal crowns. Then, the porcelain fused to metal crowns were inserted on the teeth #11, #21 and #22 by using glass ionomer cement type I luting cement (Figure 6). Evaluation was followed 3 and 6 months after treatment in which the patient got a good result (Figure 7).

Afterwards, intracanal retention was conducted to restore the crown by using post as retention on its restoration. Post used in this case was casting post (artificial post) and core also used was aimed to increase the retention of teeth and position of porcelain fused to metal crown restoration. Position of teeth with crowns that have been depleted or with heavy occlusal forces can be indicated by the crown with the casting post and core. Teeth both with short clinical crowns or without clinical crowns, but still having adequate roots in terms of length, thickness and embedded in the alveolar bone, and with the ratio between the root and the crown of the teeth can qualify for post length inserted into the root canal length at least equal to the crown length, thus, casting post and core are the best choices.^{15,16}

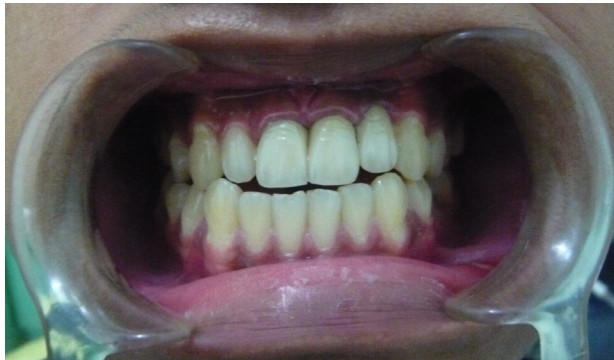
Figure 6. The insertion of porcelain fused to metal crown on teeth #11, #21 and #22.

Porcelain fused to metal crown restoration is the best option to restore tooth aesthetics, especially the shape and color of the tooth anatomy in accordance with natural teeth, and to be able to function naturally. Similarly, Hume¹⁸ also said that the porcelain jacket crown is the best choice to restore the aesthetics of the central incisors optimally. Furthermore, among 956 patients, only 63% of them were satisfied with the appearance of the anterior tooth using a crown veil, and 79% of them were satisfied with 4 or more anterior teeth using porcelain fused to metal crowns.¹⁹ Porcelain is also considered to be the most satisfying treatment because of its natural color and aesthetics. The cementation of the porcelain fused to metal crown towards post-core uses glass ionomer cement type I (luting sement).²⁰

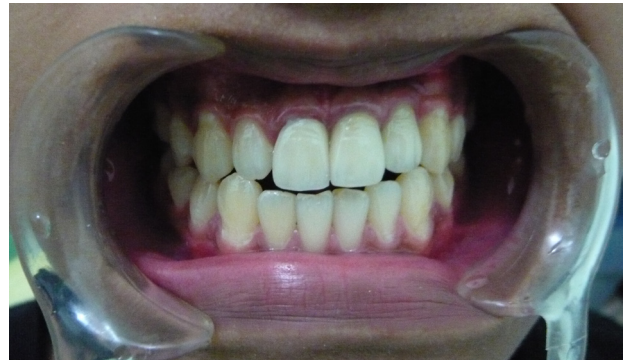
Figure 7. Control after 3 month.
