# Strengthening of Historical Stone Masonry Buildings in Oman using Textile Reinforced Mortars

A.H. Al-Saidy\*, A.W. Hago, S. El-Gamal and M. Dawood

Department of Civil and Architectural Engineering, College of Engineering, Sultan Qaboos University, Oman.

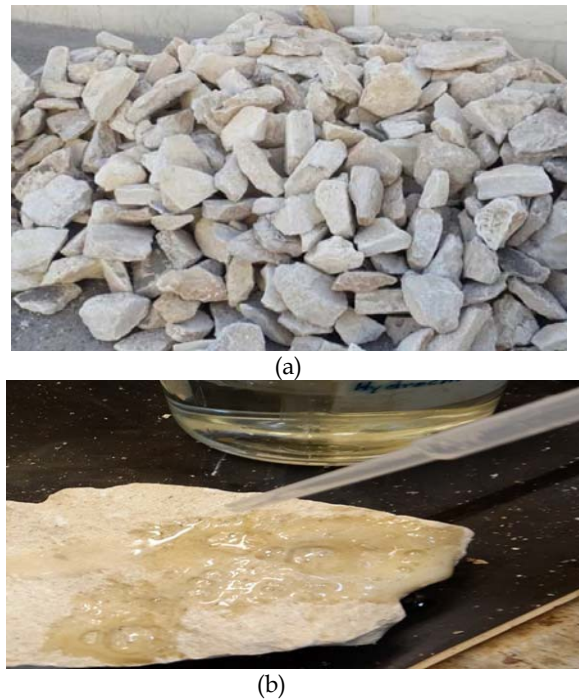
**Figure 1.** a) Limestone , b) Limestone reaction with HCl.

Limestone is defined according to the American Society for Testing and Materials (ASTM) Standards C51 (2011) as an initially sedimentary rock consisting mainly of calcium carbonate or of the carbonates of calcium and magnesium. Limestone may be high in calcium, magnesium, or dolomitic. Due to limestone's wide availability, its ease of cutting, its good heat and humidity insulation, and its aesthetics, it was widely used historically in Oman's historical buildings. The limestone used in this study was obtained from Wadi Al-Khoud, and the stones were crushed to fragments of random sizes (Fig. 1a). The stone was verified to be limestone by applying hydrochloric acid (HCl) and listening for a strong fizzing to occur due to the CO<sub>2</sub> produced from the reaction of HCl with CaCO<sub>3</sub> (Fig. 1b). A sample of the limestone crushed into particles and passed through a sieve sized 0.075 mm was prepared for chemical analysis. ASTM Standard C 25-11 procedures were followed to determine its chemical

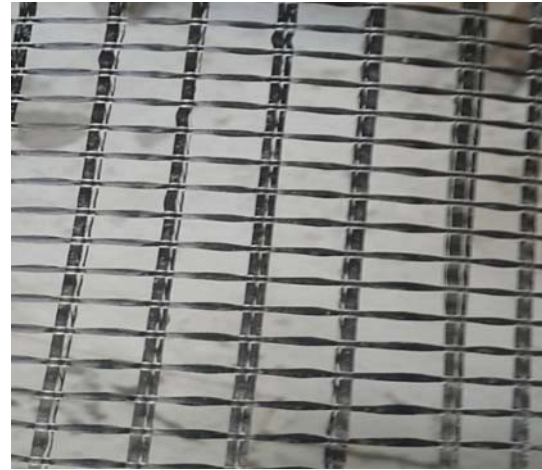
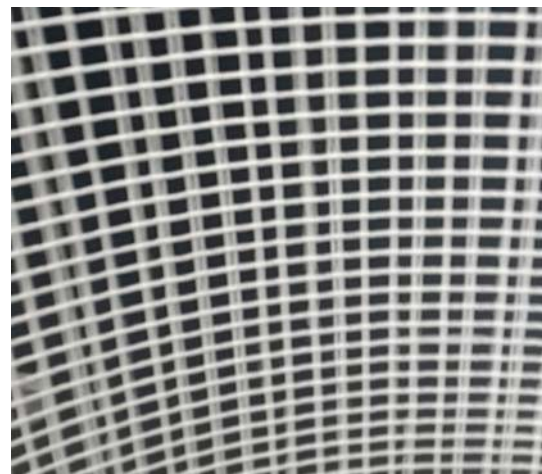
**Figure 2.** a) Carbon fiber textile, and b) Glass fiber textile.

Carbon fiber (CF) and glass fiber (GF) bi-directional textiles were used for the strengthening of the specimens. CF textile has a roving dimension of 1.1 mm wide by 0.5 mm thick in the longitudinal direction with 12 mm spacing between the rovings; and a 0.5 mm wide by 0.5 mm thick dimension in the transverse direction with 6 mm spacing between the rovings. GF textile has a roving dimension of 1.3 mm wide by 0.5 mm thick in both directions and spacing between the rovings of an average of 5 mm in both directions (Fig. 2).

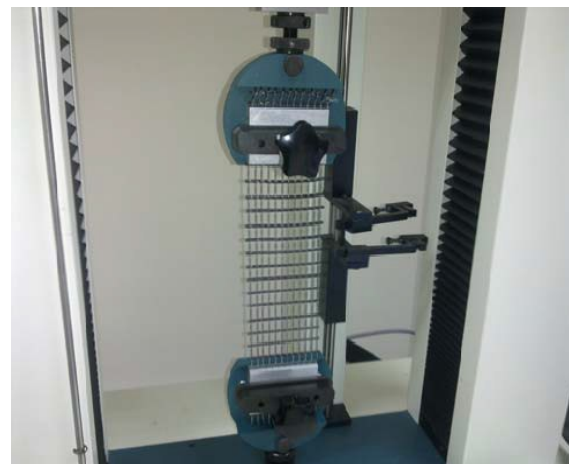
**Figure 3.** Photograph of pure tensile tests of textile specimens.

The textile was characterized in a laboratory by means of uniaxial tensile tests according to ASTM Standard D5034–09 (2013). Textile fibers specimens were cut into 220 mm lengths and 80 mm widths to fit the testing machine (Fig. 3). The test was done on a load control rate of 10 kN/s. Table 2 shows the tensile test results of the textile specimens reported as an average value of three test samples. The peak load  $F$  is reported in kN/m as a force per unit width based on the 80 mm width and strain  $\epsilon$  defined as the elongation of the specimen at peak load relative to the original length of the specimen.

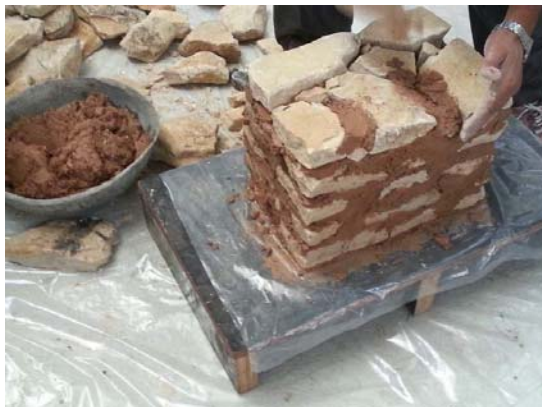
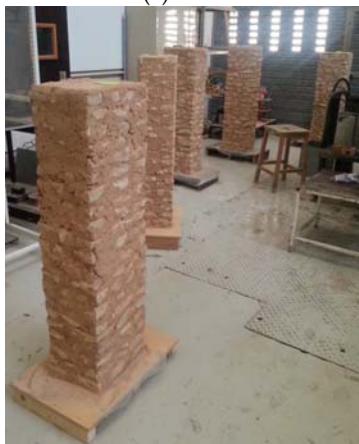
**Figure 4.** (a) Construction of stone masonry specimens, (b) Specimens air curing after construction completion.

depth x height). A professional stone mason was hired to construct the specimens. The walls and columns were constructed using an assembly of limestone bonded by *Sarooj* mortar. The specimens were constructed over a wooden platform covered by a polyethylene sheet for easy mobilization of the specimens during testing. They were constructed vertically in two phases: the layers of stones and mortar constructed to a height of 0.6 m and then left for the mortar to set to avoid squeezing the mortar at the lower layers. Stones were cut into appropriate sizes and arranged in layers, and mortar was used to bind them together (Fig. 4). The constructed specimens were left to air cure for 60 days.

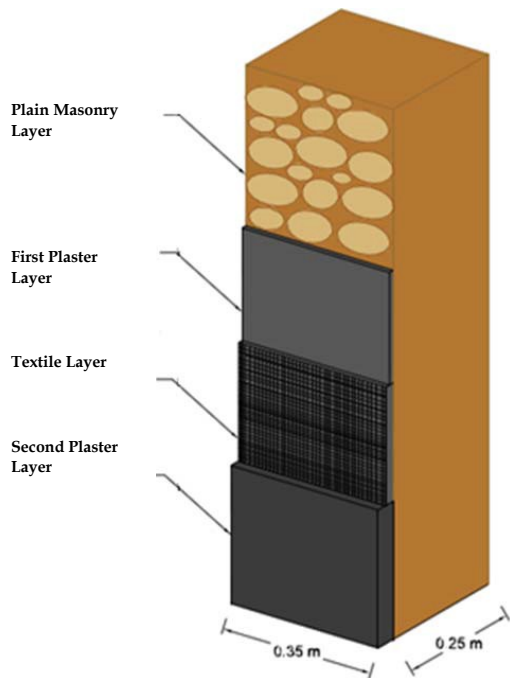
**Figure 5.** Schematic representation of strengthening procedure for walls.

After the specimens had been cured for almost 30 days, walls were strengthened with a bonding textile on the tension side. Carbon fiber and glass fiber textiles were used in combination with two matrix mortars (Table 3). The specimens were cleaned and rubbed to even the surface and increase the bond with the matrix mortar or plaster. The surfaces to be plastered were sprayed with water prior to plastering to maintain the water content in the plaster mortar. After the face of interest had been prepared, a layer of plaster mortar of 1–2 cm was applied, and then the textile was bonded on the surface, pushed into the plaster layer, and surfaced with a thin plaster layer to fix it in place. Then a second layer of mortar of 1–1.5 cm was applied. The variation in the plaster or mortar thickness was due to the uneven surface of the wall. Figure 5 shows a schematic representation of the strengthening procedure. The specimens after application of the textile were kept for 28 days under air curing at laboratory temperatures before testing.

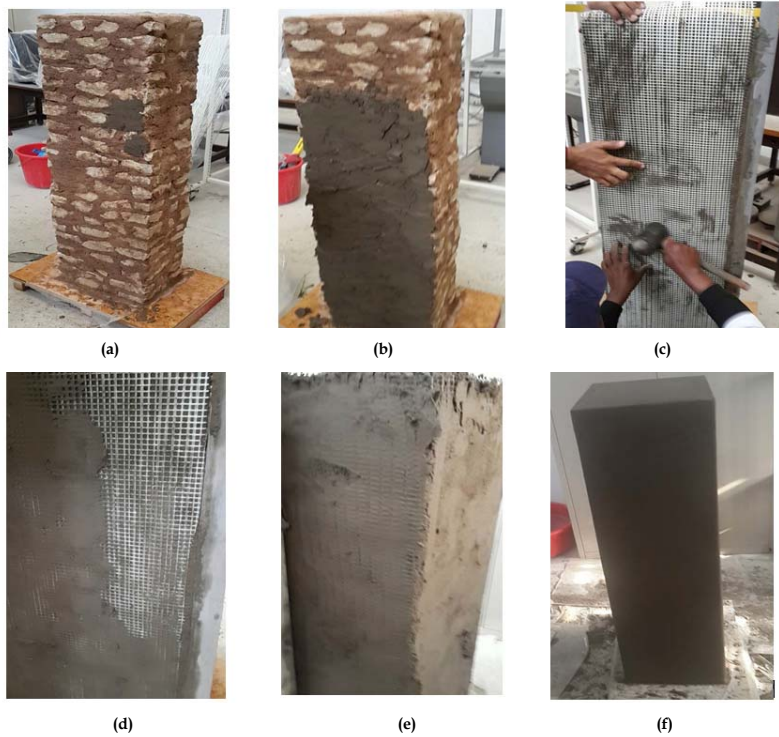
**Figure 6.** Stages of column strengthening: (a) wetting of the masonry surface replaced by, (b) Applying the first mortar layer, (c) Bonding the textile, (d) Fixing the textile with thin mortar layer, (e) Applying the second mortar layer, and (f) Finishing up the surface and capping the column.

strengthening of the column followed a similar procedure as in the wall specimens, except that for the column the process was done on the four sides of the column. A first layer of plaster mortar in the range of 1–2 cm was applied on two adjacent faces, and then the textile was bonded on the plastered area. It was pushed into the plaster layer and surfaced with a thin plaster layer to fix it. The same procedure was repeated for the other two faces. The textile was overlapped on the first face to the center of this face to ensure full confinement around the column. A second layer of plaster of 1–2 cm was then applied around the perimeter of the column. The sequence of bonding the textile is shown in Fig. 6. The column was then capped on top with the same mortar to level the surface for later axial load application. The strengthened specimen was kept for another 28 days under air curing at laboratory temperatures before testing.

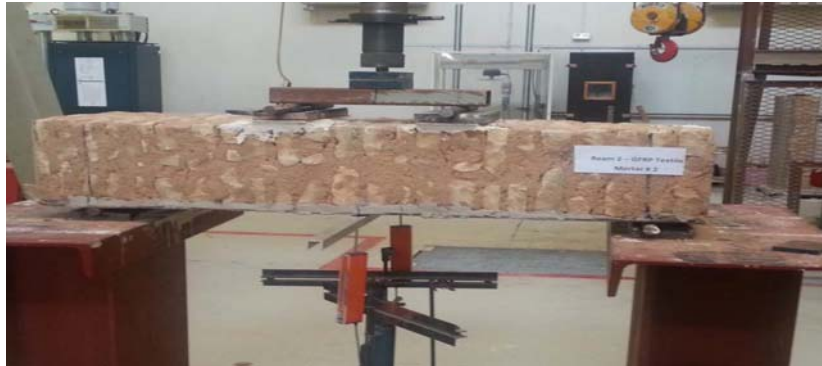
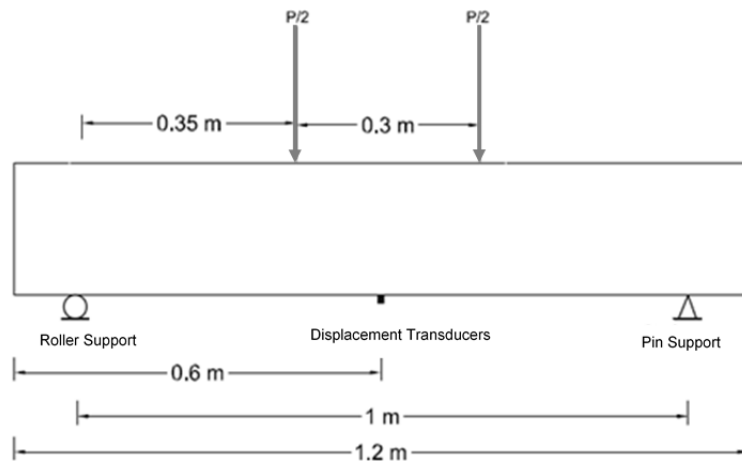
**Figure 7.** Walls test setup.

The three wall specimens were tilted and flipped such that the strengthened face was at the bottom and transported to the testing area. All wall specimens were tested under out-of-plane four-point bending. The specimens were simply supported with span length in between

supports of one meter (Fig. 7). At the wall's mid-span, two displacement transducers were placed to measure deflection at both sides of the wall. Loading was then applied using a 250 kN compression actuator at a rate of 1 mm/min until failure.

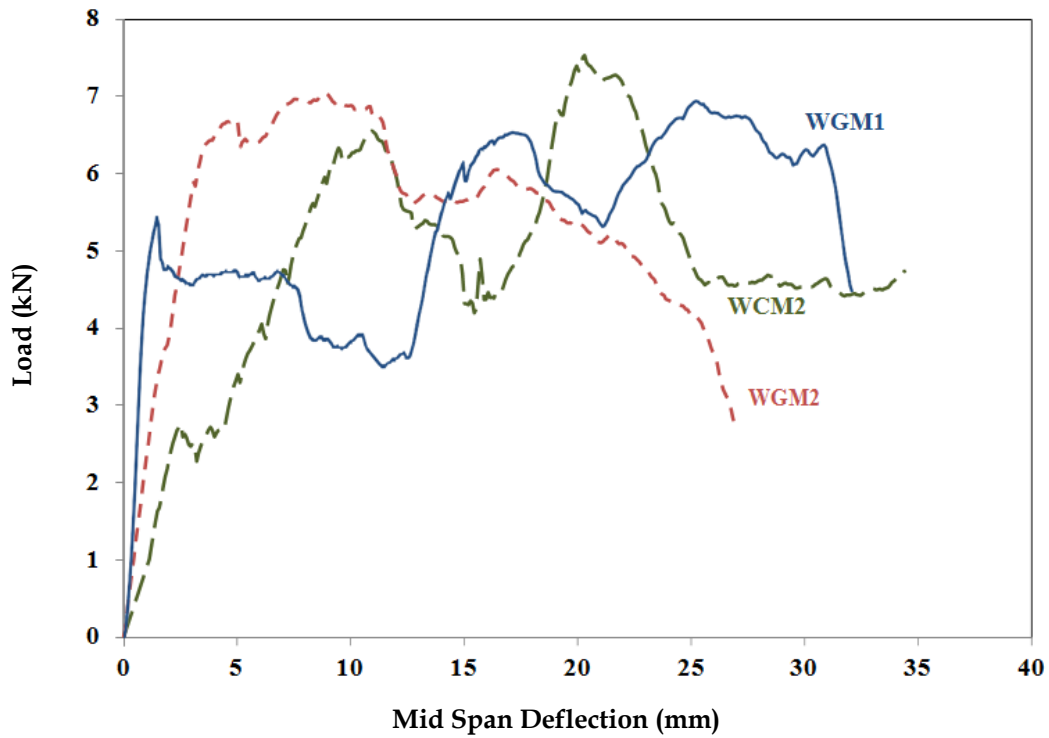
Figure 9. Load vs. Mid span Deflections for the tested walls.

The load versus mid-span deflection for the strengthened walls is shown in Fig. 9. As can be noted, there are multiple load peaks in each curve in all strengthened walls' behaviors. All the wall specimens failed due to diagonal shear adjacent to the supports within the shear span (Fig. 10). Cracks developed diagonally between the support and the loading point and, were expanded until a separation of the masonry wall occurred. As diagonal cracks developed, a drop in the applied load was observed. Then the load picked up again with further deflection with an increase in wall curvature causing cracks and gaps to come closer to enhancing the interlocking action of the limestone and further increase in the applied load. The diagonal shear failure in all walls was due to the weak *Sarooj* jointing mortar, which has very low strength as discussed in Section 2.3. No failure in the textile or the matrix mortar was observed. All textile types and matrix mortar performed well in terms of tensile and bond strength, and all failures were caused by the weak jointing mortar. Nevertheless, all strengthened walls attained high strength and ductility when compared to plain or unreinforced masonry walls. The bending moment due to the loading scheme used in the test of the walls caused tensile stresses at the bottoms of the walls, which was entirely resisted by the textile layer at the bottom of the strengthened wall. However, unreinforced masonry wall will fail when subjected to tensile stresses as a result of

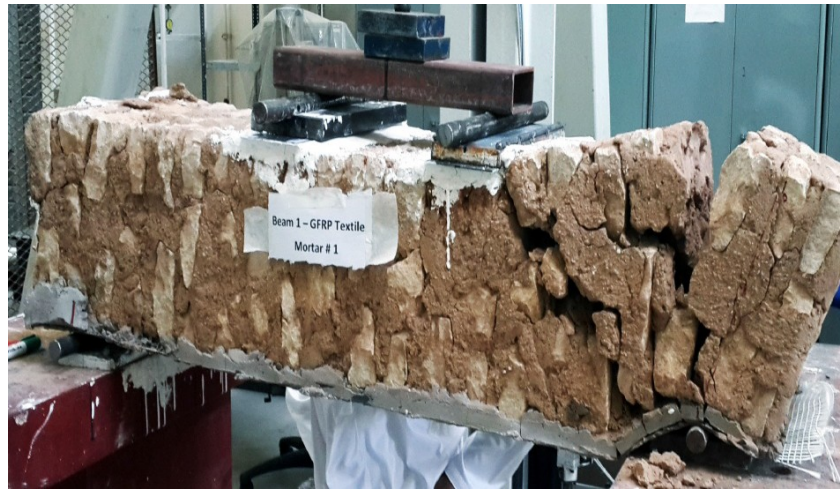
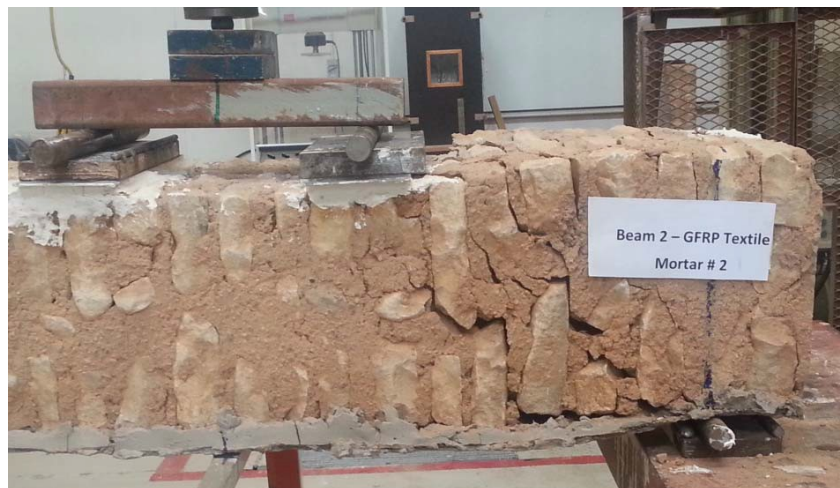
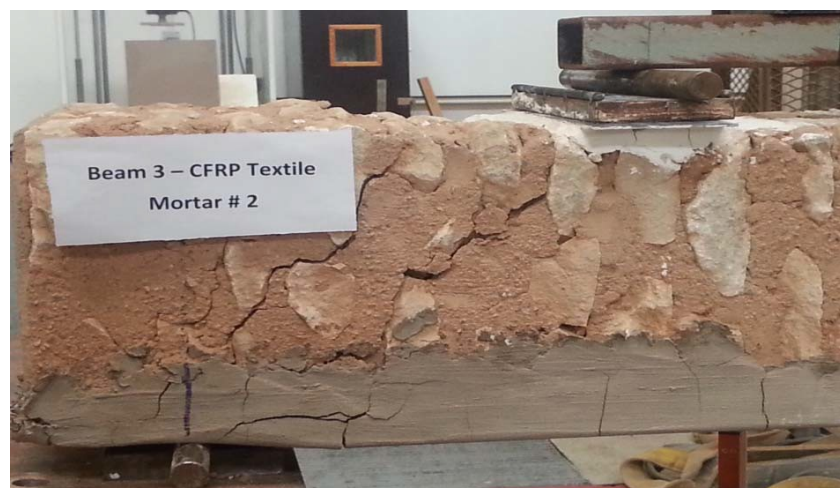
**Figure 10.** Shear failure: (a) Wall WGM1 replaced by, (b) Wall WGM2, and (c) Wall WCM2.

It was noted that the cracks in wall WGM1 started at a lower load of 5.3 kN compared to 7 kN when the cracks appeared in wall WGM2 (Figure 10 a and b). In addition, wall WCM2 resisted a slightly higher load than WGM2.

Nonetheless, the main failure was due to shear in the jointing mortar and, therefore, it is very difficult to make a fair comparison on the effect of the matrix mortar M1 and M2 as well as the effect of the glass fiber textile in comparison with the effect of carbon fiber textile. In other words, both strengthening schemes would work since the weakness was in the jointing mortar rather than the TRM layer.

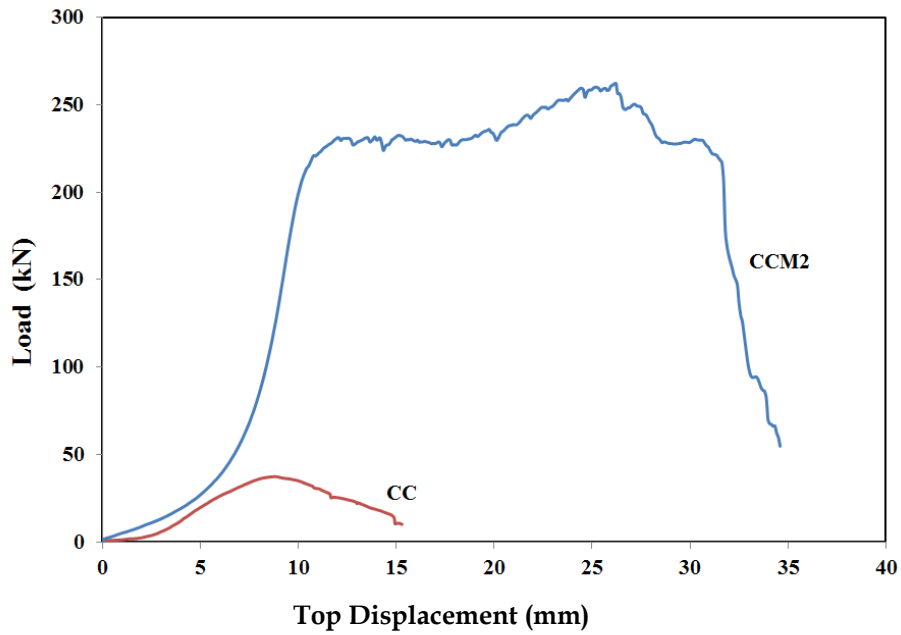
Figure 11. Load versus top displacement for columns CC and CCM2.

Column specimens were tested under axial compression. The load versus column top displacement is shown in Fig. 11. The control column (CC) reached an ultimate compression load of 37.30 kN at a displacement of 8.8 mm (Fig. 11 and Table 4). Initially the response of the column showed an increase in displacement without a corresponding increase in load. This behavior may be attributed to the low-strength *Sarooj* jointing mortar. The load then picked up once the jointing mortar between the stone layers could not be further compressed and the stone layers became effective in the load carrying mechanism. Upon reaching the ultimate load, longitudinal cracks started to develop in the column sides as a result of the lateral tensile stress or Poisson's effect (Fig. 12). The cracks then enlarged and expanded until separation in the masonry column occurred and portions of the columns collapsed, causing brittle failure of the column.

The strengthened column (CCM2) showed superior performance from the start due to the confining effect of the textile reinforced mortar (TRM) jacket around the column (Fig. 11). It has been reported by many studies (Saadatmanesh *et al.* 1994; Shirmohammadi *et al.* 2015) that using steel jackets or FRP wrapping around reinforced concrete column leads to a multifold increase in the axial load in

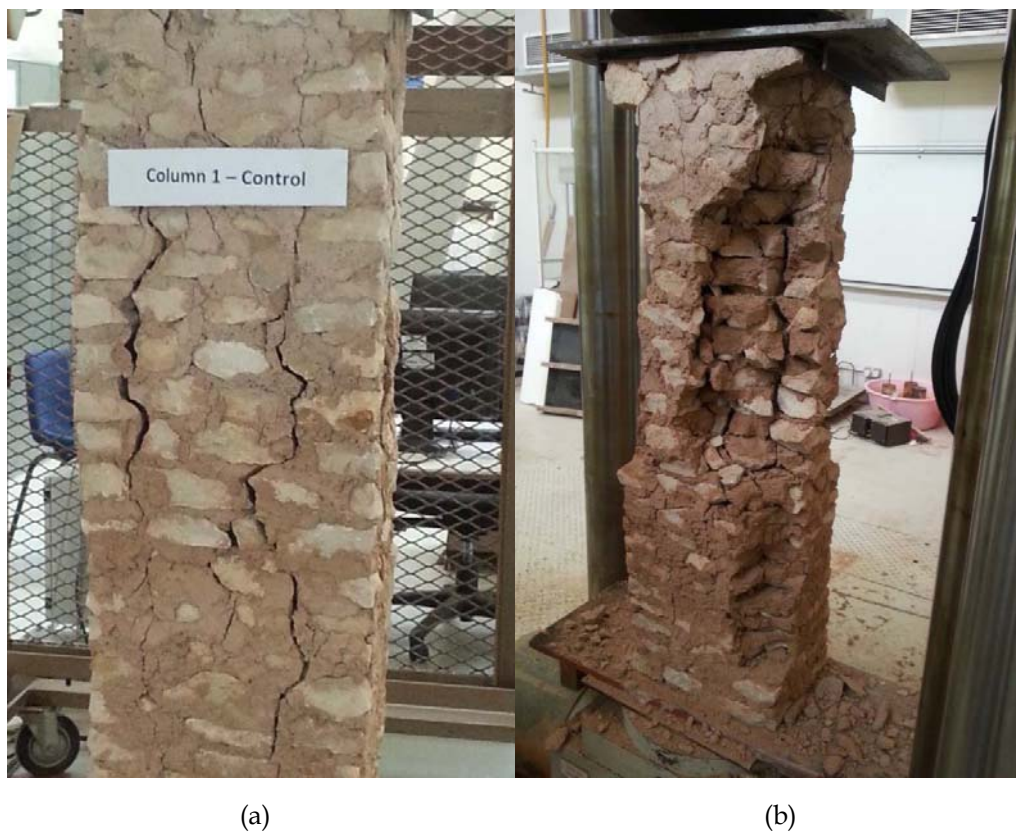
Figure 12. Column CC: (a) Longitudinal cracks development, and (b) At failure of column.

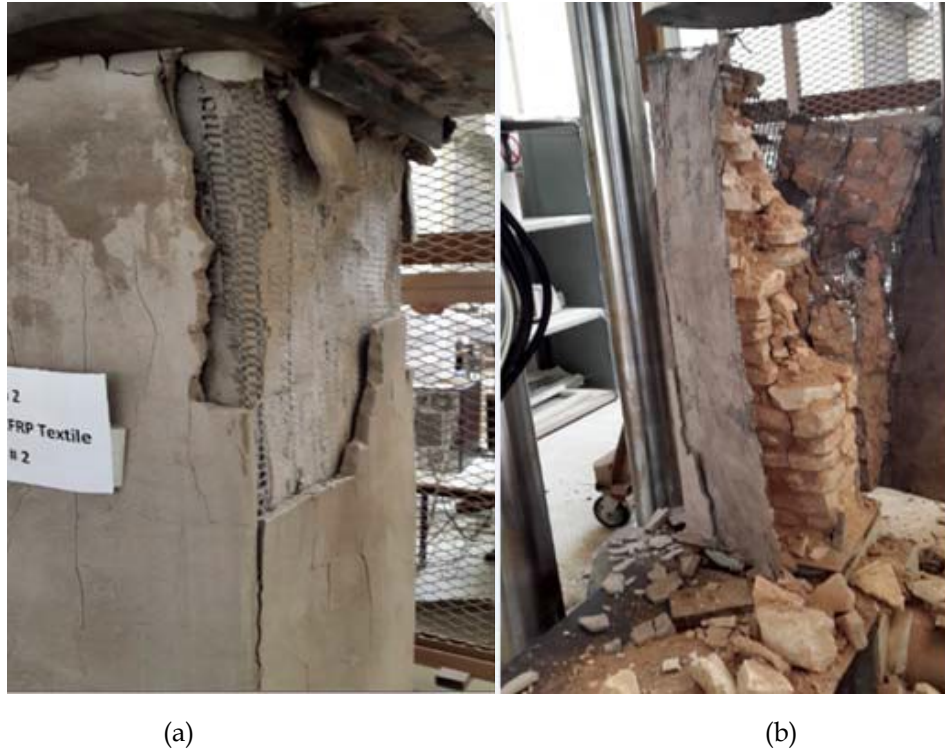
**Figure 13.** Column CCM2; (a) Outer mortar layer peeled off; (b) TRM jacket opened up at the overlapping and failure of the column.

kN at a corresponding top displacement of 26.2 mm. The failure was initiated by cracks which developed at the column sides followed by the outer plaster layer peeling off. The inner plaster layer then started to crumble at the top

of the column as the masonry expanded in the transverse direction and due to the high compressive stress at this stage. The textile started to rupture at one of the column edges in a localized manner due to stress concentration at the corners. The TRM jacket finally debonded at the overlap, causing the wrapping to open up and leading to the column's partial collapse (Fig. 13). Comparing the response of the CC and the CCM2 shows a considerable improvement in both the axial load capacity as the CCM2 was seven times that of the CC and reflected a 600% increase in the axial load capacity. Similarly, the displacement at the ultimate load attained in CCM2 was 3.2 times that of the CC, or a 216% increase, indicating an increase in the ductility of the strengthened column. Due to the failure of the wrapping at the overlapping part, it is recommended to extend the overlap to cover the entire face of the column in which the wrapping of the textile has started.
