Interior of the IBC Building in Presidente Prudente, Brazil

Investigation of historic, constructive, spatial and pathological aspects regarding the IBC (Instituto Brasileiro do Café) in Presidente Prudente, Brazil

Laura Karin Grothues¹, Cesar Fabiano Fioriti²

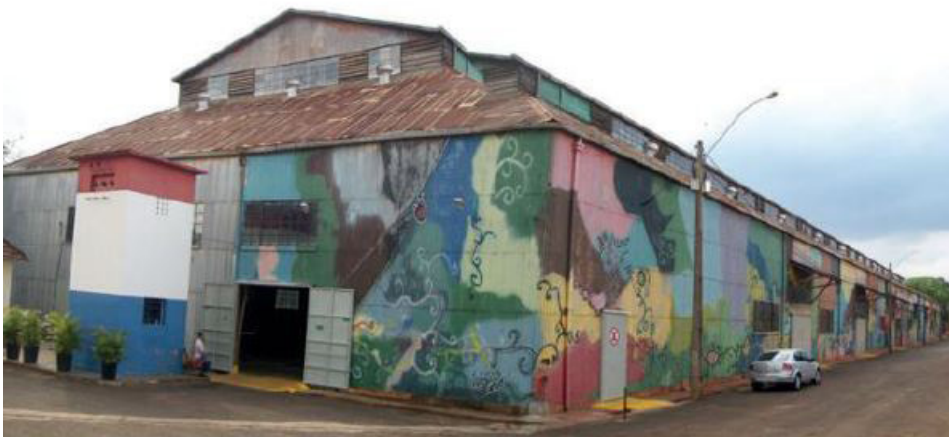
In 1998 the function of the IBC was transferred to the Ministry of Planning (Périco; Baron, 2014) and the shed was left unused (Fig.3).

Figure 3.
IBC before the revitalization
(source: Martins; Fioriti, 2015).

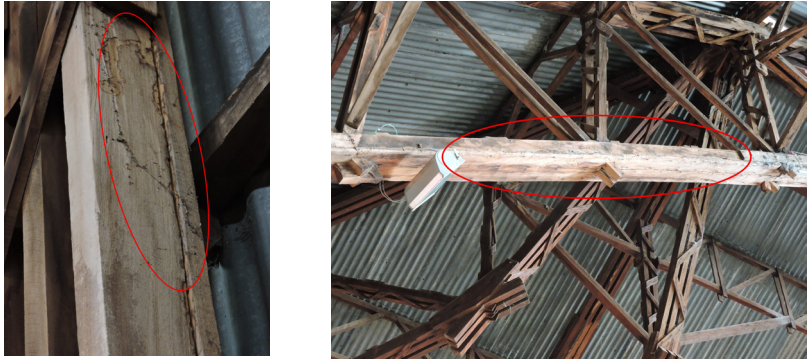
Wood is a material especially susceptible for biotic attacks e.g. by insects or fungi. These attacks don't cause mechanical problems, but they can increase the permeability and change the colorations of the surface. This will decrease its resistance to other negative influences. Another form of attacks through insects cause pipes on the surface area. This pathology is difficult to detect and to heal. The loss of strength depends on the volume of material which was consumed by the insects (Martins; Fioriti, 2015; Botelho Junior, 2006).

PATHOLOGICAL MANIFESTATION	NUMBER OF THE AFFECTED PORTICOS	EXAMPLES
Biotic attacks	n.19

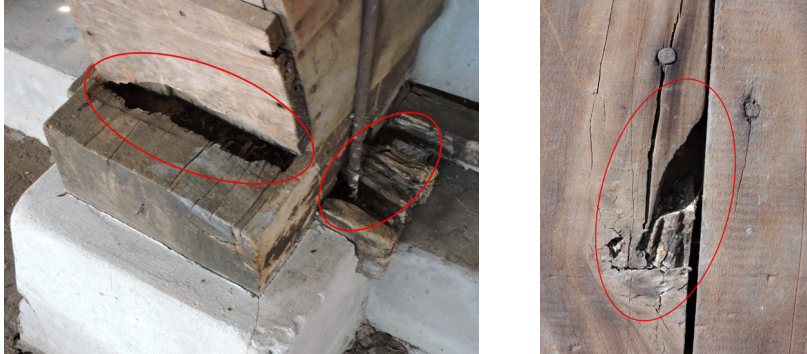
Fissures are one of the pathological manifestations that are common in the wood construction, too. Rot of pieces could be determined only at 5 points of investigations. Nevertheless, this anomaly can become a big problem, because it influences the load capacity of the construction.

Rot of pieces	n.5

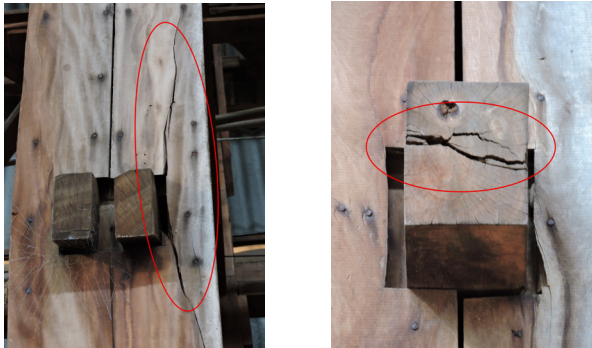
Fissures	n.16

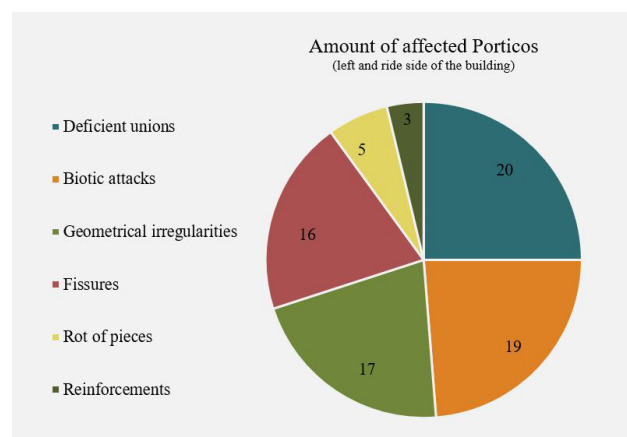
Figure 5.
Diagram about the amount of affected porticos.

The results show, that deficient unions and biotic attacks are the most common anomalies (Fig.4, Fig.5). Almost every of the 22 porticos suffer from these problems. Indeed, these problems often affect only a part of the portico. In addition to deficient unions and biotic attacks, a lot of geometrical irregularities could be determined. These deformations affect the whole portico and they are very difficult to prevent. Three of the porticos show critical deformations so that an additional support in form of a reinforcement out of metal or wood was necessary.

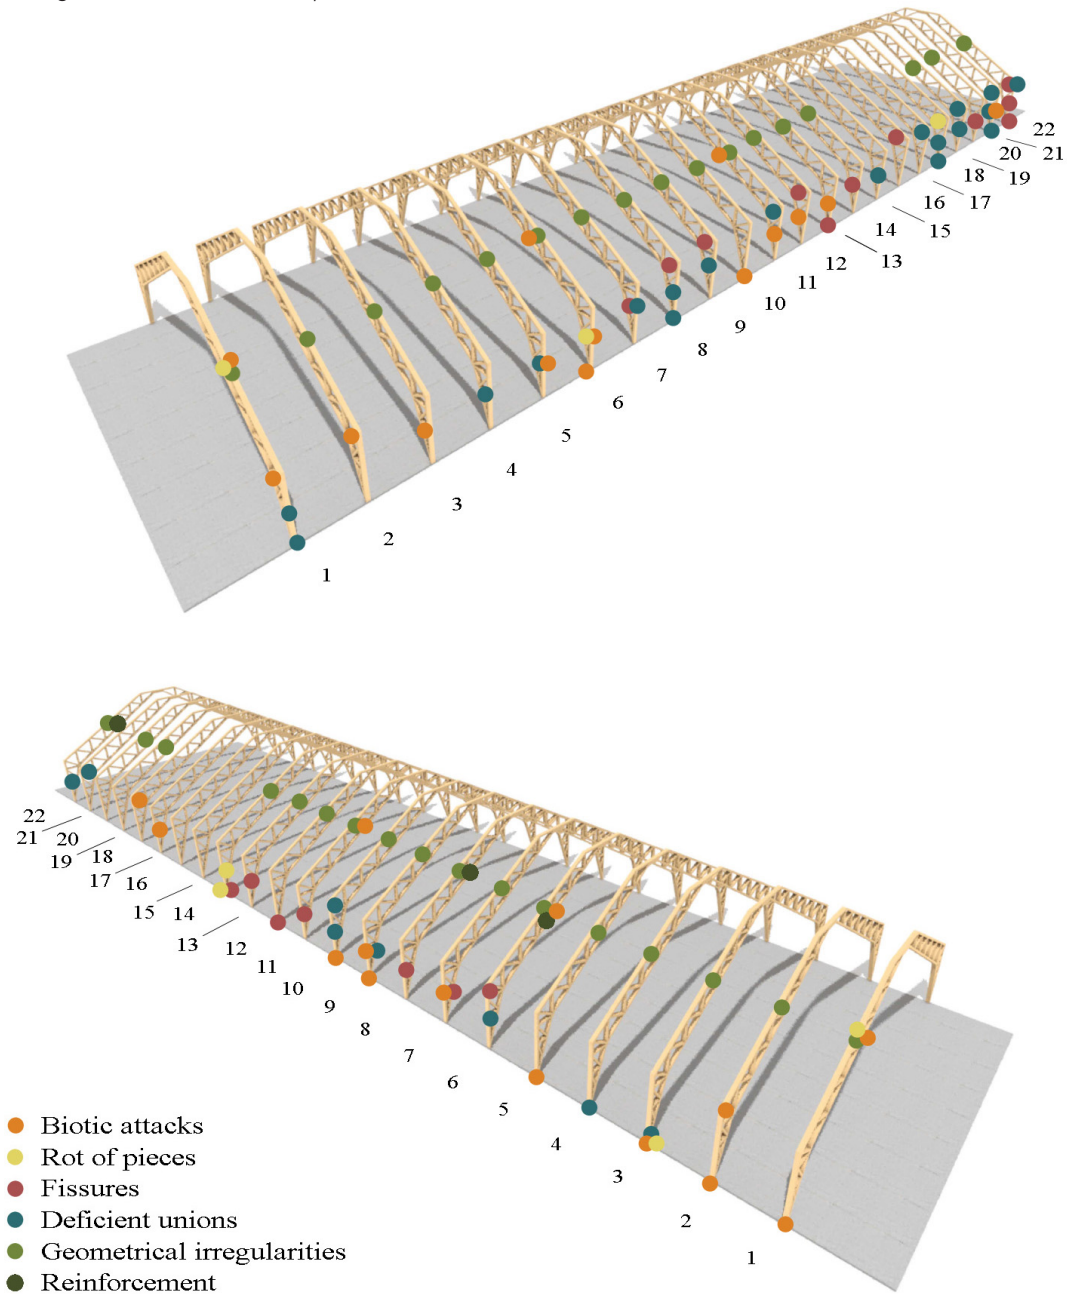
Figure 7.
Location of pathological manifestations at the porticos.

As we can see in Figure 7, the right side of the building shows a huge amount of deficient unions. Most of them are missing completely. Especially in the back part of the IBC deficient unions reduce the stability of the wooden construction. The appearance of biotic attacks is very common as well, even more than on the other side of the building.

In the right side of the building the problem of fissures affects only a few points of investigation. Nevertheless, it should also be mentioned, that the last portico (number 22) suffers from fissures, which affect almost the whole portico. Together with deficient unions and geometrical irregularities this portico suffers from serious problems.

In addition, the figure shows, that almost every Portico suffers from geometrical irregularities, which affect great parts of the beam. When this problem occurs, the other side of the portico is affected as well. For specially affected areas a reinforcement became necessary. These reinforcements can be found only on the left part of the building.

The left side of the building shows more pathological manifestations (Fig.7). A great number of porticos are affected by fissures, deficient unions and biotic attacks. Happily, the rot of pieces is not a common pathological manifestation in the IBC Building. Only at portico number 14 the rot means a huge problem. There, we can observe signs of rot at the base as well as at the pillar of the portico.

Comparing both sides of the IBC it is getting clear that the right side suffer a lot from different kinds of pathological manifestations, especially in the back area. From portico number 8 until portico number 22 almost every portico shows more than one kind of anomaly. The left side of the building is less affected. There the biggest problems show up in the middle area at the porticos 6 to 14. Here, especially deficient unions don't matter as much as on the right side of the IBC. Since the pathological manifestations affect the proper function of the building it is of great importance to prevent further damages trough an appropriate

maintenance management and restauration. Most of the anomalies could be minimized if there was a preventive periodic maintenance. It is very important to remove dirt and accumulations of moisture to protect the wood from humidity. Also, the drainage system should be cleaned regularly, broken parts of the roof should be repaired as soon as they occur, and the protective coating should be restored on time (Martins; Fioriti, 2015). Until now it was not possible to take a sample to study the material properties more intense, because this would have destroyed the wood. For this reason, the analysis could be operated only superficially and some questions regarding the inner structure of the wood remain open.

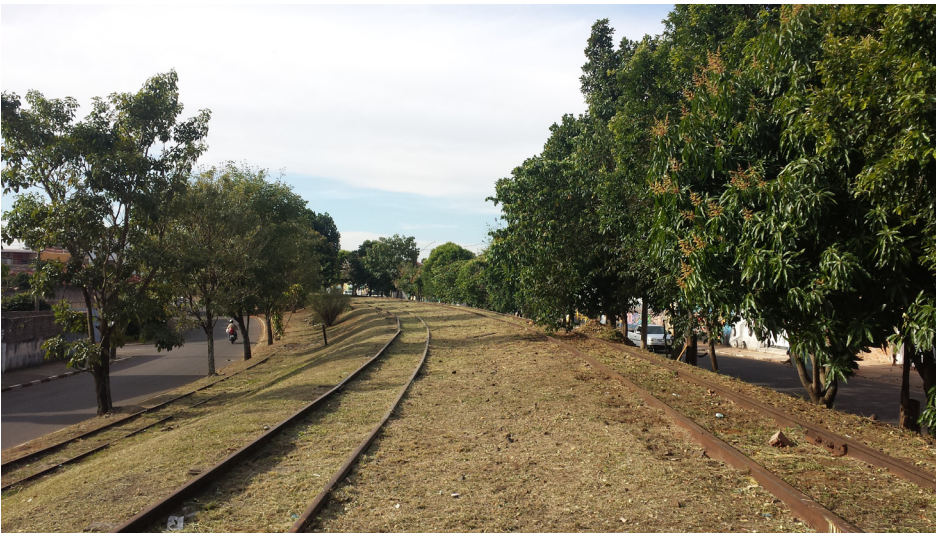
Figure 10.
*Abandoned railway in
the center of Presidente
Prudente.*

Therefore, the railway in Presidente Prudente is a missed opportunity. Until now, it is an unused and

dead area, directly in the city center (Fig. 10).

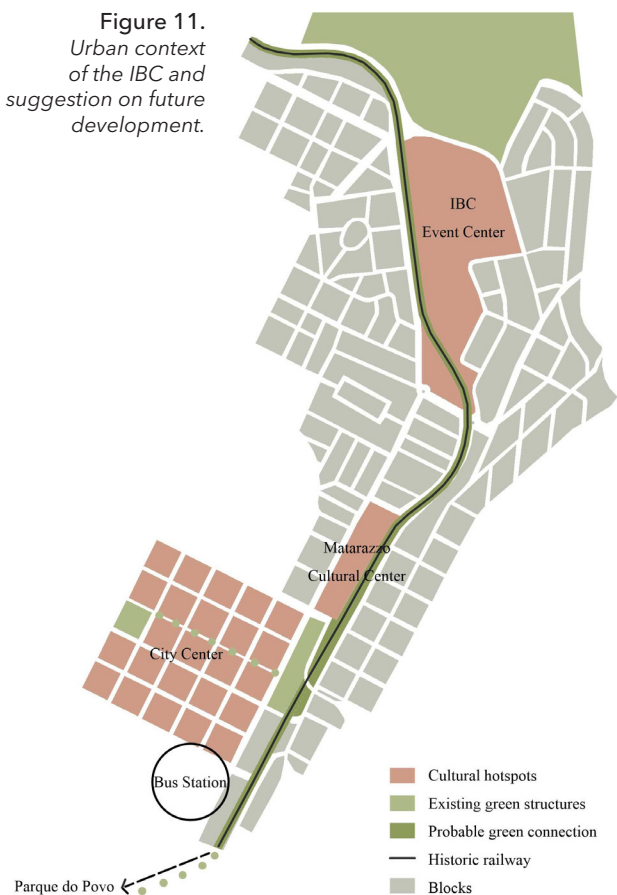
As we can see in Figure 11, a pedestrian path on the old railway could build up a historic and cultural corridor, which include the IBC, the Matarazzo and the old railway station (Fig.13). On this path there could be established a link to the history of Presidente

Figure 11.
Urban context of the IBC and suggestion on future development.
