ANNALS OF GEOPHYSICS, 62, 3, SE341, 2019; doi: 10.4401/ag-8019

"CHARACTERIZATION OF HISTORICAL MASONRY MORTAR FROM SITES DAMAGED DURING THE CENTRAL ITALY 2016-2017 SEISMIC SEQUENCE: THE CASE STUDY OF ARQUATA DEL TRONTO"

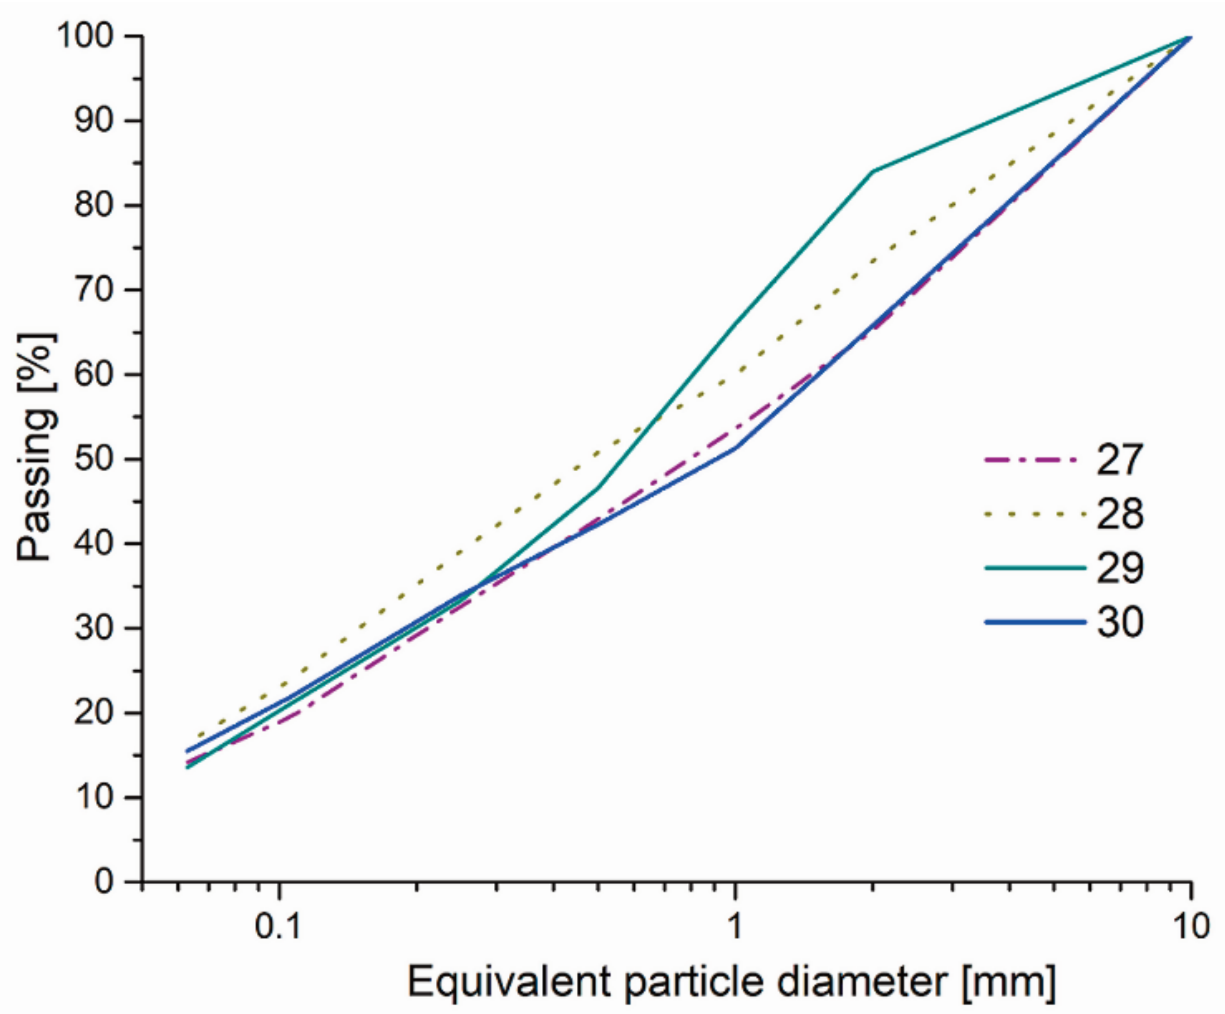
Particle–size distribution highlighted the preponderance of a fine fraction in mortar samples, especially those from Pretare, as shown in Figure 4.

FIGURE 4. Particle–size analysis.

In some cases the finer fractions, smaller than 0.5 mm, constitute more than 40% of the entire aggregates.

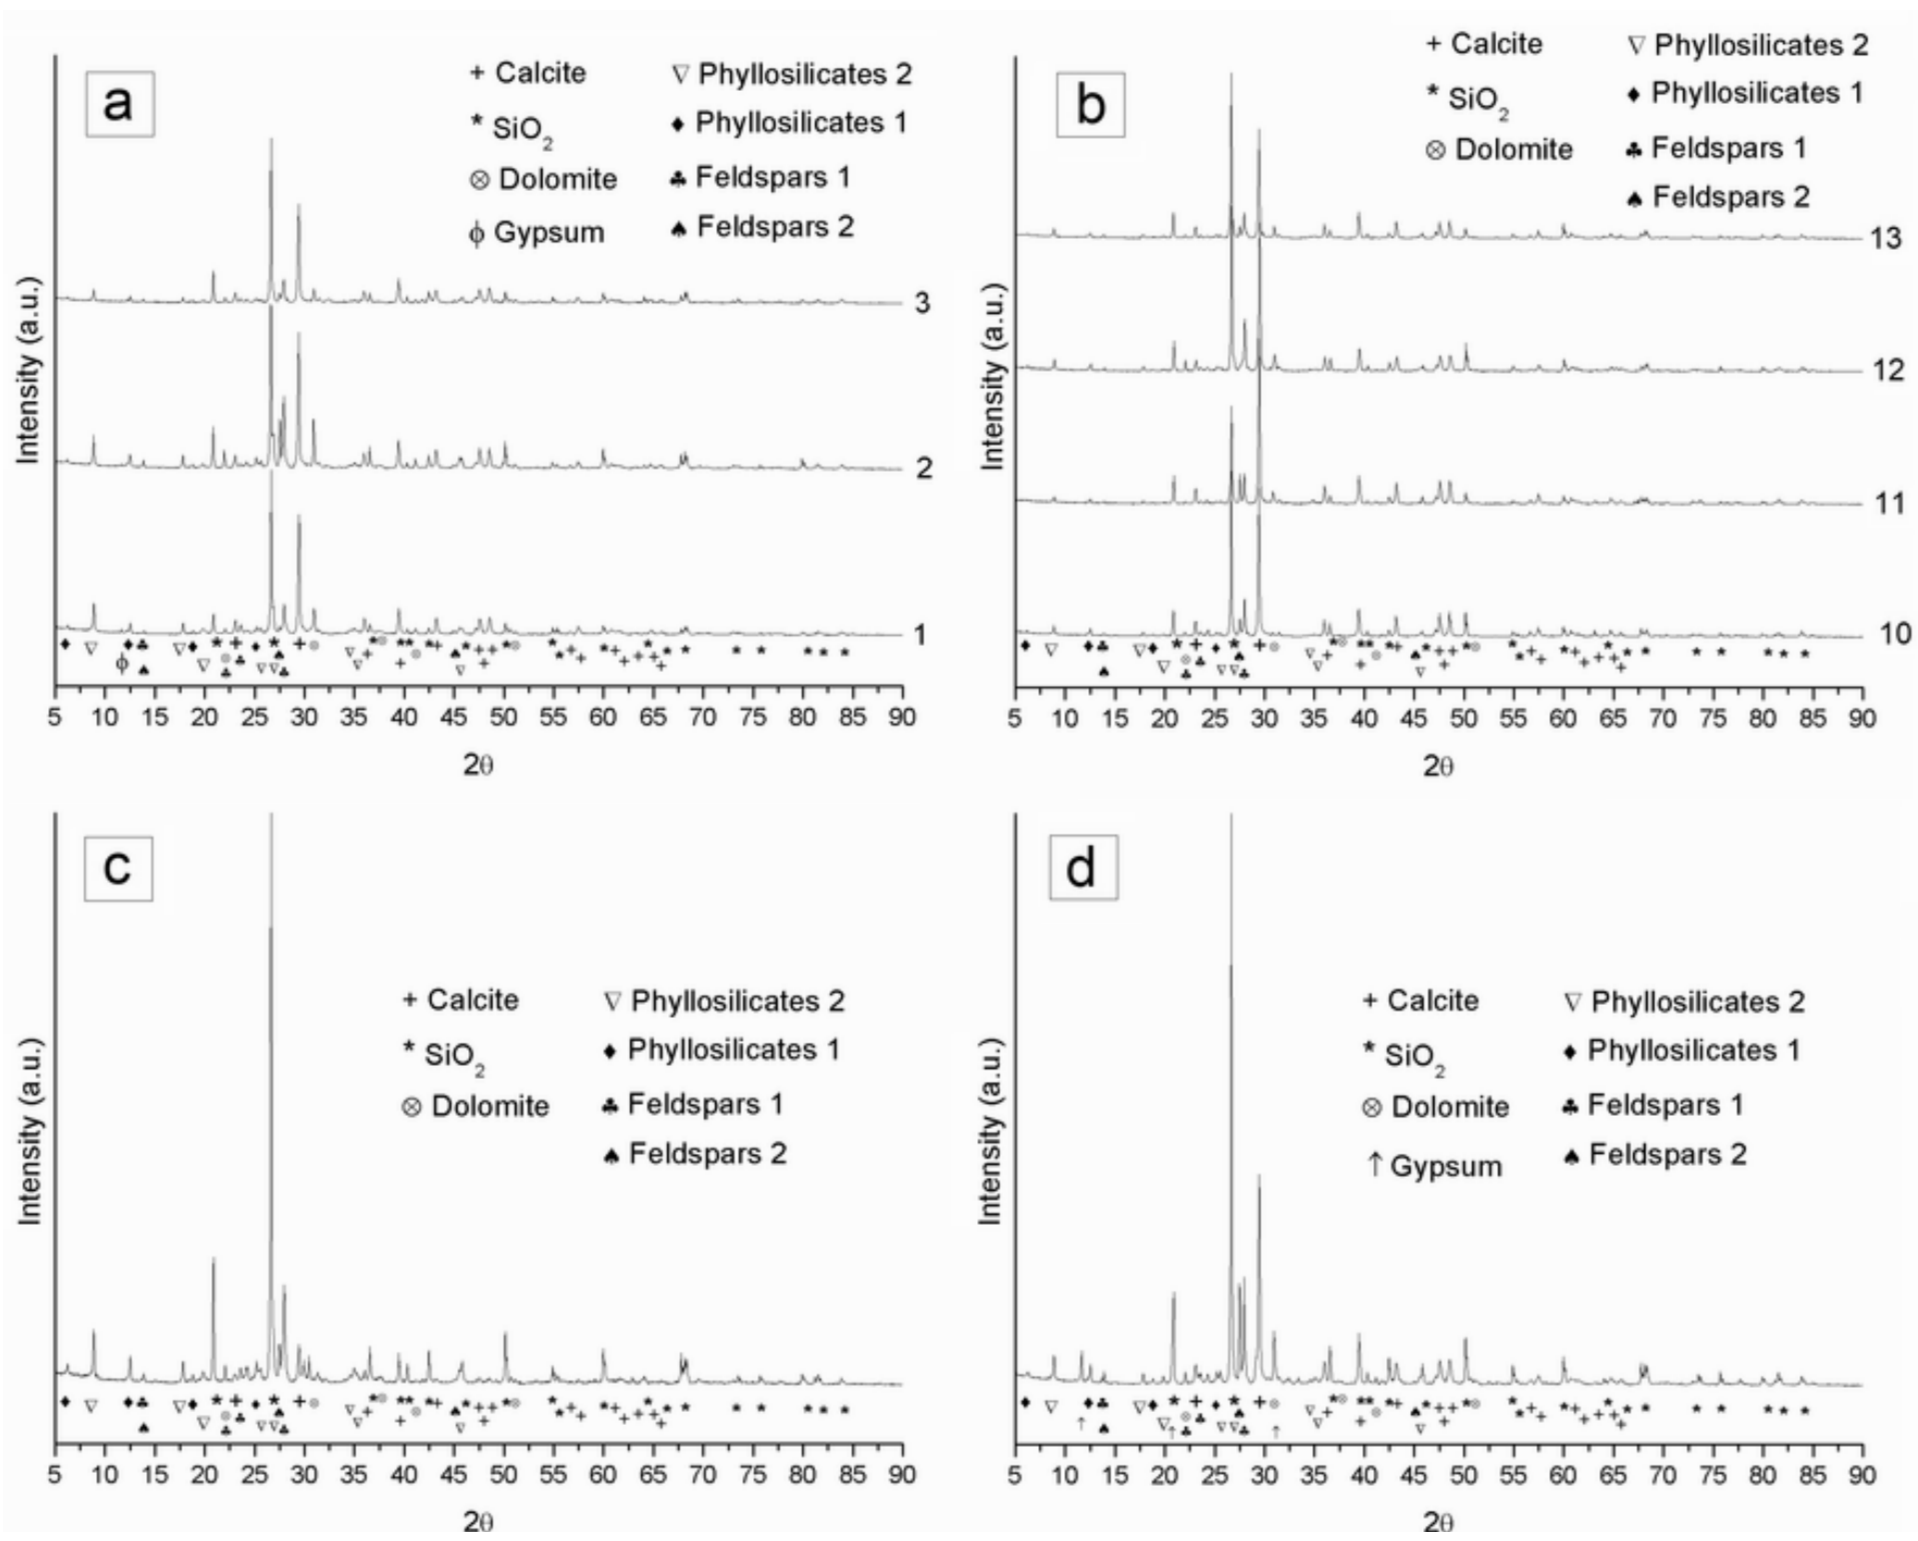
In Figure 5 XRD patterns of mortars from Arquata del Tronto (1, 2, 3), Camartina (10, 11, 12, 13), Faete (14) and Trisungo (24) are shown. The samples from Arquata presented principally quartz, calcite, phyllosilicates, feldspars and dolomite, in particular in sample 2 and some traces of gypsum. Same phases were identified in the samples from Camartina, even if only traces of dolomite were present while gypsum was absent. Sample 11 from Camartina presented higher quantity of calcite with respect to the other samples. Material sampled in Faete revealed small quantity of calcite, being quartz the most abundant phase. The sample from Trisungo presented similar phases respect to those from Arquata but also gypsum and lower concentrations of calcite. It has to be noted that no crystalline phases related to hydraulic binders have been detected in all the samples investigated. X-Ray diffraction data could give important indication about binder and aggregates even if it should be considered that the detection limit of the technique is about 1 wt%. Moreover, eventual non crystalline phases deriving from carbonation and hardening, as amorphous calcium silica gel (C-S-H), deriving from hydration of cement, could not be detected. In some samples large quantities of calcite have been detected being probably related in part to aggregate fraction [Chiari et al., 1992].

The dolomite recognized in the samples was probably used as aggregate, because peaks related to hydromagnesite and hydrated magnesium carbonate hydroxide have not been detected in the XRD patterns. The presence of hydromagnesite deriving from mortars with binders deriving from dolomite as precursor is still controversial [Montoya et al., 2003].

FIGURE 5. XRD patterns of samples from a) Arquata del Tronto (1, 2, 3), b) Camartina (10, 11, 12, 13), c) Faete (14) and d) Trisungo (24).

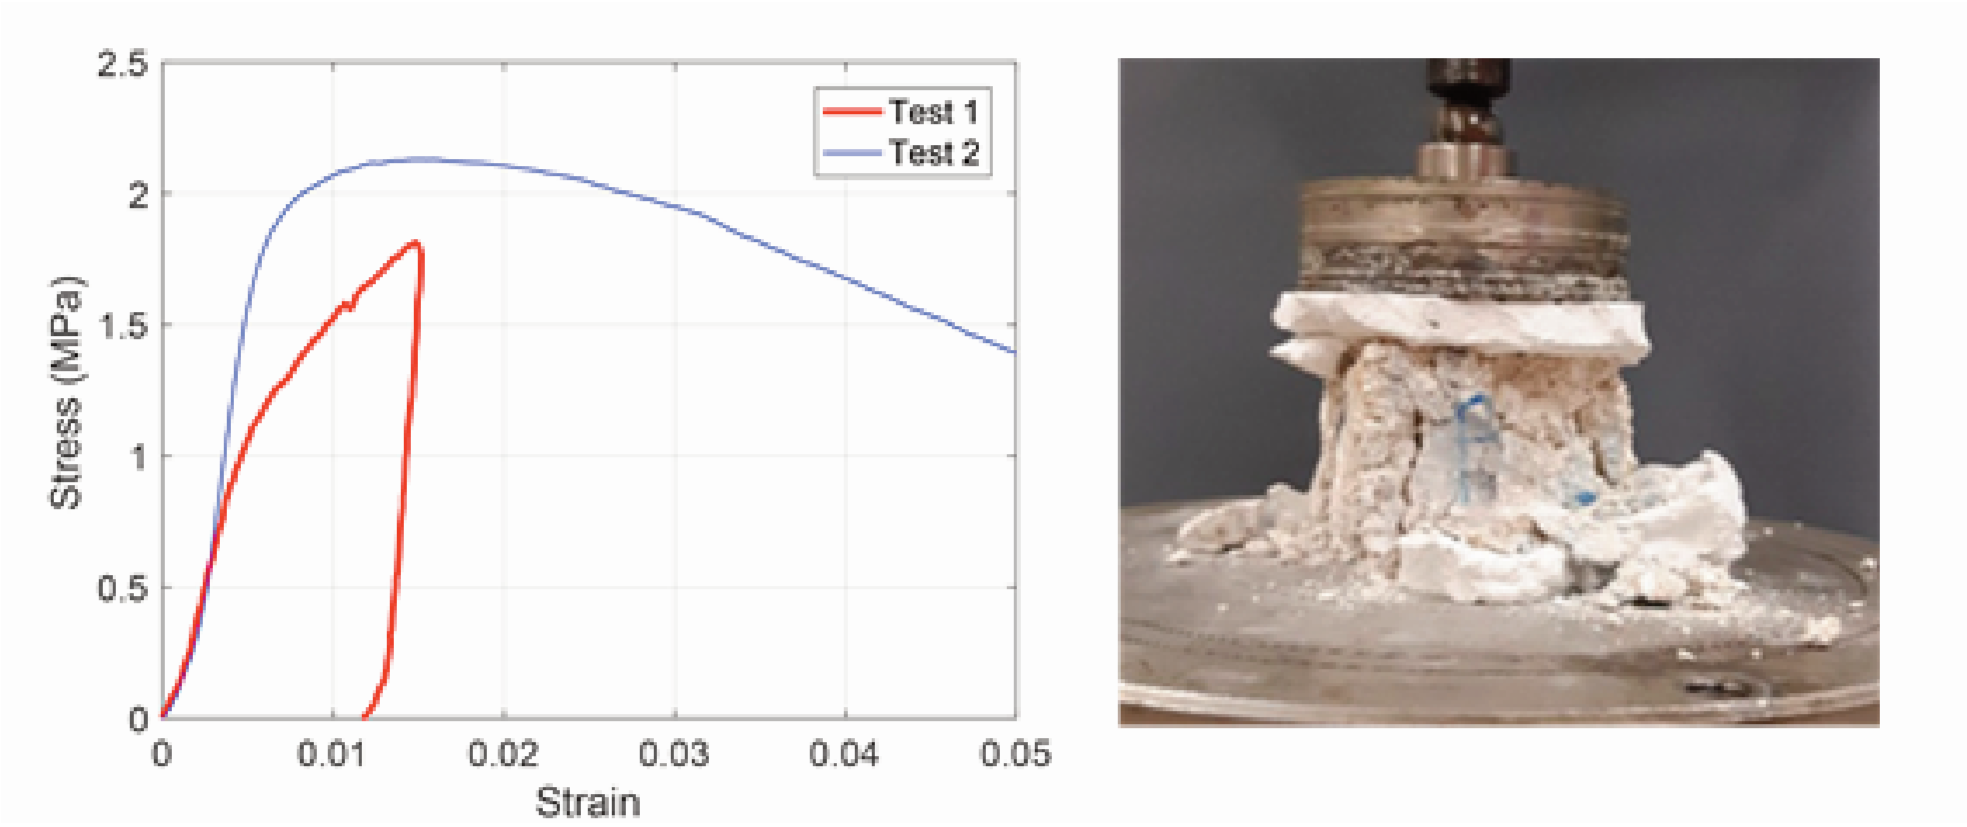
For sample 17.1, a first test was performed that did not reach failure, and a second test until failure. For sample 17.2, failure was reached at the first test. For each sample, the stress-strain curve is reported in Figures 7-8, along with a picture of the sample at the end of the test.

FIGURE 7. Sample 17.1: left, stress–strain curve; right, sample at the end of the test.

The two samples highlight an almost perfect match in terms of strength, but a significant difference in terms of strain at ultimate load. Such difference could be ascribed to sample scatter, to disturbance introduced during sample preparation or, more likely, to the fact that sample 17.1 underwent a first test before the failure one. The strength value can be compared with the 60 values collected from literature in [Liberatore et al., 2014] for clay brickwork: there are six samples with a smaller strength (the smallest being 0.28 MPa). If the 42 sample of tuffwork in [Marotta et al., 2016] are considered, Arquata's samples are larger of just four values (minimum value 0.55 MPa). Additionally, it is worth emphasising that the current Italian building code [DMIT, 2018] prescribes a minimum strength of 2.5 MPa for ordinary loads (Sect. 11.10.2), and 5.0 MPa under earthquake loads (Sect. 7.8.1). Instrumental error of the load cell is declared by the manufacturer as ±0.5%, and the same error can be assumed for strength estimation.

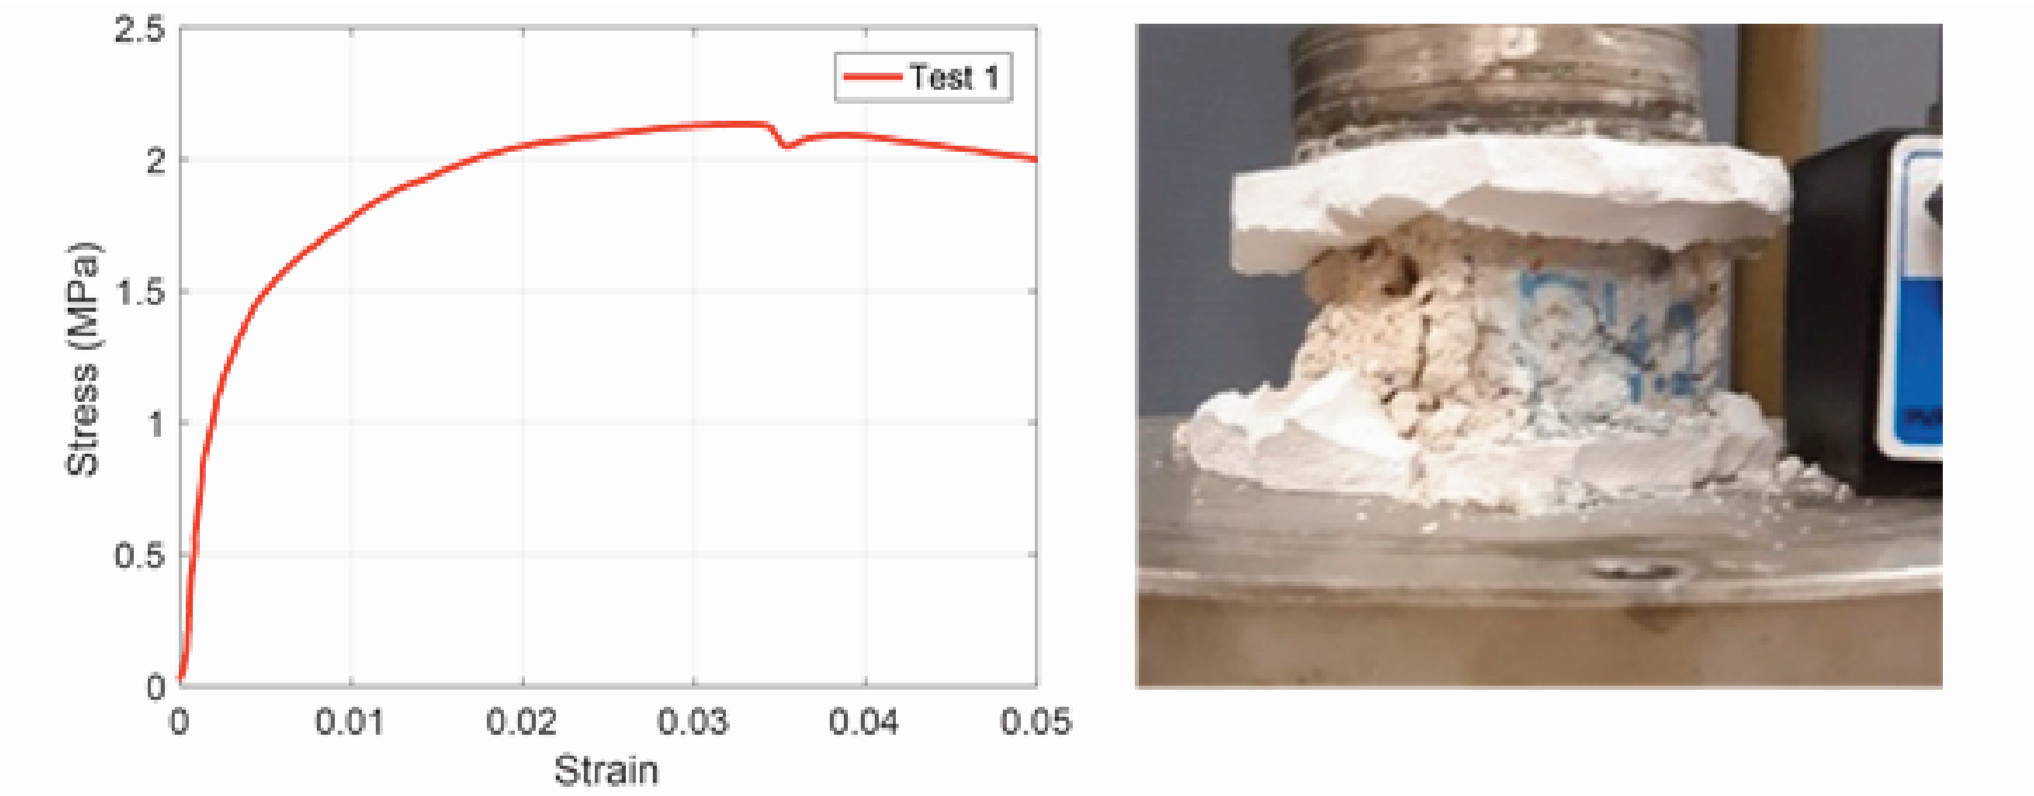
FIGURE 8. Sample 17.2: left, stress–strain curve; right, sample at the end of the test.
