# NATIONAL TRANSPORTATION SAFETY BOARD

## RAILROAD ACCIDENT REPORT <sup>2110.</sup>

HEAD-ON COLLISION OF CHICAGO,  
SHORE AND SOUTH BEND RAILROAD  
TRAINS NOS. 123 AND 218  
GARY, INDIANA  
JANUARY 21, 1985

NTSB/RAR-85/13.

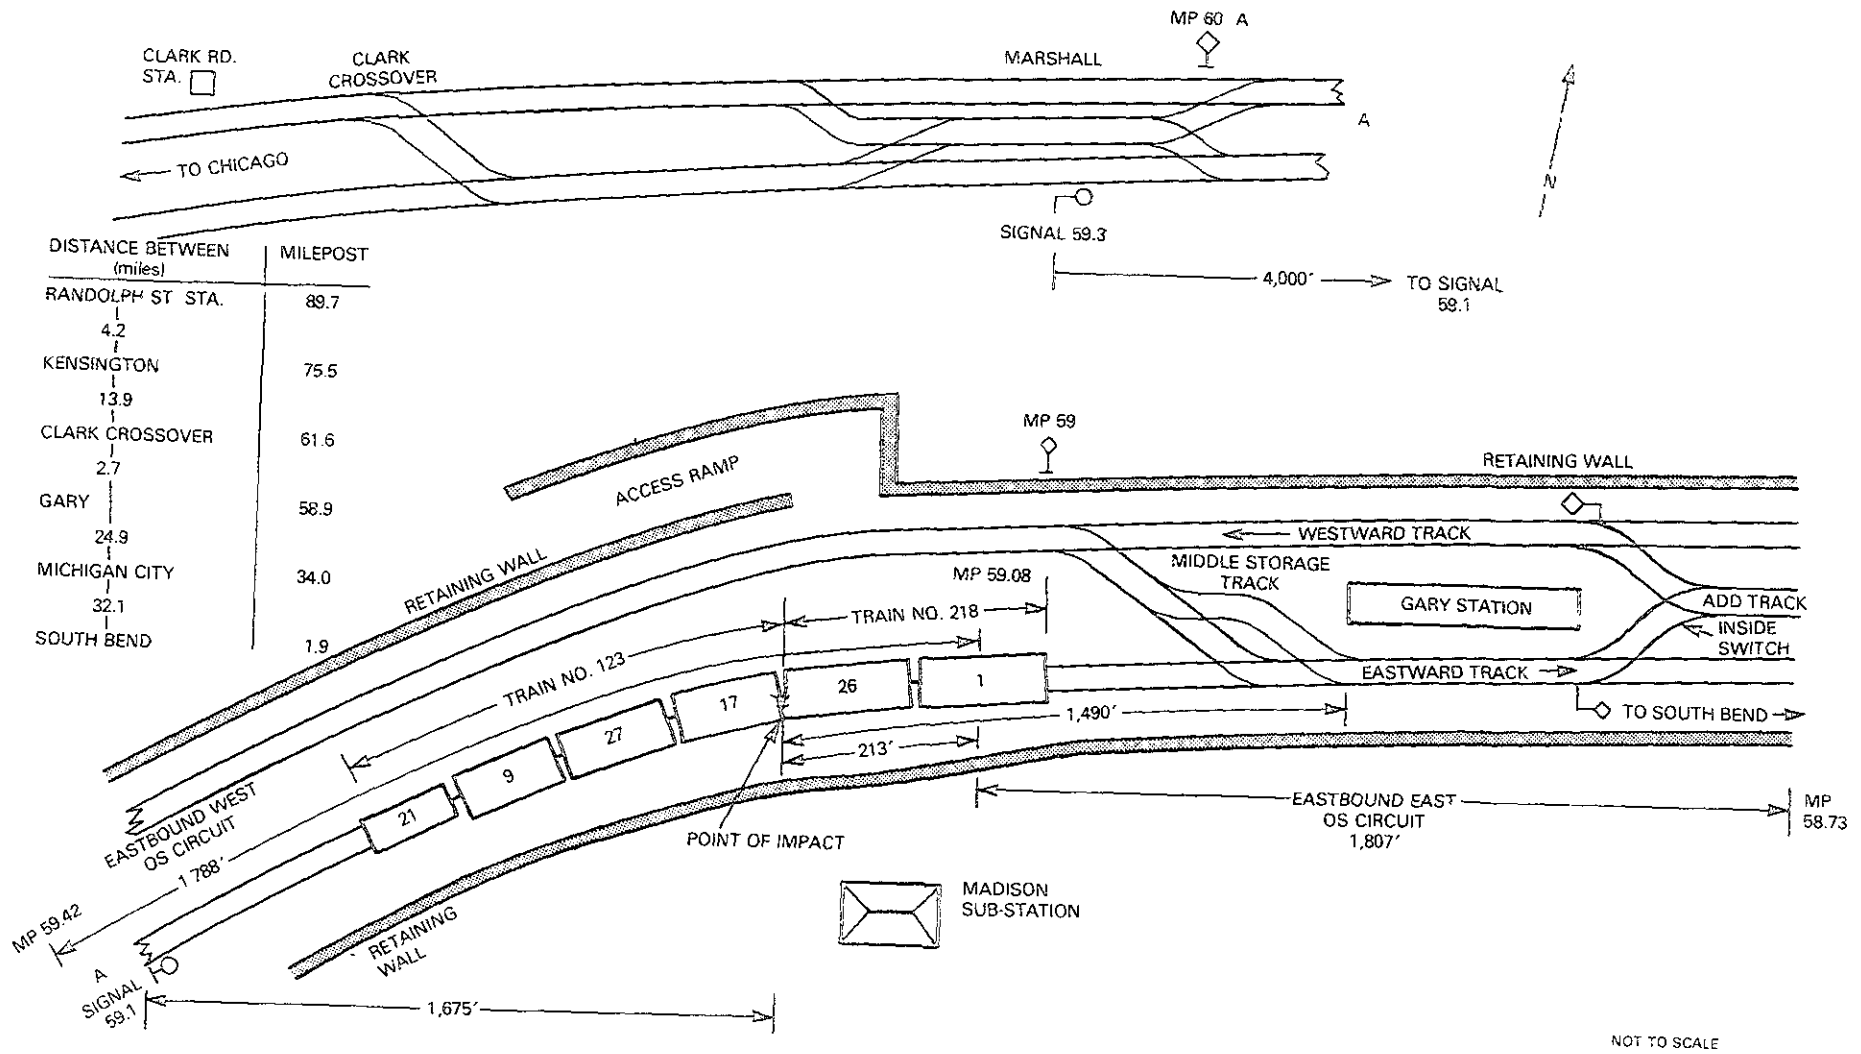
Figure 1.--Plan view of accident site.

The notice eliminated the requirement for the train dispatcher to issue a train order to move each train between the track limits specified in the notice. All the area covered by the notice was within Gary yard limits. (See figure 1.) The notice was posted about 10:15 a.m. on January 21, 1985, at the reporting point for traincrews and enginecrews in Michigan City. About the same time, copies of the notice were forwarded by a train messenger to be posted at the Randolph Street Station in Chicago.

Under single-track operating rule No. S-71 (Timetable Special Instructions) on the South Shore, a westbound train is superior to an eastbound train, i.e., an eastbound train must clear the main track if it meets a westbound train of the same class. Opposing trains of the same class 14/ are allowed to meet on "flat time," which means that an eastbound inferior train complies with operating rule No. S-71 if it clears the main track at a designated point before a westbound superior train is scheduled to leave that same point. For trains of the same class, no clearance margin of time is required. South Shore operating officers said that train No. 123 should have cleared the track for train No. 218 at Clark Crossover (by remaining west of the crossover) or at Marshall, or at the west end of Gary Station before 6:50 p.m., the scheduled departure time of train No. 218. (See figure 1.)
