# PROPOSAL FOR SECURING A ROCK MASSIF NEAR BEROUN RAILWAY STATION

**ABSTRACT.** The proposal concerns the securing of a 100 m long section of the rock slope along the lead track at Beroun railway station, where a relatively massive rock block collapsed in June 2016. The rock slope is about 30 m high and its character is mainly determined by the orientation of several discontinuity systems. It was proposed for the most dangerous discontinuities that monitoring elements be used for measuring deformations at least for half a year. Dynamic barriers and protective fences were proposed for the most endangered parts of the slope.

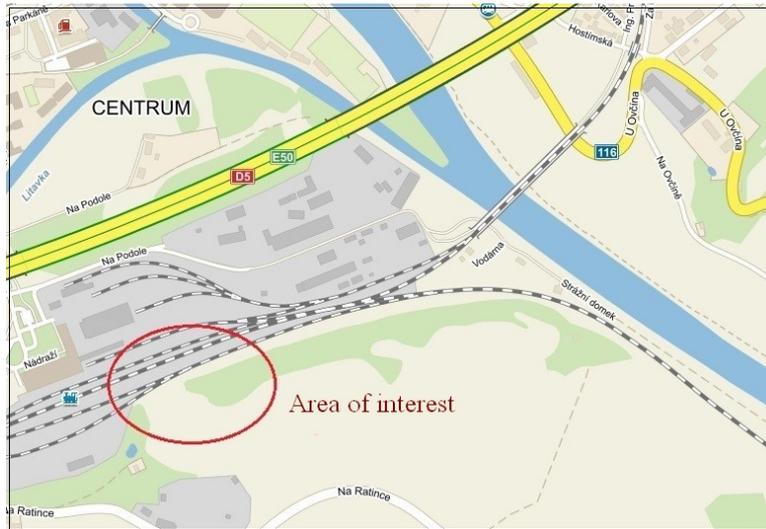
FIGURE 1. Layout of the location of concern.

The Geotechnical characteristics relate to a circa 100 m long section of the rock slope along the lead track at Beroun railway station (see Figure 1). The rock slope in the particular area is very steep, accessible only by using climbing techniques. The above-mentioned lead track runs closely along the base of the slope. That this track be open to use is very important for the organisation and smooth running of station operations.
