# Emergency Runaway Reaction - What Precedes? What Follows?

Eckhard Fiedler

BASF SE, Ludwigshafen, Process Safety GUS/AA - M 940  
 eckhard.fiedler@basf.com

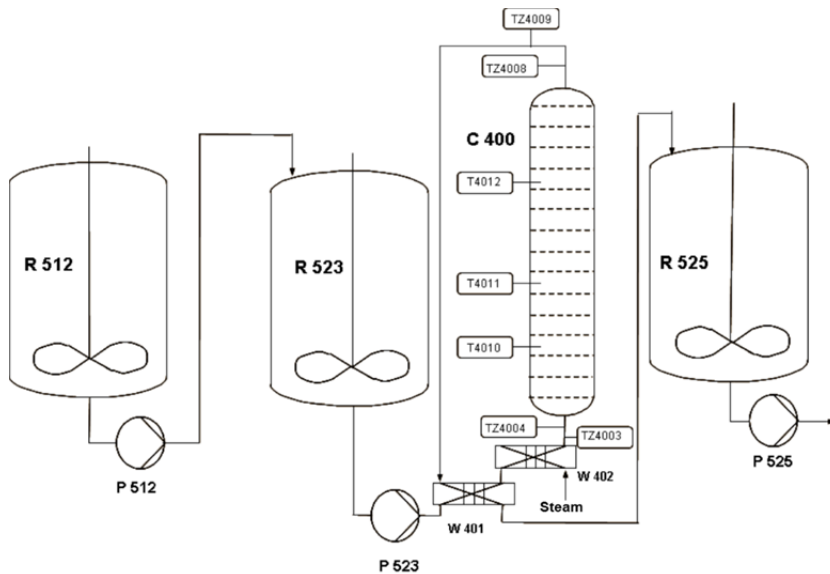
Figure 2: Reactor Cascade

According to Figure 2 the synthesis took place in a three-stage reactor cascade consisting of two stirred reactors (R 512, R 523), two heat exchangers (W 401/W 401) and a subsequent adiabatic tube reactor (C 400) for finishing. This residence time reactor had a capacity of several m<sup>3</sup>. The NTN solution is directly transferred via the heat exchanger W 401 to the next reaction step (R 525).

NTN decomposes in a gas forming, self-accelerating reaction above 90 °C with an exothermicity of - 600 J/g. The tube reactor C 400 is safeguarded by temperature control at the inlet and outlet in SIL 3 quality triggering a reactor draining to a dump vessel (not shown in Figure 2).
