# “HISTORICAL BUILDING CODES ISSUED AFTER THE STRONG ITALIAN EARTHQUAKES OF NORCIA (1859) AND ISCHIA (1883)”

Early regulations; earthquake-resistant techniques; geometrical limitations; historical earthquake engineering; standard recommendations.

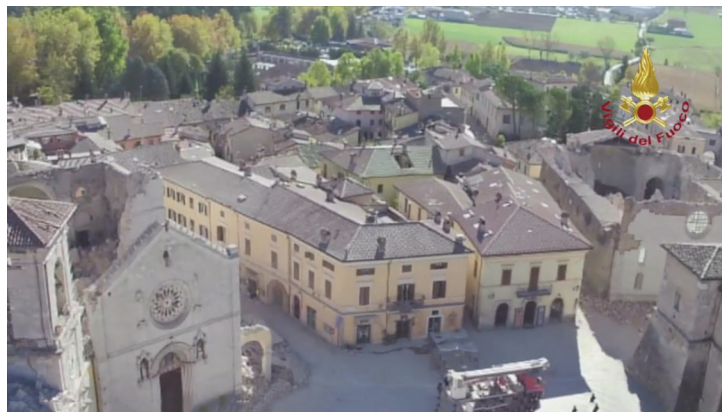
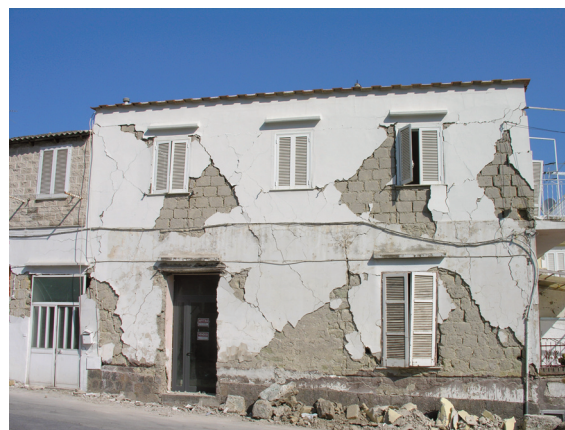
**FIGURE 2.** Example of damage occurring in: a) Norcia, after the 2016 earthquake (Snapshots from videos released by the Firefighters Corps, [www.vigilfuoco.tv](http://www.vigilfuoco.tv)) and b) Ischia, after the 2017 earthquake (photo courtesy of Antonio Formisano).

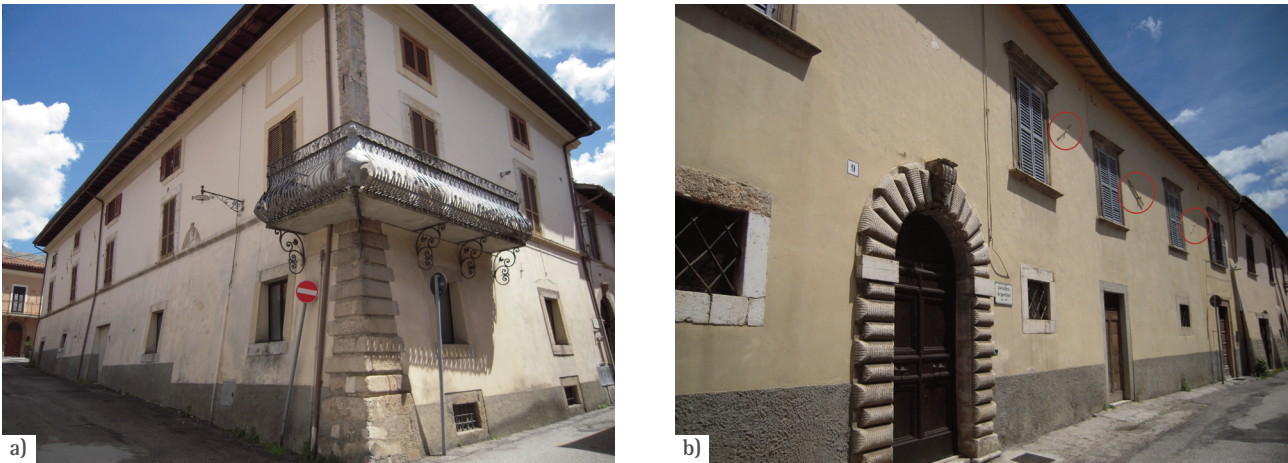
FIGURE 4. a) Example of a two-storey building constructed after the 1860 building code with basement and external walls with tapered thickness; b) Example of the extensive use of metal tie-rods in Norcia.

Nonetheless, this provision was only partially enforced in the façades of Corso Sertorio. Surprisingly, the code did not mention metal tie rods, extensively used in Norcia (Figure 4b) and elsewhere [AlShawa et al., 2018].

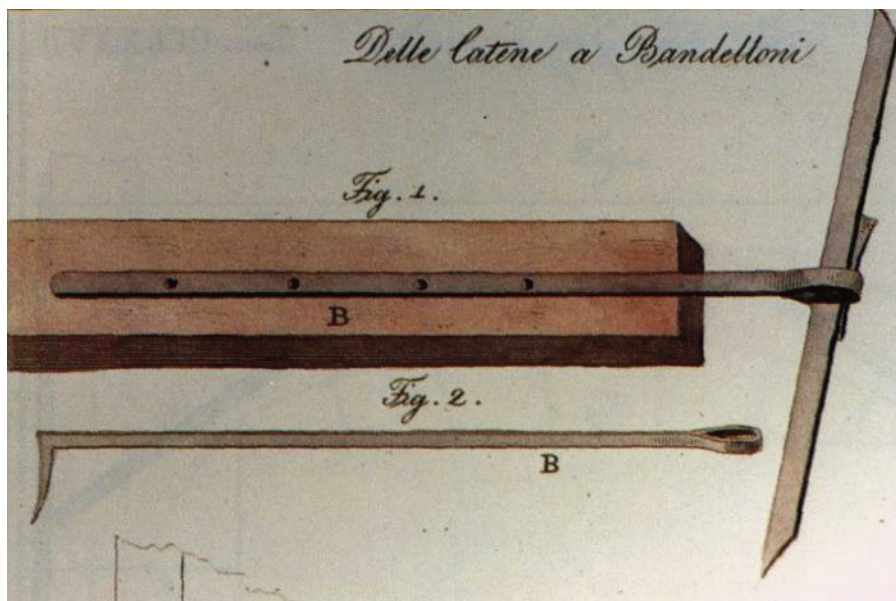
FIGURE 5. Drawings of metal wall-floor connections (Valadier [1832], tome IV, plate CCLXXVI).

Article 23 was devoted to roofs, which had to be supported by horizontal battens resting on the whole thickness of the wall, or resting on a spreader beam. All girders had to be connected to supporting walls by means of iron anchors, and there was a similar provision for horizontal floors in Article 24. Similar indications can be dated back to at least the 1<sup>st</sup> century b.C. (Ecclesiasticus 22,16) or, closer in time, were suggested in the aftermath of the 1783 Messina earthquake [Biblioteca Regionale di Messina, 1784], or in the Milizia treatise [Milizia 1785, tome 3, book 3, chapter 9, p. 190]. Therein, it was additionally recommended that all floors be at the same level, as suggested also by Camillo Morigia after the 1786 Rimini earthquake in northern Italy [Archivio di Stato di Forlì, 1787]. Drawings of metal wall-floor connections can be found in the handbooks by Valadier [1832] (Figure 5) and by Colonnetti [1953].

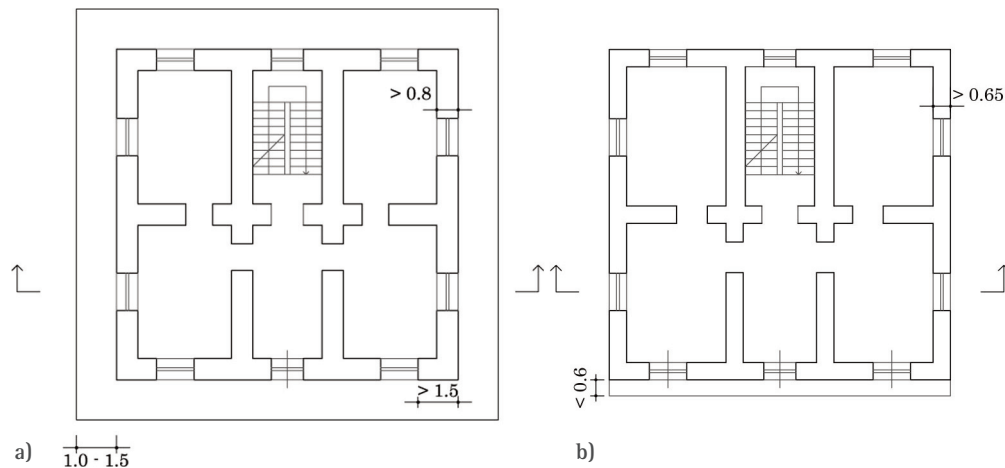
**FIGURE 6.** Exemplification of a two-storey house on stiff soil according to Giordano and Comotto's proposal for the Ischia building code: a) ground-floor; b) first-floor. All measures in m. Approved code allowed only one storey.

Furthermore, it was suggested that a single-storey (two-storey) building should rest on a 0.7 (1.2) m thick foundation mat. A basement up to 1.5 m above ground was allowed, but if absent, the foundation mat should exceed the perimeter of the building by 1.0 to 1.5 m, according to the specific site conditions (Figure 6a).

In addition to the severity of shaking and site influence, building vulnerability was properly recognized, especially in the excessive number of storeys. The two engineers, consequently, recommended restrictions, looser for timber and steel structures and stricter for masonry (p. 47). Only one floor of limited height was suggested for masonry buildings located in the high-hazard zone. According to the proposal, a second floor was permitted on lava or well-cemented tuff soils (ps. 69 and 77, Figure 6b and Figure 7a), but the approved code allowed

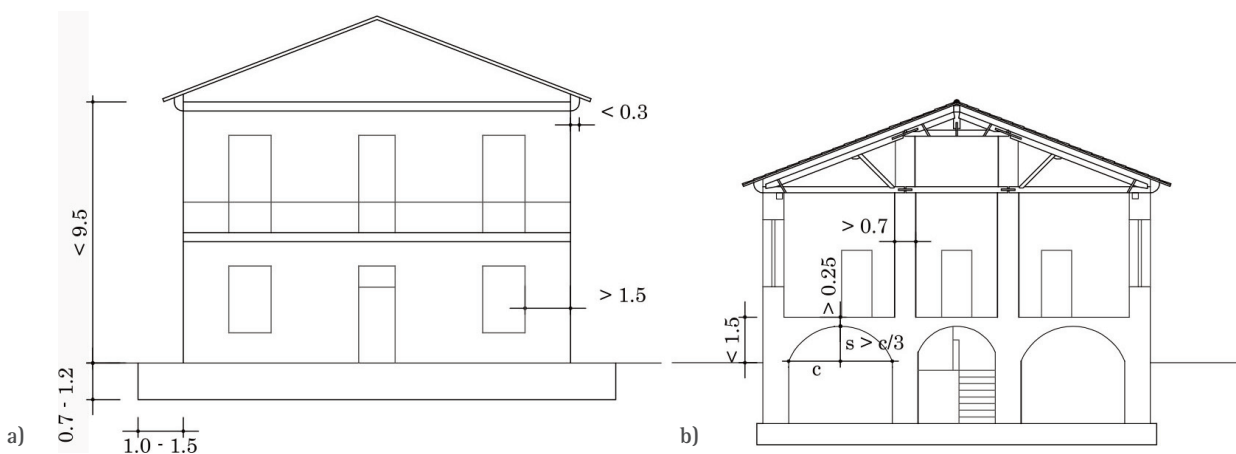
**FIGURE 7.** a) Exemplification of the elevation of the two-storey house on stiff soil according to Giordano and Comotto's proposal for the Ischia building code (approved code allowed only one storey); b) Cross section of the one-storey building allowed by the Ischia building code. All measures in m.

only one (Figure 7b). As in Norcia, in the case of existing buildings, Giordano and Comotto permitted the preservation of a lightly damaged third floor (p. 79).

tion (p. 53). In fact, in light of the inspections performed after the 2017 seismic event, the use of tie-rods was found not to be widespread on the island. In this regard, Giordano and Comotto seemed to be influenced by Milizia's [1785, tome 3, book 1, chapter 8, p. 88] opinion, that well-constructed buildings do not need these type of connections, which are just remedies for old and collapsing constructions. As in Norcia, vaults already present on the ground floor of existing buildings might be preserved, if only lightly damaged, reinforced by tie-rods and after removal of the backfill (p. 79). Otherwise, their proposal allowed basement vaults, provided they were made with good quality masonry, had span/rise ratio smaller than 3, and thickness at crown greater than 250 mm (Figure 7b, p. 70).
