Borehole logs from the Precambrian basement on Bornholm, eastern Denmark: geology and groundwater flow

Peter Gravesen, Bertel Nilsson, Per Rasmussen and Stig A. Schack Pedersen

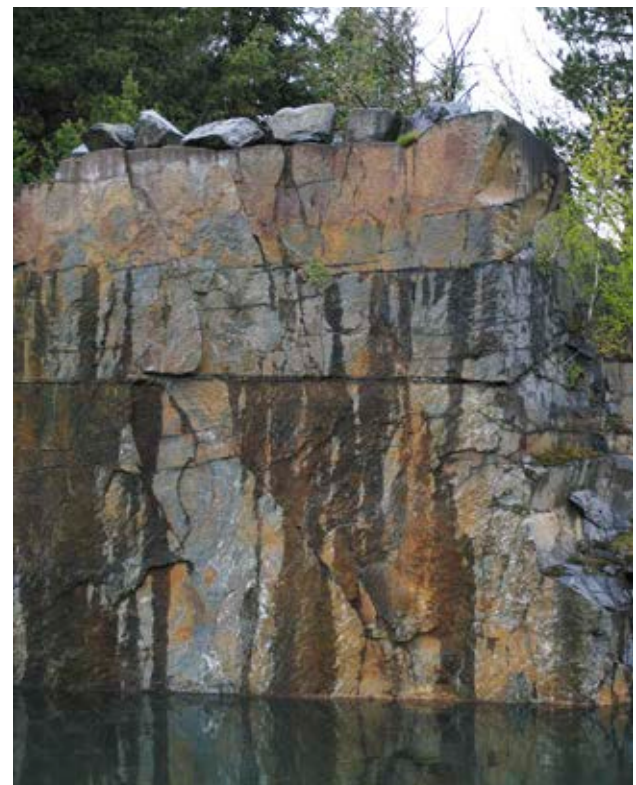
Fig. 2. Paradisbakke migmatite in Præstebo quarry at the northern rim of Paradisbakkerne. Horizontal and vertical fractures are common whereas oblique fractures are rare. The height of the outcrop is *c.* 12 m.

The rocks are cut by four fracture systems, which can be observed in quarries with Paradisbakke migmatite along the northern rim of Paradisbakkerne (von Bubnoff 1942; Fig. 2). After deformation and cooling in the Precambrian, large tectonic faults and fractures and minor vertical fractures were formed.

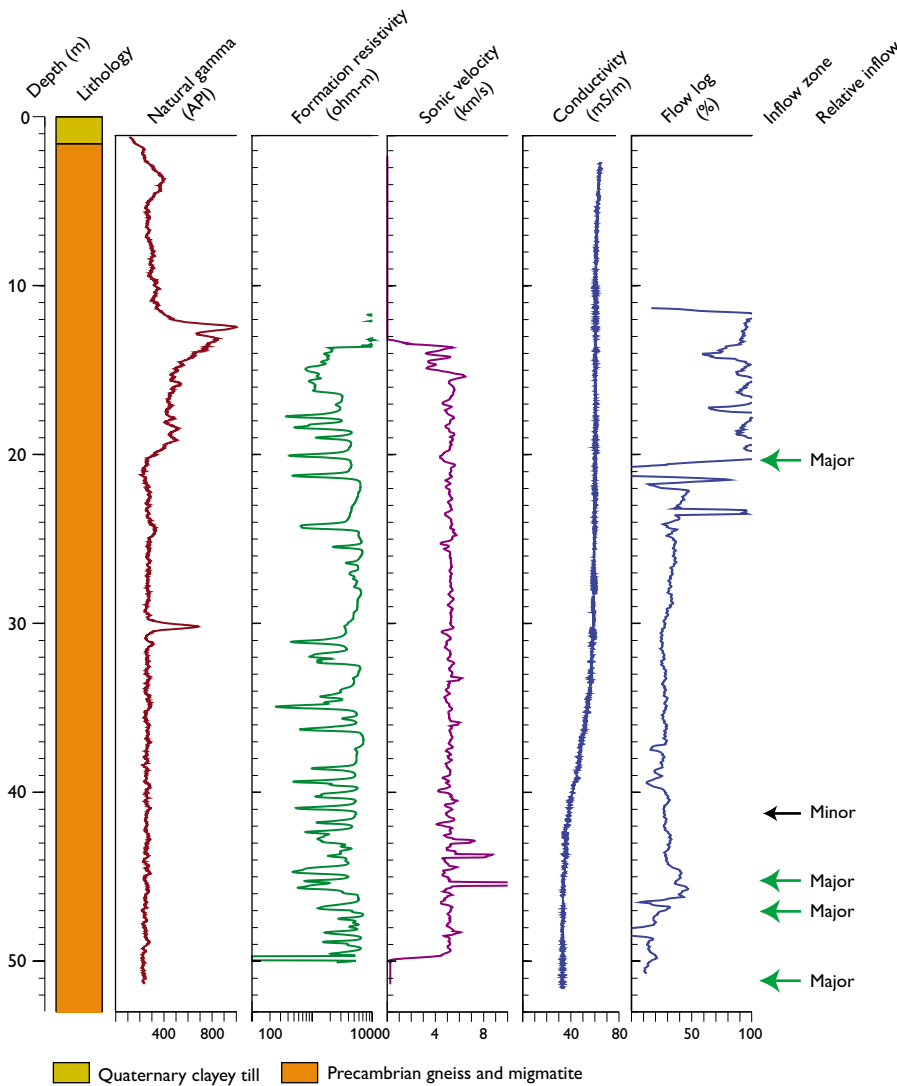
Fig. 3. Lithology and logs in borehole DGU no. 247.458. The flow-log data were acquired at a pumping rate of $1.3 \text{ m}^3 \text{ h}^{-1}$. API: American Petroleum Institute units.

The results from the logging of borehole DGU no. 247.458 are shown in Fig. 3 and two constructed geological sections through the study area are shown in Fig. 4. In the *c.* 5 km long north–south section, the fracture inflow into four boreholes is shown (Fig. 4A). The depths of water flow in the basement rocks indicate the location of fractures and the inflow is evaluated semi-quantitatively as ‘major’ or ‘minor’ in each borehole. ‘Major’ indicates that the fracture inflow contributes a large part of the total inflow whereas ‘minor’ indicates only a minor contribution. ‘Major’ inflows are interpreted from the flow log where an increase in the flow log (%) occurs, measured from the bottom towards the top of the borehole. ‘Minor’ inflows are interpreted from the conductivity log where

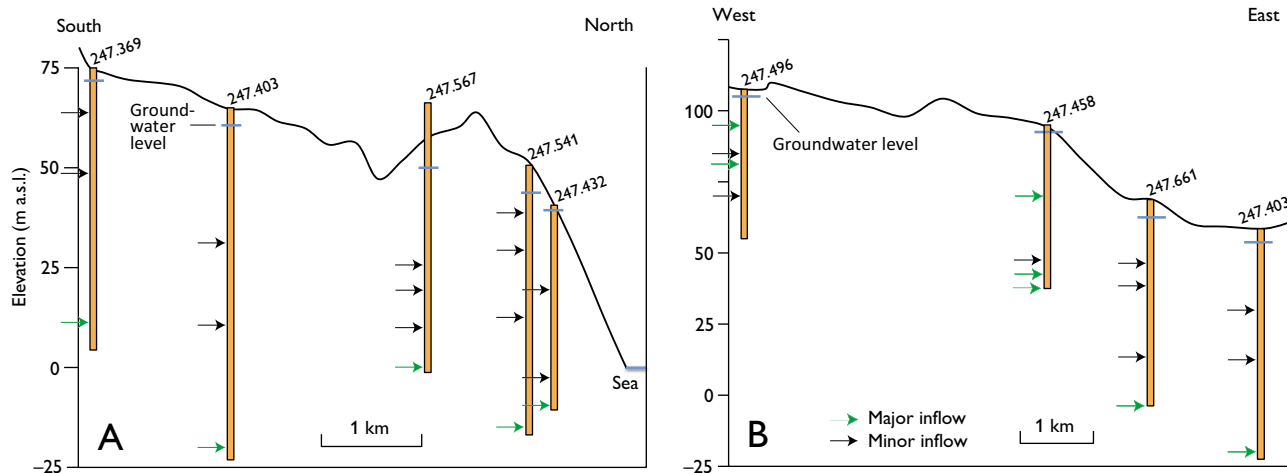
Fig. 4. Two cross sections through the logged boreholes. For location see Fig. 1. Note different horizontal and vertical scales.

changes in conductivity appear. The conductivity log can be more sensitive to minor influx zones than the flow log. It is relevant to compare the boreholes because they have the same low specific yield (0.05–0.22 m³/h⁻¹). Figure 4 shows fracture inflow at four different depth intervals. Major inflow is registered near the bottom of the boreholes and minor fracture inflow is seen closer to the surface. The groundwater table is situated a few metres below the surface in all boreholes.

In the *c.* 8 km long west–east section, fracture inflow is registered between *c.* 100 m a.s.l. and 25 m b.s.l. (Fig. 4B). Borehole DGU no. 247.496 at Østermarie waterworks is included in this section (Rasmussen *et al.* 2007). Inflow is seen in all boreholes but the largest inflow is found at the bottom of borehole DGU no. 247.403. Several important water-bearing fracture zones are found in the waterworks borehole. The fractures occur at shallower depths at at least four levels.
