# Comparison of Corrosion Rate on Paint Coated and Uncoated SS400 Steel

Eko Hariyadi <sup>a</sup>, and Moh. Jufri <sup>b</sup>, Hasan <sup>c</sup>

<sup>a,b,c</sup>Department of Mechanical Engineering, Engineering Faculty  
University of Muhammadiyah Malang  
Jl. Raya Tlogomas No. 246, Malang, Indonesia  
Telp. (0341) 464318-128 Fax. (0341) 460782  
e-mail: [ekohariyadi@umm.ac.id](mailto:ekohariyadi@umm.ac.id)

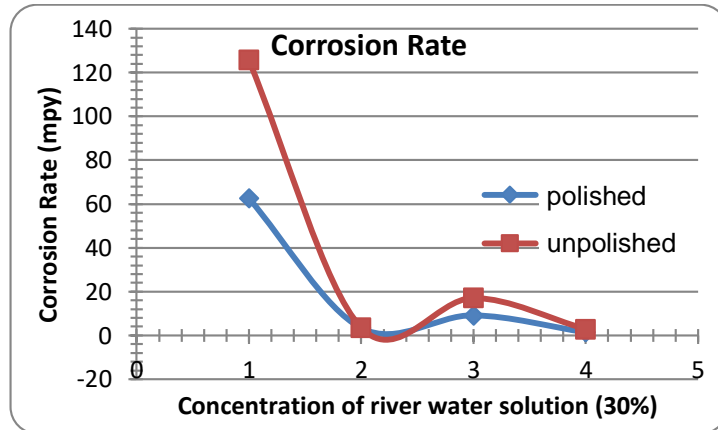
Figure 3.3 Corrosion Rate for Unpolished and Polished Speciment dipped in River Water Solution

Corrosion rate for river water solution gave the similar results. The corrosion rate for uncoated specimen was the highest both for unpolished and polished one. Different paint also gave different result on corrosion rate after dipped into 30% concentration of river water solution for 15 days as shown in Figure 3.3.

Note: 1. Uncoated specimen                    3. Paint coated Avian  
 2. Paint coated Jotun                        4. Paint coated Pylox

Pylox coated specimen was most resilient againts corrosion for 1.33 mpy for polished one and 2.75 mpy for unpolished one. The uncoated specimen was prone to corrosion process for 125.68 mpy. The results were in accordance with previous research [8].

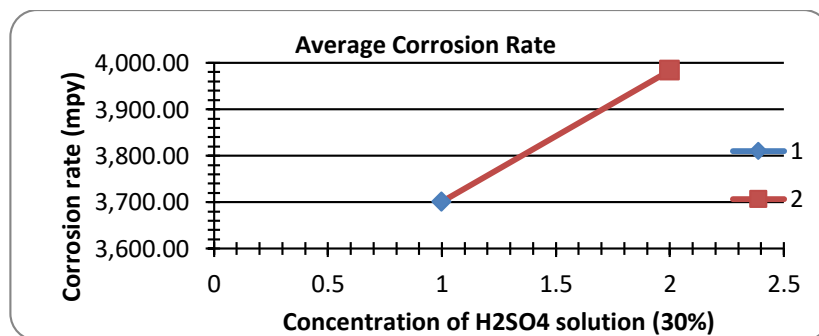
Figure 3.4 Average Corrosion Rate for 30% Concentration of H<sub>2</sub>SO<sub>4</sub> Solution

For H<sub>2</sub>SO<sub>4</sub> solution, the highest average corrosion rate was for the unpolished SS400 steel dipped into 30% concentration of H<sub>2</sub>SO<sub>4</sub> solution for 3,983.64 mpy. The polished one had lower average corrosion rate for 3,700.80 mpy as shown in Figure 3.4.

Note:  
 1. Polished specimen                            2. Unpolished specimen
