# Expert System Source Identification of Excessive Vibration

R. Gordon Kirk and Zenglin Guo

**The importance of vibration data in determining the condition of rotating machinery is well established in both the aircraft and the heavy equipment industries. Installation of noncontact displacement probes for shaft motion and either velocity or acceleration sensors for bearing cap or foundation motion is standard practice for equipment manufacturers. Automation of the diagnostic evaluation of certain simple faults can be easily implemented. The advances in computer languages in recent years have made it difficult to keep pace with the graphical capabilities available to the programmers. One major concern is the content of the knowledge base and the method of modifying the knowledge base or the procedure of evaluating the confidence of a given identified possible cause of a problem. This article addresses the application of one such expert system to a recent vibration problem on a 7-megawatt steam turbine-driven generator located at the power plant of Virginia Polytechnic Institute.**

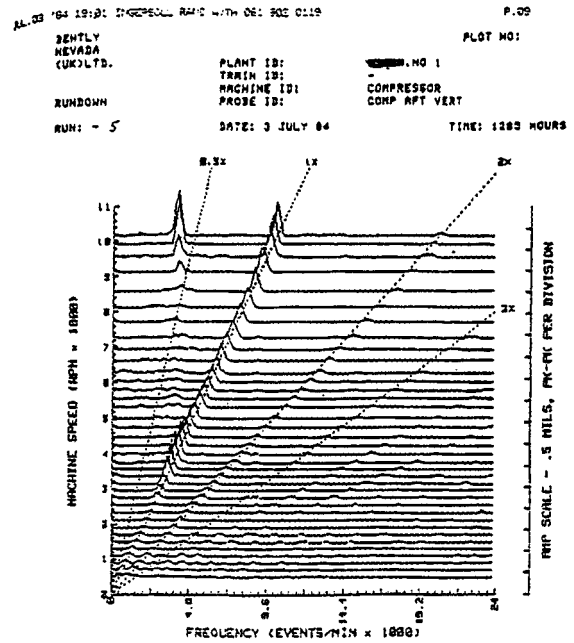
FIGURE 5

(a) Shaft whip instability caused by balance drum labyrinth.  
 (b) Reduced shaft whip instability with balance drum labyrinth radial shunt line.

At high speed and full pressure, with live gas, the same compressor as that referred to in Figures 3 and 4 shows the shaft whip instability, as shown in Figure 5. In this case, the excitation mechanism is not the oil seals, but the gas labyrinth seal of the balance drum. The fix was to provide a purge flow at the balance drum's entry so as to block and prevent the forward-swirling flow from last-stage impeller leakage to the balance drum.

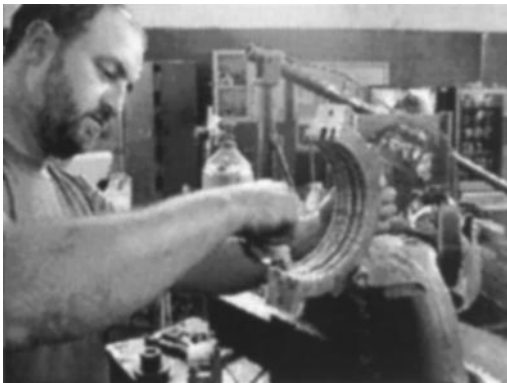
**FIGURE 9**

Scraping in the seal clearance.

bearing. The outer seal was scraped to secure the proper clearance (Figs. 8 and 9). The inner air seal was not removed nor was the clearance increased.

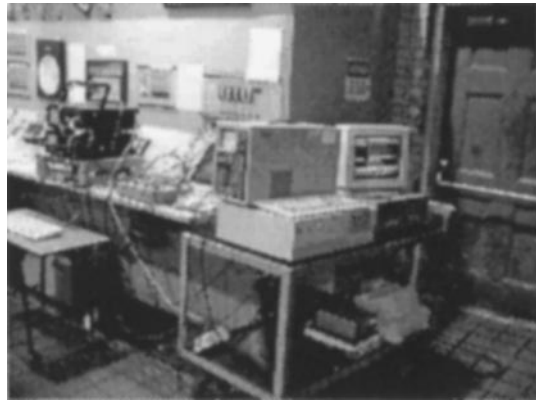
**FIGURE 12**

DAI-108, FFT, DVF-2, orbit O-scopes, switchbox, ADRE computer, and printer.

all eight bearings from the BNC control panel meters, as shown in Figure 12. The set-up was just finished and the first check of the data acquisition system was the start-up. Unfortunately, a high level of 60-cycle ground loop was in the instrumentation, so the at-speed readings were originally in error as they were recorded by the DAI-108. The meters were correctly grounded and isolated. The start-up was recorded using the DAI-108 for documentation of the system's vibration. The meters were all
