# Assessing active and capable faulting as best practice for post-earthquake reconstruction activities: the Sant'Eutizio Abbey case study, in the epicentral area of the 2016 central Italy seismic sequence

Keywords: Post-earthquake reconstruction; Active and capable faulting; 2016 seismic sequence; Sant'Eutizio Abbey; Central Italy.

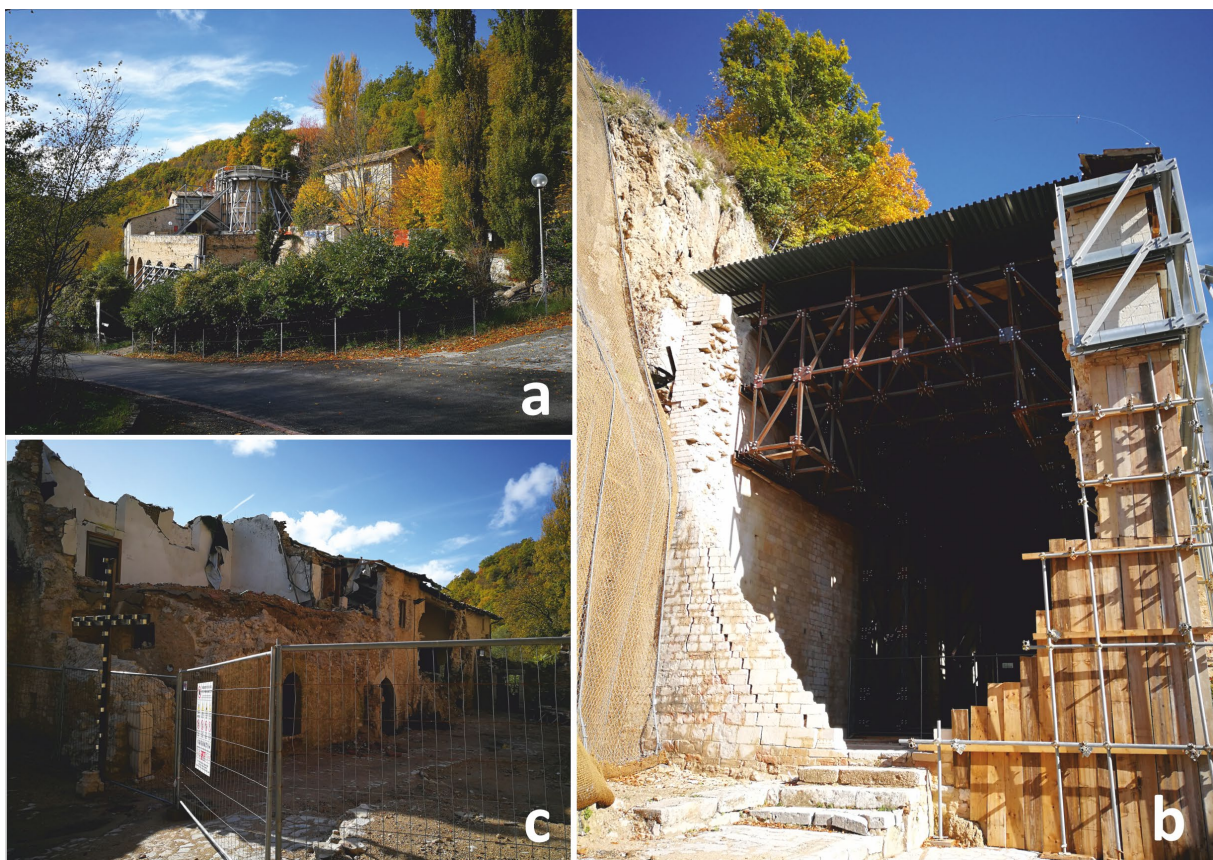
**Figure 1.** (a) View of the Sant'Eutizio Abbey partially collapsed owing to shaking and seismically triggered landfall; The figures (b) and (c) show the church and building severely damaged, respectively.

Some important historical monumental buildings have been severely damaged by the quake, such as the San Benedetto Basilica in the town of Norcia, that almost completely collapsed, and the Sant'Eutizio Abbey (hereafter SEA), near Preci, which underwent partial collapse owing to shaking and seismically triggered landfall (Figure 1). The Abbey is one of the most relevant medieval religious buildings of the central Apennines, being considered the place of origin of the Benedictine Catholic Order.

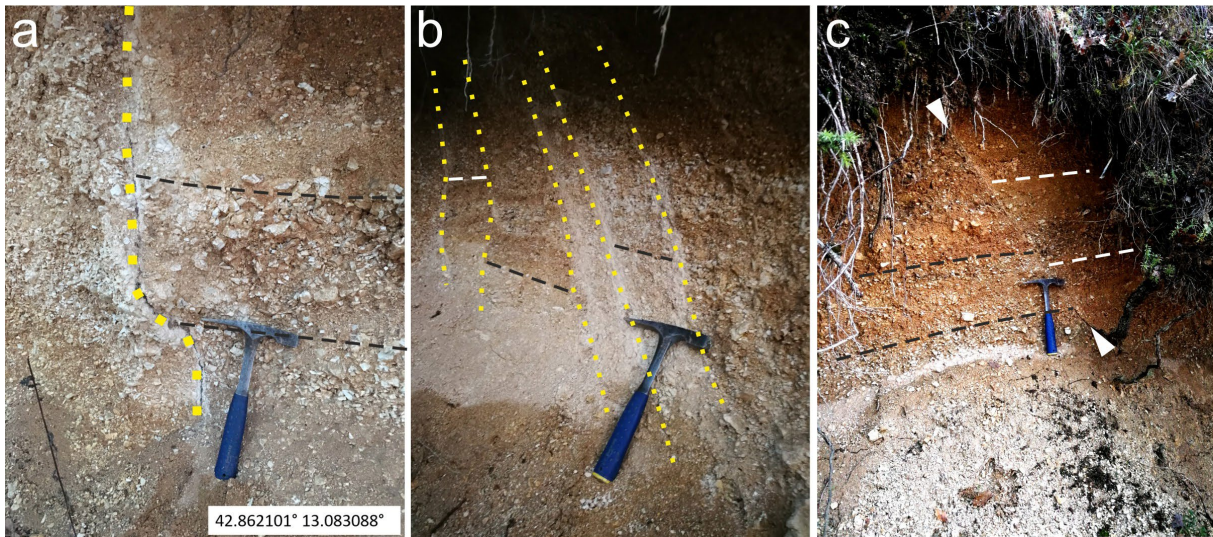
**Figure 8.** (a) Shear plane (marked by yellow dotted line) affecting probably Late Pleistocene-Holocene slope deposits (attitude is marked by black dashed lines) along the gravitational trench. (b) Shear planes (marked by yellow dotted line) affecting probably Late Pleistocene-Holocene slope deposits (attitude is marked by black and white lines) along the gravitational trench. (c) Shear plane (indicated by white triangles) affecting probably Late Pleistocene-Holocene slope deposits (attitude is marked by black and white lines).

In the Campi basin area we found further slope debris affected by shear planes, showing extensional sense of motion (Figure 8a, b, c). Noteworthy, they did not occur along the trace of the CPFs but in the central-southern sector of a NW-SE trending small trough, that affects the slopes bounding the Campi basin to the north. These slope debris are similar by lithology and sedimentological characteristics to those described by Maceroni et al. [2019], thus suggesting a late Quaternary age. Importantly, as described above, the displaced debris occurred within a small trough.

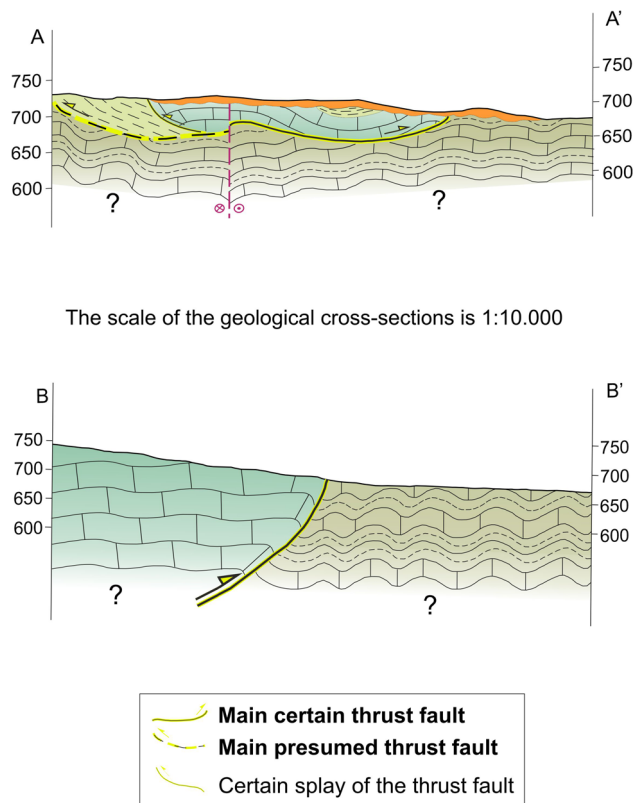
**Figure 17.** Geological cross-sections in the SEA area, that refer to topographic profiles in Figure 16.

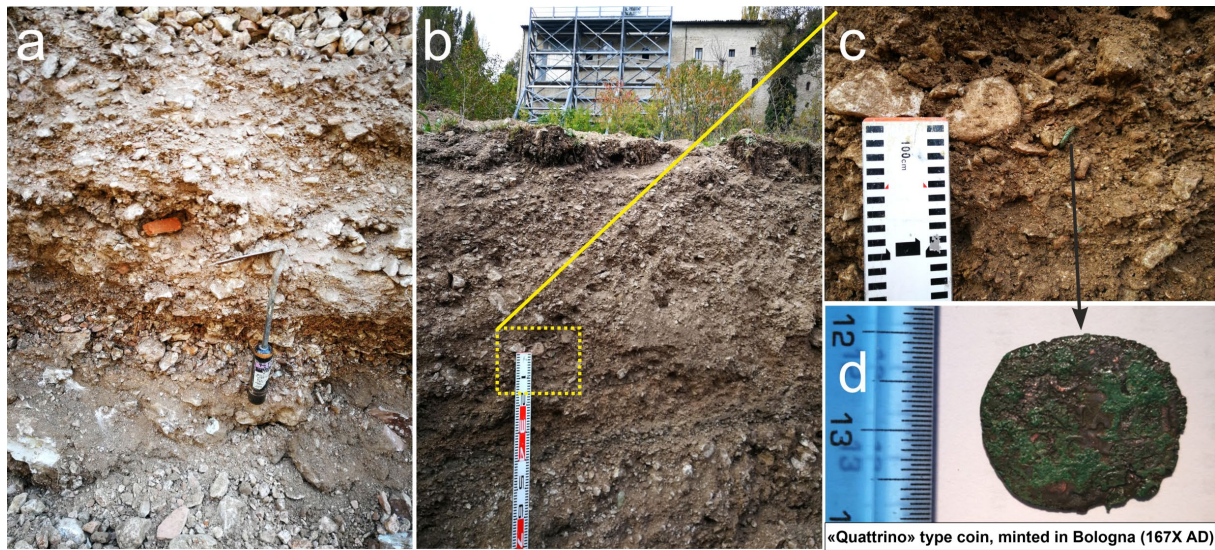
**Figure 20.** (a) Photograph detail of Unit 4 showing a tile or brick fragment (indicated by the yellow arrow) embedded within the carbonate gravel. (b) Section of Unit 1 in which the coin, shown in “c” and “d” was found. (c) and (d) Detail of the “Quattrino” coin found within Unit 1.

Unit 3: it unconformably overlaid Unit 4 through an erosional surface gently dipping towards the SW. The sedimentological features of Unit 3 are very similar to Unit 4. It consists in layered alluvial gravel, made of cm-size to decimeter-size sub-rounded carbonate pebbles, with almost sub-horizontal attitude gently dipping SW-ward. A large number of pottery fragments, brick and tiles fragments and shards have been found within the unit.

Unit 1: it represents a colluvial-alluvial deposit. Towards the SW, it consisted of a colluvial body, made of angular, up-to-cm size carbonate clasts in a sandy matrix, containing abundant pottery fragments, and showing an overall sub-horizontal attitude. A coin has been found in the uppermost portion of the unit (Figure 20b, c, d). It has been archaeologically determined as a “Quattrino” type coin, minted in Bologna (northern Italy) during the seventies of the 17<sup>th</sup> century AD. (i.e. 167x AD). Towards the NE, the colluvial deposits graded into alluvial sediment that showed sub-rounded carbonate pebbles and channel-type structures.
