THE INTERACTION OF FLOODS WITH TRANSPORT INFRASTRUCTURE

IVAN VANÍČEK^{a,*}, JIŘÍ VANÍČEK^b

KEYWORDS: Flood protection, transport infrastructure, dams.

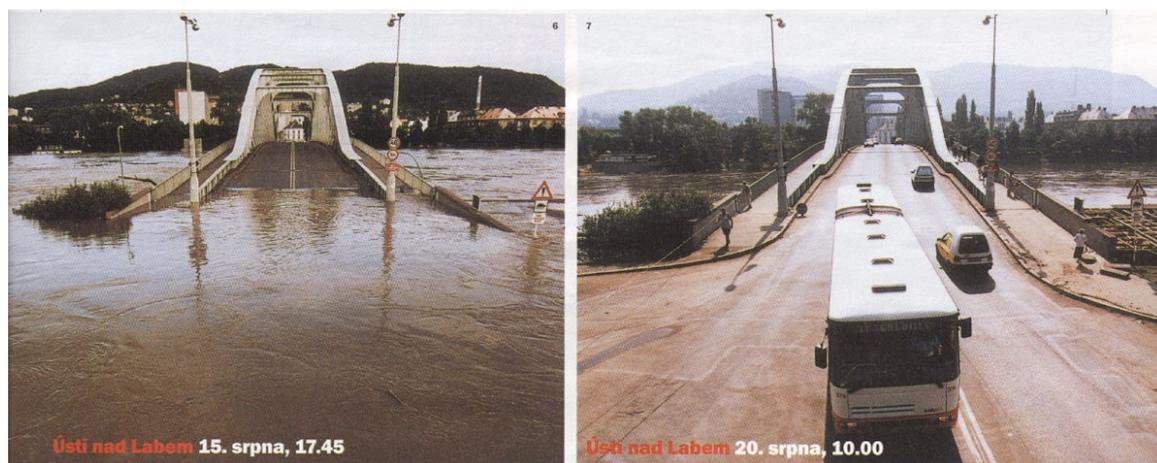
FIGURE 1. Re-opening of the bridge in Ústí nad Labem five days after flooding.

The basic case of interaction studied here is the flooding of transport infrastructure, where the water is above its level and a structure is thus rendered unusable. Nevertheless, often the damage is relatively small and the transport infrastructure can be used shortly after flood wave cessation. The bridge over the river Labe, flooded on August 15 and reopened on August 20, 2002, would be a good example, see Figure 1.

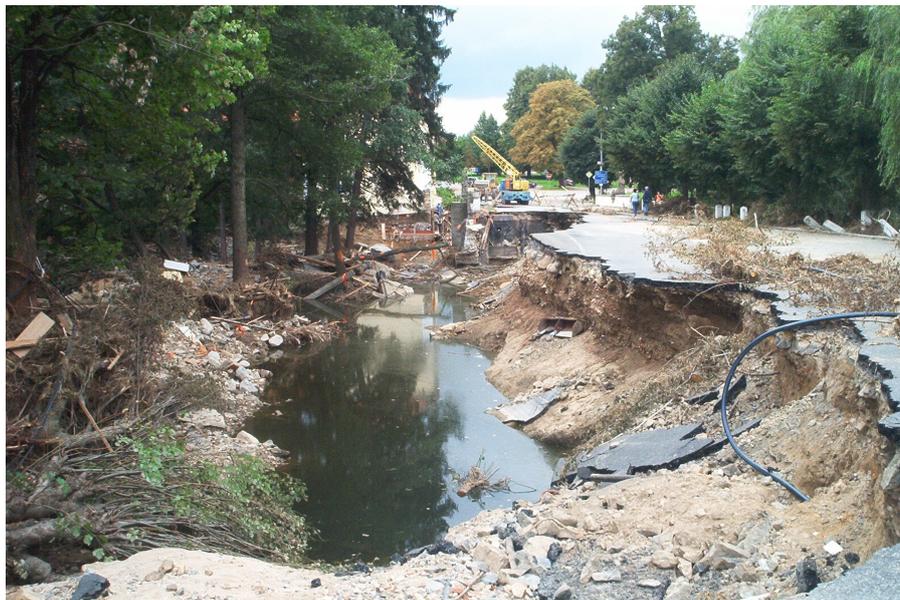
FIGURE 2. Example of disturbance of the downstream slope and crest of a dam which is used as an important communication line – E 49.

For the Lomnice river basin, there was a chance to compare the floods which occurred in 1895 with those in 2002. Although for the first case the crest overflow was smaller, all 7 dams failed. In 2002 two dams did not fail completely, namely the dams the crests of which were covered by an asphalt carpet. Figure 2 shows one such example.

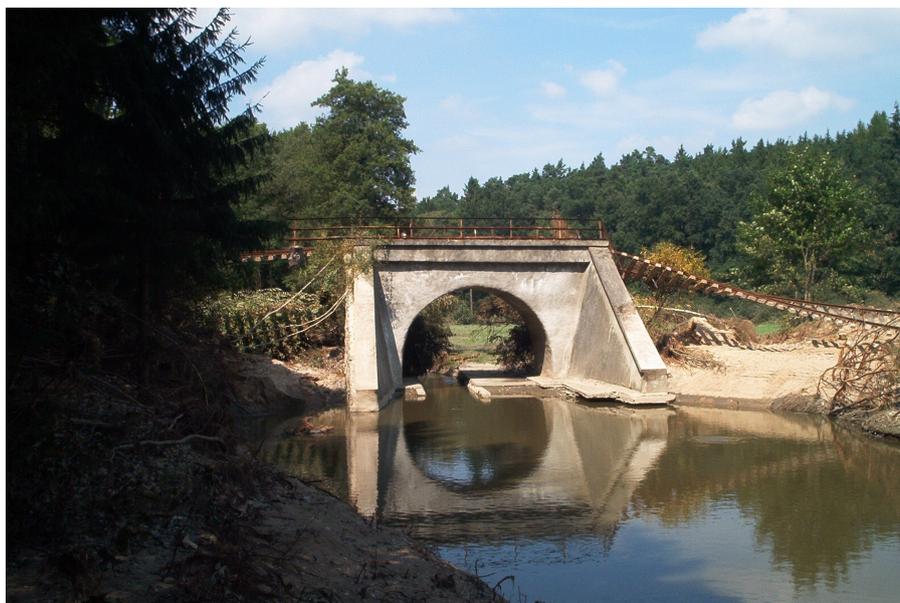
FIGURE 3. The erosion of Blatná – Nepomuk railway embankment. The water table shown on photo is typical for an ordinary flow rate.

Another example of the interaction was observed on this river basin. The river Lomnice crosses the railway track Blatná – Nepomuk. The relatively large culvert

was not able to transfer the supplemental flood wave from the above situated failed dam. This was probably also due to a partially blocked flow profile caused by transported vegetation, by shrub and smaller trees. A subsequent overflowing onto the track started and the erosion left the rails on the track raised above the ground, as shown in Figure 3.

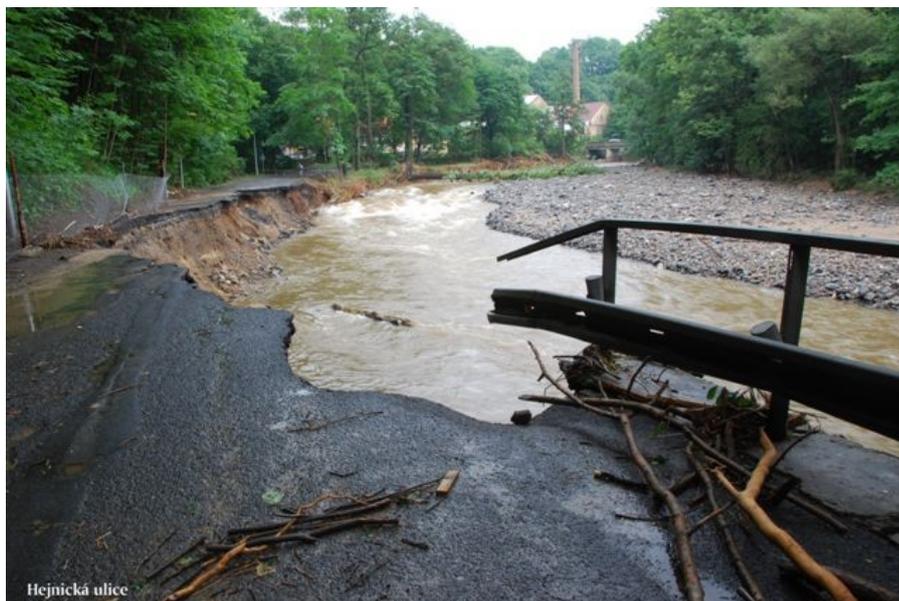
FIGURE 4. An example of lateral erosion of a transport embankment in the Frýdlant region, 2010.

Significant rainfall in the northwest part of Jizera Mountains brings a very quick rise to flood wave on the small rivers Smědá and Řasnice which flow through the town of Frýdlant. Most of the town was flooded on Saturday August 7th, 2010. The roads changed into rivers. Regrettably some people died. Damage to properties, on transport lines and on infrastructures was very high. Figure 4 shows the example where a parallel communication line was partly eroded by water stream in interaction during floods.

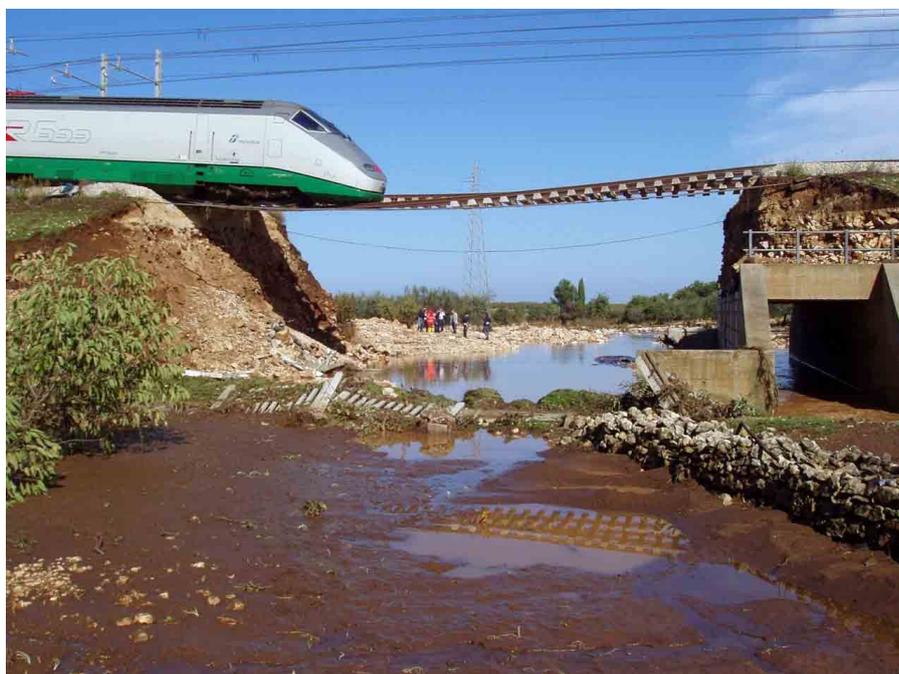
FIGURE 5. Failure of the railway track Bari – Taranto, 2005.

The problem of floods and their interaction with transport infrastructure was the main concern of the study by the post-graduate student M. Burdo [6]. During heavy rainfall the surface runoff was greater than the capacity of the culvert below the railway track Bari – Taranto. The embankment was damaged, and only due to a rather positive coincidence the problem had no exceptional impact as the train stopped just in front of the damaged part of the embankment, see Figure 5. Therefore the major part of this post graduate study was connected with analytical and numerical methods of investigating slope stability, and later on with a combination of more individual aspects. The infiltration of retained water into the partially saturated embankment was simulated, and then the subsequent impact on slope instability was checked. After this the rainfall on the “downstream slope” was also simulated. Air bubbles were enclosed between saturated zones, and with continuing infiltration, the pressure in the air bubbles went up and this can cause the uplift of the saturated downstream slope. Therefore the subsequent collapse can be associated both with internal erosion and with slope instability.
